# Explosion Hazards of Aluminum Finishing Operations

Jérôme Taveau <sup>a,b</sup>, Simone Hochgreb <sup>c</sup>, Saul Lemkowitz <sup>d</sup>, Dirk Roekaerts <sup>b,e</sup>

<sup>a</sup> Fike Corporation, Blue Springs, MO, USA

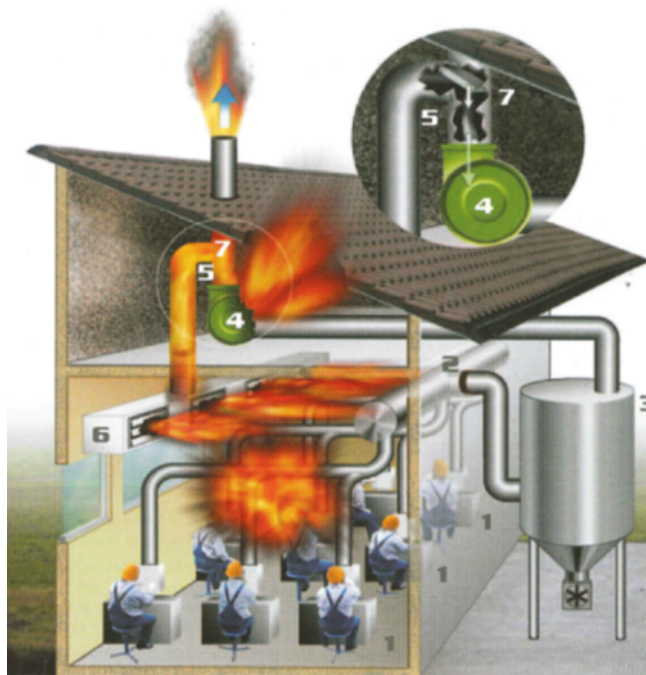
A very similar case to the Manitowoc explosion that happened many years after is discussed in a booklet published by the International Social Security Association (ISSA, 2005). The explosion took place in a facility where finishing work of cast aluminum parts was ongoing (Figure 3). The working stations were all equipped with a central dust collection connected to an extraction fan and a water-filled dust separator placed outside the building. Ignition was initiated by the shock of an air flap falling into the fan, causing an initial explosion in the ducting. The explosion propagated within the recirculating air ducting, which blew and ignited dust into the grinding room, and killed all eight workers. The grinding building was completely destroyed. The recommendations in the ISSA booklet highlighted the importance of avoiding a recirculating air system, unless the ducting is equipped with an explosion isolation system that can prevent the flame from propagating back to the building in case of an explosion.

Figure 3: Aluminum dust explosion in a grinding room (ISSA, 2005)

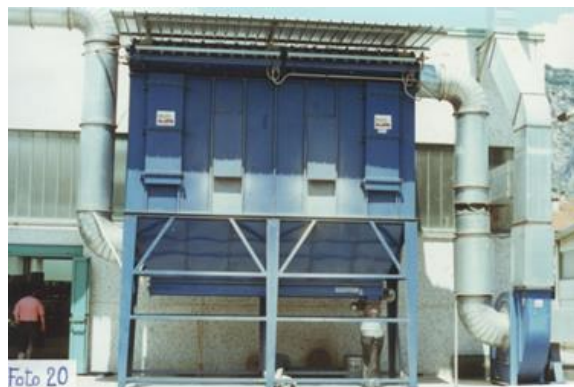
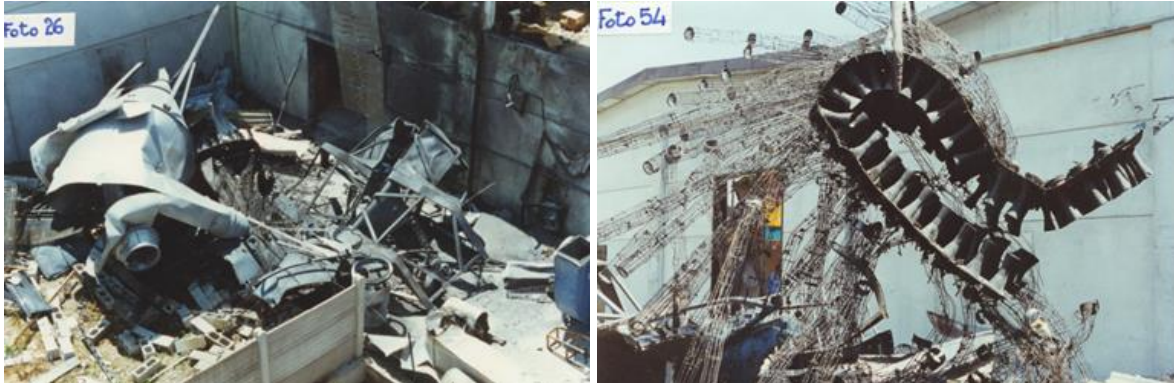
- A second accident (2000) took place in a small factory in the North-West of Italy (Marmo et al., 2015) where polishing and other surface finishing operations were routinely conducted on aluminum coffee pots using sixteen grinding machines. The dust was captured through sixteen drawholes and sent to a cyclone followed by a bag filter. The filter was equipped with four overpressure relief panels hinged to their upper parts, which were weighed down with four metallic 1.2 kg plates. The explosion destroyed the equipment and threw ejected equipment beyond 60 m. Three workers were slightly injured. The first deflagration happened inside one of the grinding machines and was caused by the breakage of one belt. Sparks and burning particles were aspirated by the abatement plant, causing the aluminum dust to ignite in the lower part of the cyclone, giving rise to the first major explosion. The cyclone collapsed and the pipes connected to the machines broke, releasing aluminum dust in the work areas. The flame front propagated to the bag filter, causing a second more violent explosion. Figure 4 shows the bag filter before and after the event.

Figure 4a. Bagfilter before the aluminum dust explosion (Marmo et al., 2015)

Figures 4b and 4c. Bagfilter before after the aluminum dust explosion (Marmo et al., 2015)

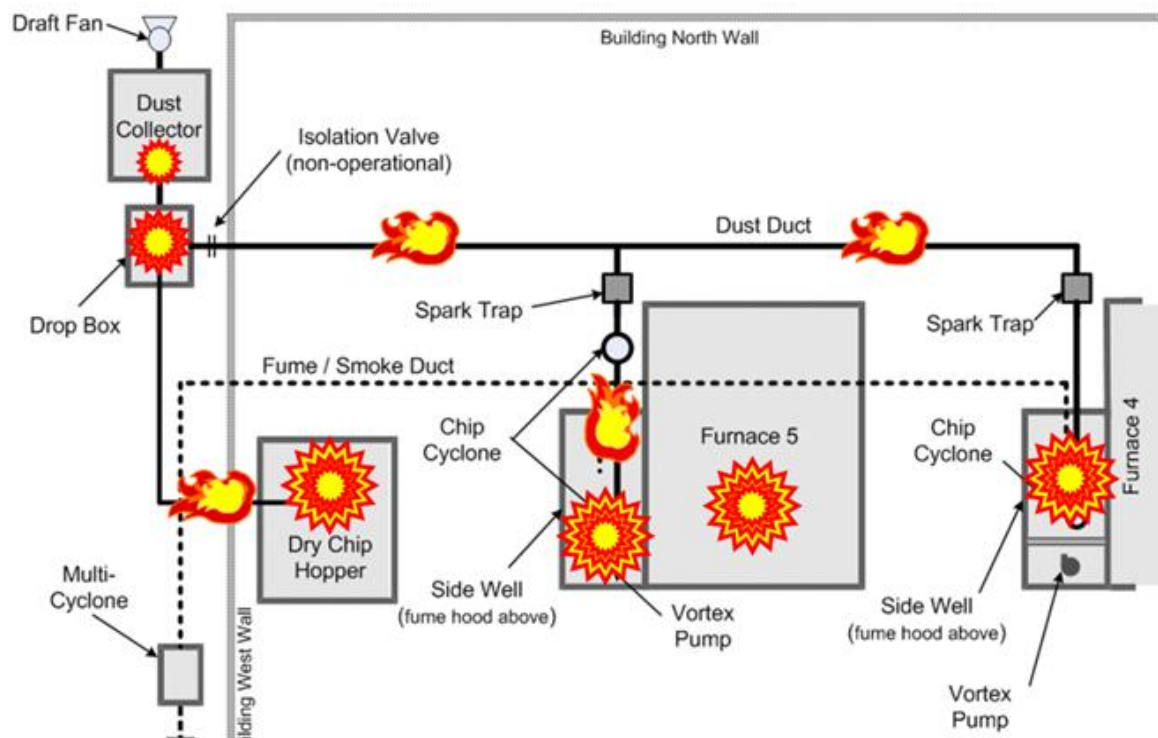
On October 29<sup>th</sup>, 2003, a deflagration started in the dust collector of a cast aluminum automotive wheels manufacturing plant located in Huntington, Indiana, and propagated to a drop box, interconnected pipes and finally to the plant (Figure 5). The deflagration caused major damage to the dust collector: the vent panels and three maintenance doors were blown open, the top section of the housing was dislodged and the cleanout section was distorted. According to the Chemical Safety Board (2005) which investigated the accident, this damage shows that the venting was not sufficient to prevent structural damage to the dust collector caused by the overpressure generated in this accident. The drop box, on the other hand, failed and fractured into several large pieces (Figures 6).

Figure 5: Assumed sequence of events (from top left): ignition in the dust collector, larger explosion in the drop box and propagation to other process areas (adapted from the Chemical Safety Board, 2005)

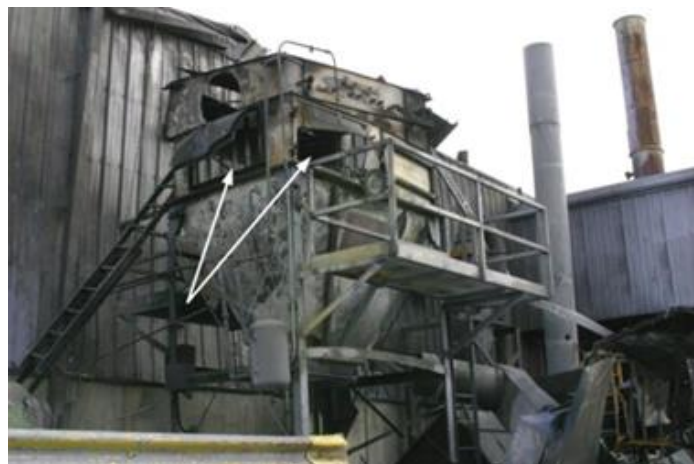
Figure 6a. Damage to the dust collector (Chemical Safety Board, 2005)

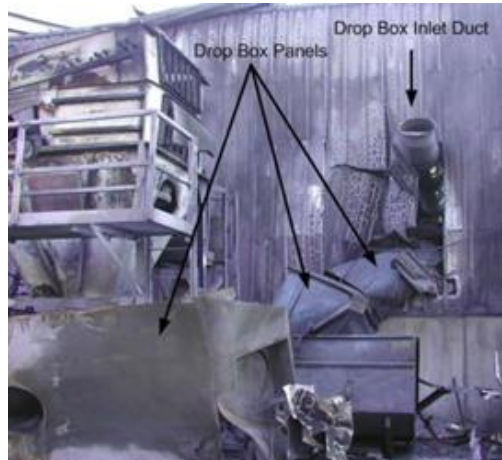
Figure 6b. Damage to the drop box (Chemical Safety Board, 2005)

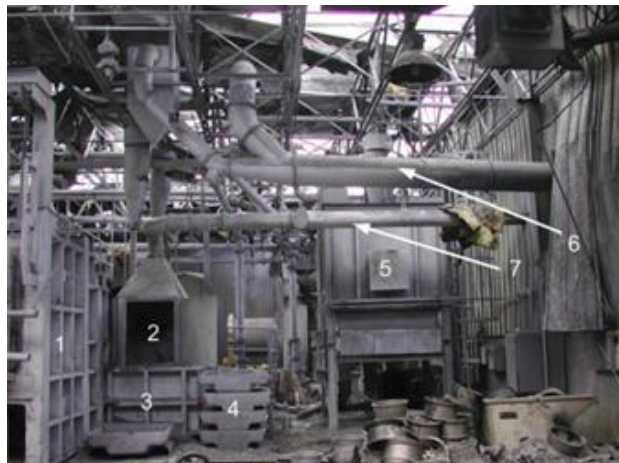
Figure 6c. Damage to the interior of the facility (Chemical Safety Board, 2005)

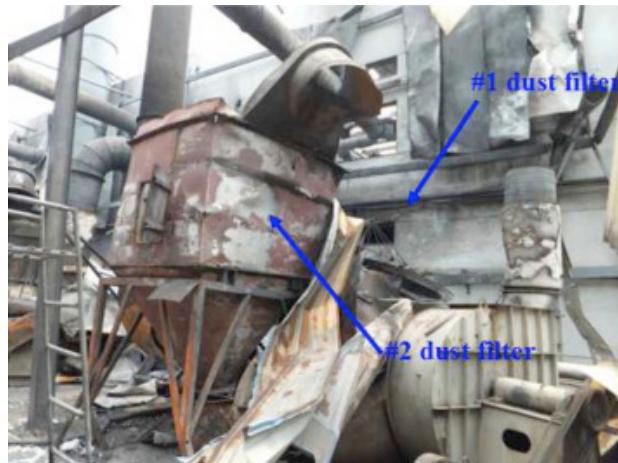
Figure 7b: Damage to the dust collectors (Li et al., 2016)

The investigation concluded that the primary deflagration started in a dust collector located outside, which then propagated into the main building via the dust extraction system. Ignition was determined to be the self-heating of aluminum dust in a collecting barrel below one of the dust collectors. Some dust samples were collected across the facility. The results of tests using the collected powders are given in Table 2. The authors underline that the presence of explosion isolation systems in the ducting would have limited the consequences of the deflagration substantially. They also point out the difficulties of isolating deflagrations involving highly reactive dusts, especially when dust collectors and work rooms are separated by short distances.

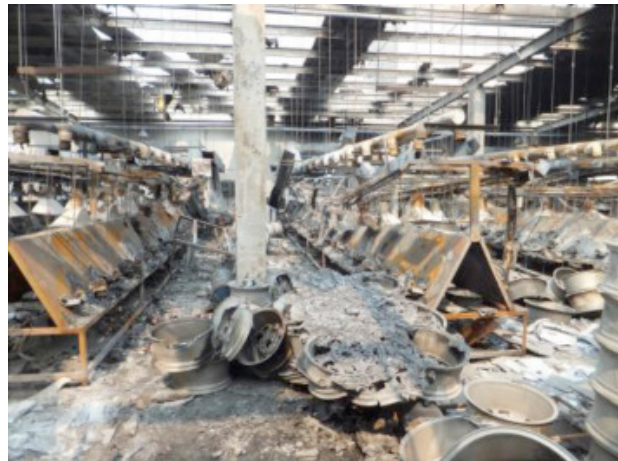
Figure 7c: Damage to the production lines and work stations (Li et al., 2016)

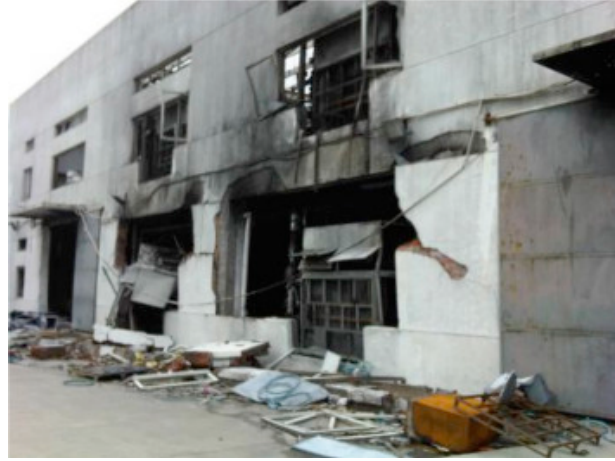
On August 2<sup>nd</sup>, 2014, an aluminum dust deflagration took place in an automotive parts factory of Jiangsu province, killing 146 people and injuring 114 people (Li et al., 2016). The explosion was heard several kilometers away, and shattered glass up to 500 meters away (Figures 7).

Figure 7d: Damage to the eastern wall of the main building (Li et al., 2016)

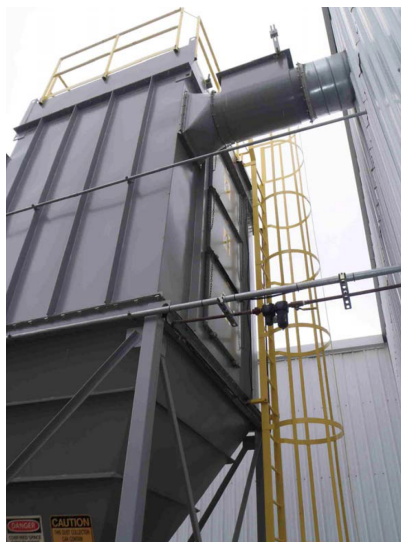
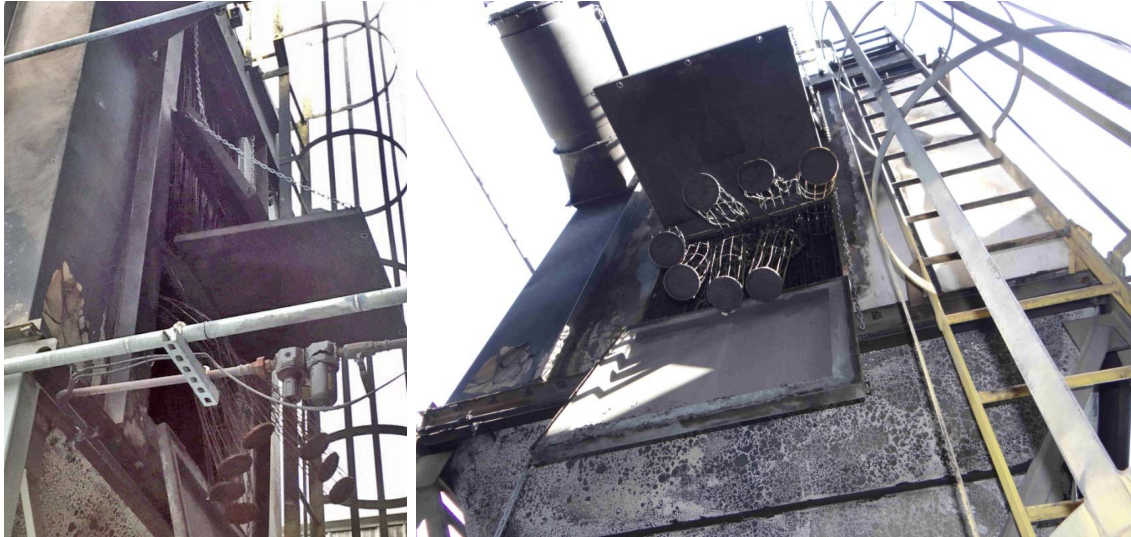
A recent incident, referred in a public input to NFPA 68 2013 edition (Luzik, 2015), further questions the scalability of aluminum dust explosibility parameters. The dust involved in this incident was an aluminum alloy with a tested  $K_{St} = 186$  bar.m/s. While the installed vent area (20.4 ft<sup>2</sup>) exceeded the required vent area per NFPA 68 (17.9 ft<sup>2</sup>), the dust collector experienced significant structural deformation during the deflagration (Figures 11), suggesting that the internal pressure was higher than calculated.

Figures 11b and 11c: Dust collector after the deflagration: filters blown through the vents (Luzik, 2015)

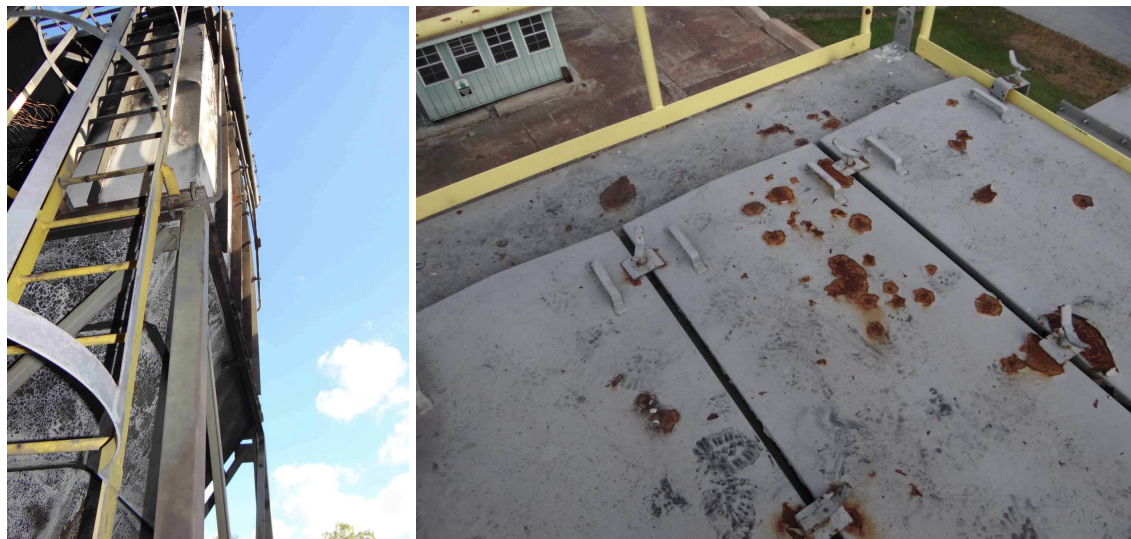
Figure 11d and 11e: Dust collector after the deflagration: deformation of the reinforced wall and access doors (Luzik, 2015)
