Prestressing in Coventry Cathedral

Chris Burgoyne*

Abstract

Keywords: Prestressed Concrete, Corrosion

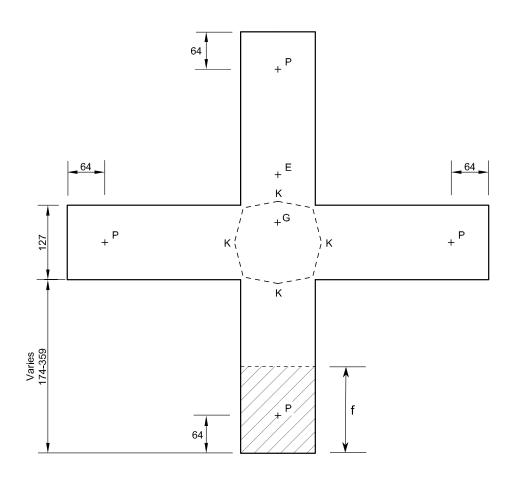
Figure 18: Canopy column cross-section. All dimensions in mm. The points labelled K define the central area within which the axial force must be applied to induce compression everywhere. Point E is the location of the centroid of the three remaining tendons if the bottom tendon completely corrodes away. The shaded area at the bottom would be cracked with only three tendons and the centroid of the resulting area would be at G.

Suppose that one of the four tendons corroded completely. Figure 18 shows the Kern points (K) for the section which define the area within which an axial force has to be applied if the section is to remain everywhere in compression. Also shown in the figure is the location (E) where the resultant of the three remaining tendons would act if one tendon (the bottom one in the figure) completely failed. E lies outside K so the prestress would cause the section to go into tension, and if it cracked completely in tension it would crack to a depth f. The stiffness of the column would then reduce, making buckling more likely. Because the section varies over its height, f varies with height, being about 47 mm at the bottom but nearly 200 mm at the top. The reduction in stiffness varies from 24% at the bottom to 47% at the top, and when the Rayleigh buckling analysis is repeated for this case the critical load drops to 2,820 kN if clamped at the top (Table 7), which is still significantly in excess of the applied load of 247 kN.

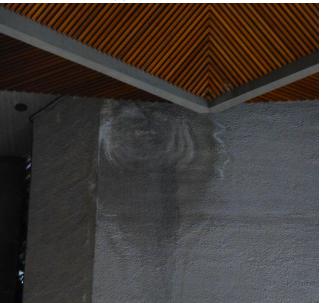
(b) Internal water stainingFigure 19: Roof drainage

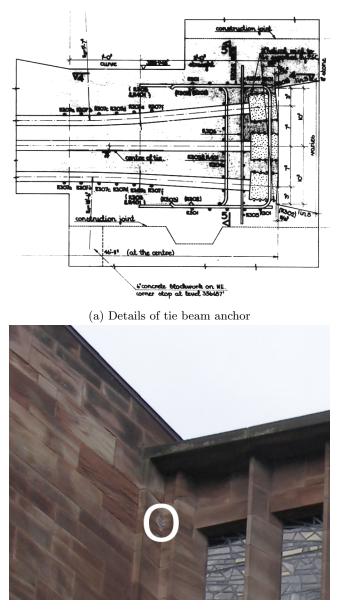
Immediately above the anchors themselves is the parapet wall that extends upwards, but next to it is the low point on the roof, where the water collects before flowing to the drain. Figure 21b shows a photograph of the outside of the wall at one of the tie-beam anchorage locations. The approximate location of the anchorage is shown by the white circle. The stone is, to some extent, porous, as is the concrete, so it must be presumed that in certain weather conditions dampness will get to the face of the anchorage. What is not certain is whether sufficient moisture can penetrate past the anchor to allow corrosion to take place in the tendon itself.

The most likely position for corrosion is thus likely to be immediately behind the anchorage. If the tendon is properly grouted, the tendon can be expected to reanchor itself post-fracture after a suitable transition length - perhaps 30 tendon diameters. In a conventional prestressed beam, which carries load by flexure, that rebonding would probably be sufficient because the maximum flexure could be expected to occur at mid-span. But in a tension tie the force must be carried from end to end, so the anchorage itself is important. Some of the force to be reacted is imposed by the inclined rib at the tie location (Figure 20) and this could be applied along the length of the tie, so bond would be effective. However, each tie has to react the force from two other ribs, and tie 603/1 also has to carry the forces from the baptistry roof: these forces can only enter the tie via the roof of the hallowing place and then through the anchorage, which is thus critical.

(b) Approximate location of the beam anchor as viewed from outside

Figure 21: Tendon anchorage at end of a tie beam

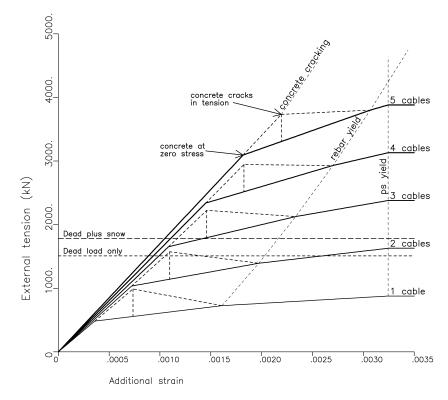
Figure 22 shows the expected strain response of this tie to an externally applied axial tension. The dead load of the roof causes a tension of 1,510 kN, but this increases to 1,781 kN when the snow load is added. Several lines are shown on the figure, corresponding to different numbers of effective tendons; the upper solid line shows the expected response as built. If the external tension were somehow increased, the concrete would go into tension at about 3,100 kN, or almost double the normal dead load. If the concrete immediately cracked, it would follow the solid line until the rebars yield at a tension of 3,800 kN, and the tie would continue to carry load until the prestress yielded at about 3,900 kN. This ignores the tensile capacity of the concrete, the effect of which is shown as a higher dotted line. The original stiffness of the tie would be maintained until the tensile strength of the concrete was reached, at which point the section would crack very quickly. It is assumed that all tension stiffening would have been eliminated by the time the rebar yielded.

Figure 22 also shows similar lines for different numbers of tendons; these reflect how the tie would behave if some tendons were removed. With four the section would still be fully prestressed under the dead and snow loads, but if only three tendons remained the concrete would be in tension under snow load. With two tendons it would be severely cracked and would be relying on the rebar and the very high strength of the remaining prestressing tendons.

Figure 22: Variation of stress in tie 603/4

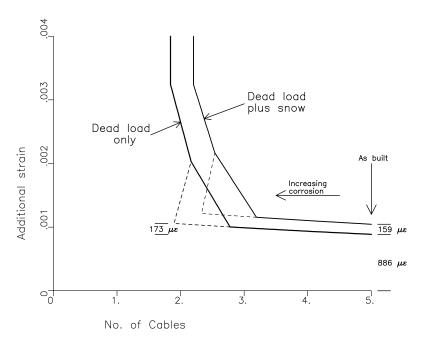
What could be observed if the tendons corroded slowly over time? Figure 23 shows the same data plotted in a different way, with two lines showing the strains in the tie, measured relative to the initial condition after prestressing, for the two loading cases: dead load only and dead load plus snow. The as-built condition is at the extreme right of the diagram, when all prestressing losses have occurred but there has been no corrosion, so all five tendons are effective. The tie has a tensile strain of 0.000886 relative to its prestressed but unloaded state. It would only increase by a further 159 $\mu\varepsilon$ if the full snow load were applied.

Figure 23: Variation of strain at constant load for Tie 603/4

If corrosion occurs, the number of effective tendons decreases, so the loading moves to the left on the diagram; fractional loss of tendons is possible, at least locally, because individual wires can break or lose sectional area. As with Figure 22, the solid line shows the response if the tensile strength of the concrete is ignored, with the dotted lines showing the likely effect of tension stiffening. With the tie subject only to the permanent dead load, the strain would only increase by 173 $\mu\varepsilon$ when the concrete cracks in tension, by which time only about 1.9 of the tendons would be effective. Although some of the prestress is being lost, enough is present for the concrete still to carry the load.

The important conclusion from this result is that the effect would almost certainly not be noticeable. Tie 603/4 is 28.1 m long, so a strain of 173 µ ε corresponds to a change in length of 4.9 mm. But that would only occur if the tendon were unbonded, or to corrode uniformly over its whole length, which is very unlikely. If the broken wires reconnected with the concrete over a length of 1 m, which seems not unreasonable, the change in length of the tie would only be 0.17 mm. This would not be noticed and is the same extension that would be caused by a temperature change of only 0.6°C, assuming that the concrete has a coefficient of thermal expansion of 1×10^{-5} per °C.
