CONSERVATION TREATMENT RECORD

Lab number: 8430
 Brief description: Cu Alloy Brooch
 Name of owner: S. Thomas
 Owner's number: n/a

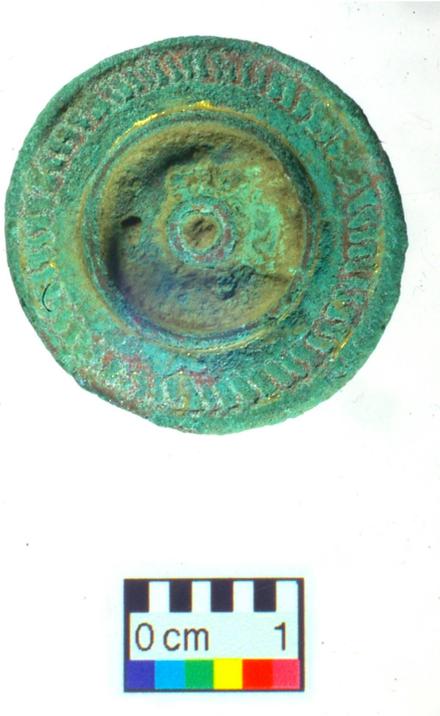
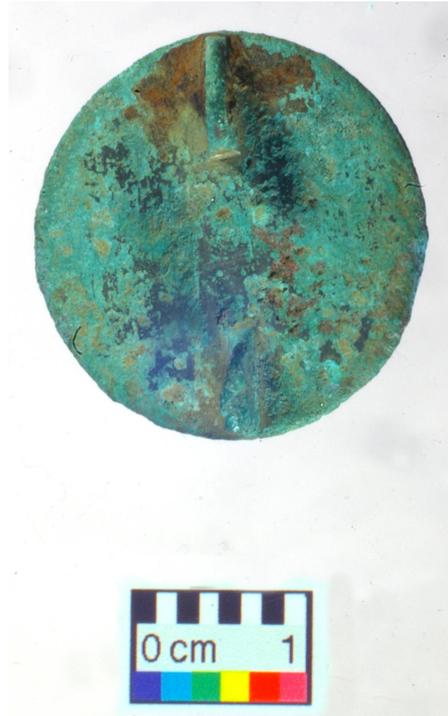
Before Treatment

<p>Examination Microscopic examination revealed gilding remaining on the front of the brooch, and textile pseudomorphs present in the corrosion products on the back of the brooch.</p> <p>Tests / analysis The brooch was examined using optical microscopy, scanning electron microscopy, and x-ray fluorescence spectroscopy.</p>	
<p>Justification for treatment Treatment was undertaken in order to remove dirt and soil remaining from burial, as well as to remove disfiguring corrosion. In order to enable future study the object was not given a protective surface coating.</p>	
<p>Cleaning The brooch was initially cleaned by submerging it in Industrial Methylated Spirits and cleaning with a soft brush. This was followed by careful glass bristle brushing to emphasize the surface decoration.</p>	
<p>Stabilisation N/A</p>	
<p>Reconstruction / repair N/A</p>	
<p>Loss compensation N/A</p>

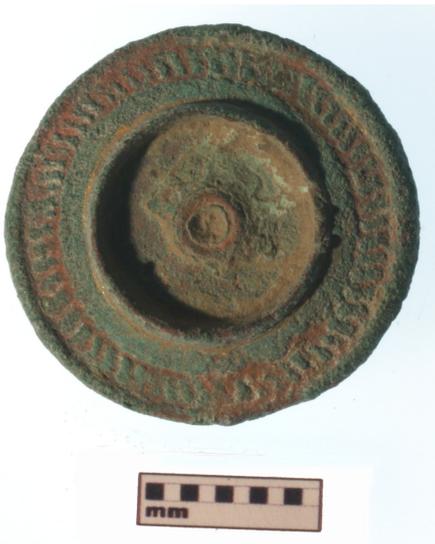
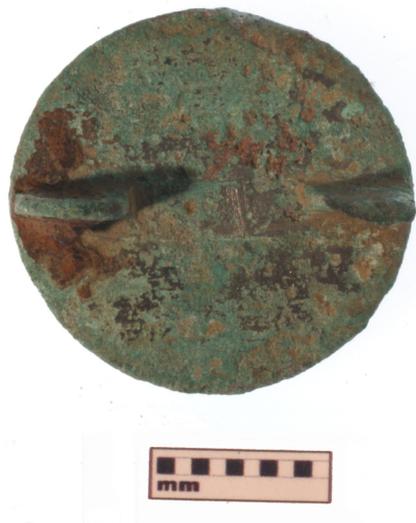
After Treatment

Other	
Packaging The object was packaged for return to its owner. Silica gel was not included in the packaging as it is unlikely it would be maintained upon return of the object.	
Condition after treatment The object is stable, and the excess soil and dirt was removed from the surface. The surface decoration has been emphasized through the careful glass bristle brushing.	
Student evaluation of treatment The object was successfully cleaned, and the textile pseudomorphs present on the back of the brooch were documented through scanning electron microscopic imaging. No gilding was damaged during the cleaning process.	
Recommendations for further care The object should be checked regularly for further corrosion. The object should be handled carefully to prevent dislodging any remaining gilding or damaging the pseudomorphs on the back of the brooch.	
Photography / other illustrations <i>Colour slides/prints enclosed</i>	Other documentation (analytical, object report, etc) XRF and SEM data enclosed
