# The Marsh Lane Railway Viaduct: 2 years of monitoring with combined sensing and surveying technologies

Abstract. Marsh Lane viaduct is a typical example of a 19th century brick masonry railway arch in the UK. It frequently carries passenger trains to and from Leeds Station. This paper broadly discusses the sensing techniques and associated analysis procedures used to (i) identify the reasons for existing damage, (ii) quantify their impact on the dynamic response of the structure and (iii) measure degradation of the response over a period of one year. To identify existing damage, distortions in geometry of the structure are examined with new point cloud processing techniques. With the aid of limit analyses, these distortions are interpreted, and past support movements which may have caused the distortions are identified. Then, to measure the dynamic response of the bridge, quasidistributed fibre optic strain sensing and digital image correlation displacement measurement techniques are used. These highlight the increased dynamic response around locations of existing damage, and point out to the global mechanisms of response that could propagate damage. Continuous fibre optic strai

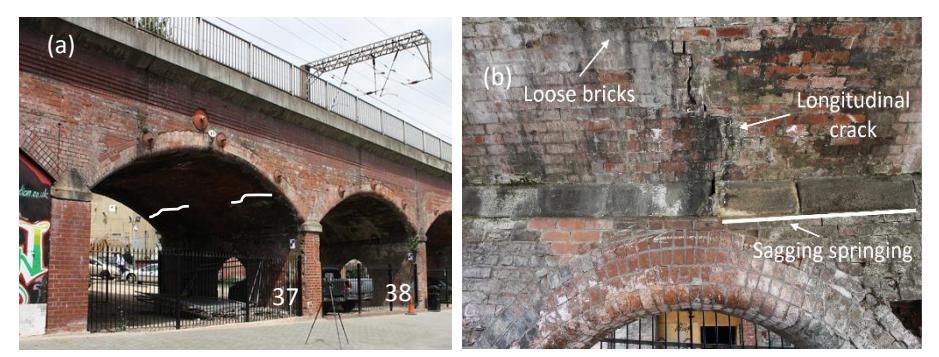
Visible structural damage is evident in Arches 37 and 38. Key aspects of the damage is reported here, for more details refer to [1]. Significant transverse rotations are observed in the pier between 37 and 38, which are visible in Fig. 1b. Notably, the skewback stones decline in elevation on both sides of the relieving arch, resulting in a sagging springing line. Cracking in the relieving arch suggests an accompanying spreading mechanism where pier blocks to the left and right side of the relieving arch rotate in the transverse direction towards the spandrel walls. The longitudinal crack emanating from the relieving arch in Fig. 1b, is indicative of this. A seemingly independent transverse arch barrel crack was observed above the backing of the pier between Arches 37 and 38 (sketched in Fig. 1a). This crack resulted in significant water ingress and loss of mortar joints.

**Fig. 1.** (a) A side view of the Arches 37 and 38 of the Marsh Lane Viaduct and (b) a photo of the damage observed in the pier and Arch 38 barrel around the relieving arch located between Arches 37 and 38.

Various structural interventions were conducted to arrest the transverse movements observed in the arch barrel and piers. In the 1990s, ties were installed through the arch barrel to limit further opening of longitudinal barrel cracks (sketched in Fig. 1a). In September 2015, several additional ties were installed on the piers close to the ground level and on the spandrel walls. Furthermore, the relieving arch was tied internally with steel bars and filled with concrete. Some existing cracks were grouted and stitched.

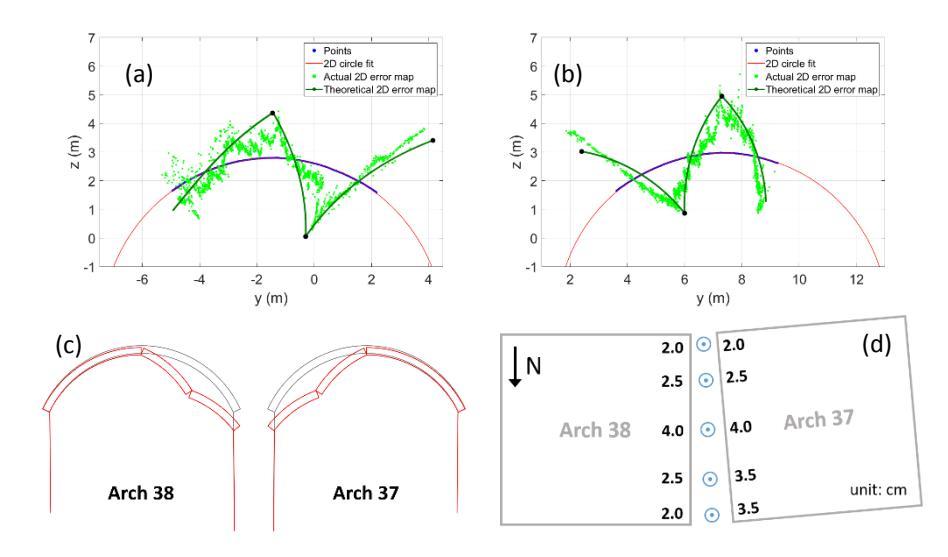
**Fig. 2.** Error map (x100 magnification) describing the discrepancy between the 2D point cloud slice and fitted circle for Arch (a) 38 and (b) 37. (c) The identified three hinge mechanism and support movement is illustrated with a schematic and (d) a plan view of the arches shows the relative settlement of the pier between Arch 37 and 38 identified from the analyses.

The discrepancies between the fitted shape and the actual point cloud is informative. This is shown in Fig. 2a and b for longitudinal arch slices passing through the centrelines of Arch 38 and 37. The real point cloud and the fitted circle are shown with blue dot markers and a red line in the background. In the foreground, green points demonstrate the discrepancy between the real point cloud and fitted shape. These error maps plot the discrepancies with 100 times magnification on the fitted shape. It is interesting to note that sharp kinks are observed in these error maps, and the distortions in Arches 38 and 37 look like mirror images of each other.

To understand the implications of these geometrical distortions, kinematic analyses were conducted on mechanisms of three hinged arches with various support movements. It was assumed that the kinks in the error maps describe hinges, where a rotational discontinuity is observed. Then, considering the mirror image symmetry in the Arch 38 and 37 error maps, it was postulated that a purely vertical support movement occurred at the pier between Arches 38 and 37. 4cm of vertical settlement at this pier, resulted in distorted theoretical arch shapes which were fitted with circles. Error maps associated to these theoretical distortions are shown in Fig. 2a and 2b with black lines and demonstrate excellent agreement with the error maps. This indicates that 4cm vertical support settlement of the pier at the centreline of the bridge (coinciding with the crown of the relieving arch) could explain the distortions in bridge geometry.

The kinematic mechanism and associated support movement identified using this approach are schematically shown in Fig. 2c. This mechanism indicates the presence of an extrados hinge near the quarter span of the arches. This is consistent with the presence of a transverse arch barrel crack which was discussed earlier (see Fig. 1a). Finally, Fig. 2d shows the settlements inferred from distorted arch barrel geometry across the width of the bridge. This analysis also clearly indicates that the settlements are the greatest at the bridge centreline, reducing in magnitude towards the spandrels.

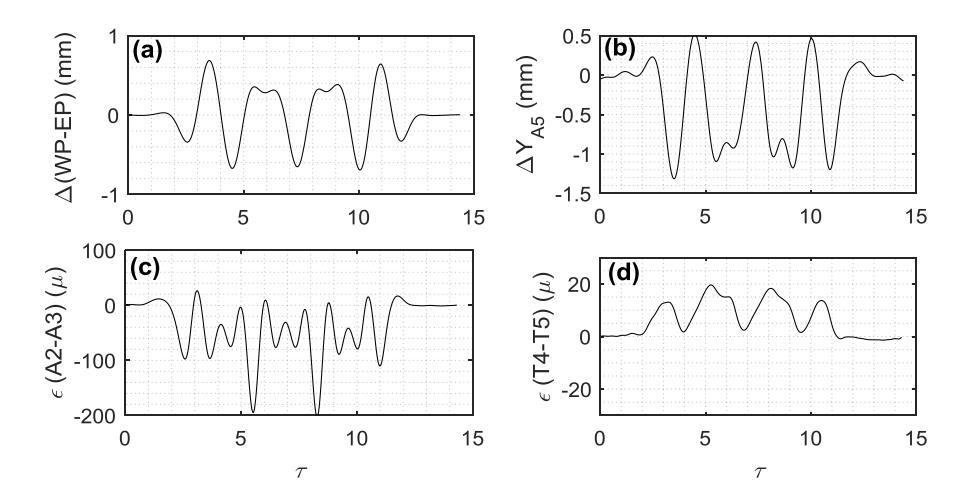
**Fig. 4.** (a) Span opening and closing, (b) crown vertical displacement, (c) longitudinal strain measurement over the transverse crack and (d) transverse strain measurement around the longitudinal crack tip during the passage of an eastbound Class 185 train on the northern side of Arch 38.

Fig. 4 presents critical dynamic displacement and strain measurements recorded during the passage of a Class 185 train. In the x-axis,  $\tau$  is a dimensionless time parameter, normalized by train speed and arch span. The data is from underneath the northern tracks, where the eastbound train passes. Fig. 4a shows the span opening and closing recorded by FBGs. This signal is influenced strongly by the relative position of axles and the span length of the arch. It is noteworthy that an identical maximum magnitude of 0.7mm is observed for both span opening and closing. However, the accompanying vertical displacements at the crown (measured by DIC, see Fig. 4b) indicate different arch response mechanisms for span opening and closing. Crown descends by 1.3mm when the span opens by 0.7mm, but it ascends only by 0.5mm when the span closes by the same amount.

Fig. 4c shows the longitudinal strains experienced over the transverse crack sketched in Fig. 1a. The strains are compressive due to the closure of the open crack during train passage. It is noteworthy that the strains experienced at this location are an order of magnitude higher than all other locations. Fig. 4d shows the transverse strains experienced over the tip of the longitudinal crack visible in Fig. 4b. As expected, the strains are tensile, but strain magnitudes are very small.

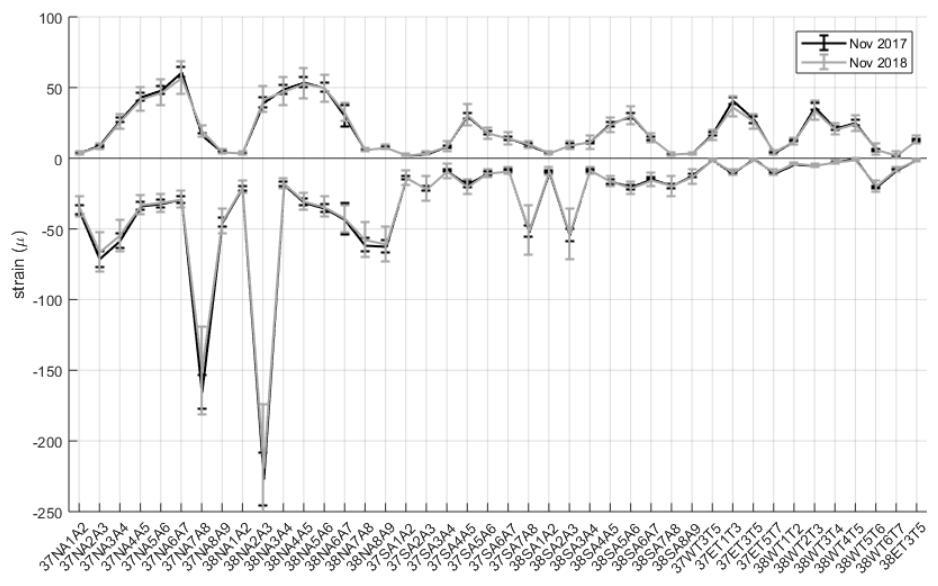
Thus, to investigate ongoing deterioration, it is informative to explore annual changes in data from the same calendar month, where temperature differences are negligible. Fig. 5 compares the mean and standard deviation values of the peak strain values of each sensor on the bridge gathered during November 2017 (black line) and November 2018 (grey line) under the Class-185 3-carriage train. All trains have similar speed and same direction to permit direct comparison. On the y-axis, solid lines show the mean values and the error bars indicate the standard deviation,  $\pm \sigma$ . On the x-axis of the plot, sensor ID's are given. For instance, sensor 38N A2-A3 refers to the FBG gauge traversing the transverse crack in the north of the arch, as discussed in Fig. 4c. This sensor experiences the highest magnitude of strains. The locations of other listed sensors are described in [5].

From Fig.5, it can be observed that the changes in the mean peak values of strain for all sensors are not statistically significant. The mean values and the standard deviations observed for all sensors are consistent. This indicates that noticeable progressive damage has not occurred in the bridge during the 1 year monitoring period. However, this is informative to explore past visual assessments, which indicate that the current damage occurred over periods of decade rather than one year. The fibre optic strain sensing technology allows strain measurements over such long time scales and can provide new insight into degradation behavior.
