CFRP Prestressed Concrete Lighting Columns

Giovanni P. Terrasi and Janet M. Lees

Synopsis:

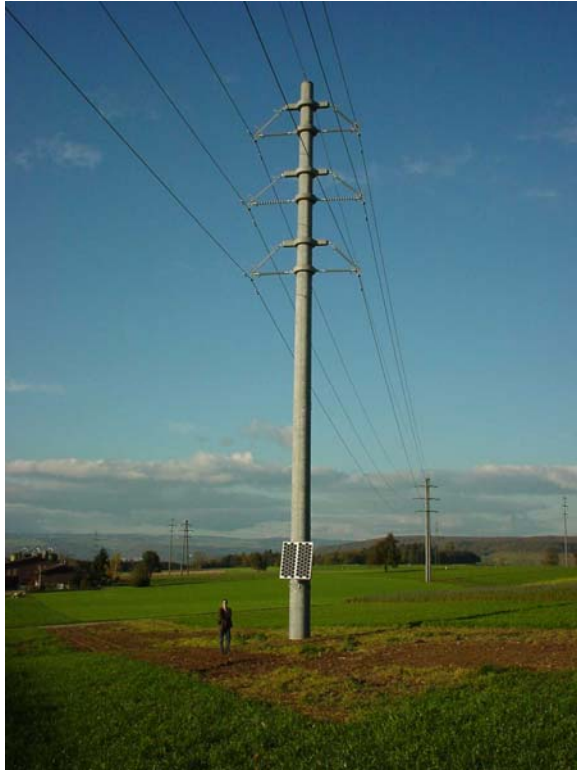
Figure 1

Figure 1: 27 m CFRP prestressed electricity pylon

In September 2000, the world's first carbon fibre reinforced polymer (CFRP) prestressed high strength concrete electricity pylon was installed in Switzerland⁽¹⁾. The 27 m high pole was manufactured using a centrifugally-cast high strength concrete containing blended silica-fume cement (see Figure 1).

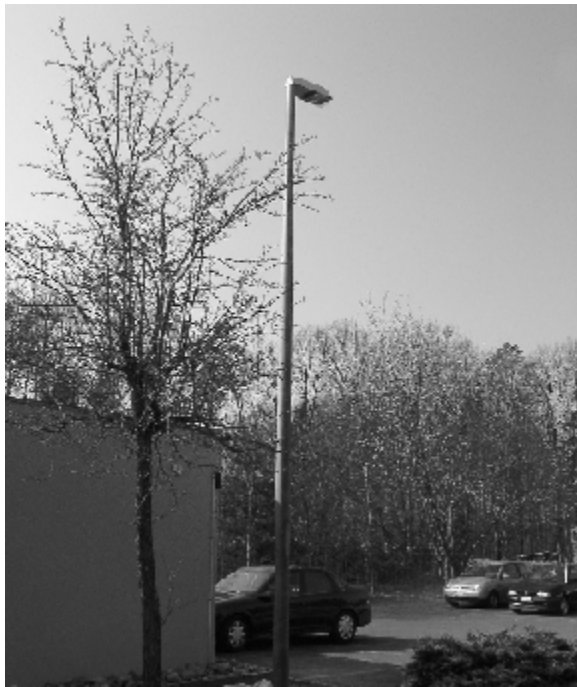
Figure 2

Figure 2: Installed lighting column

In March 2003, an 8 m high prototype Carbolith® lighting column was erected in the SACAC AG car park in Lenzburg, Switzerland (see Figure 2).

The tapered high strength concrete pole was prestressed with six CFRP tendons (prestressed to 60% of the ultimate tendon stress, f_u) and contained no shear reinforcement. It was thus directly comparable to two of the prototype poles tested in the experimental programme that will be described later in this paper. A 1.2 m deep hole was dug and the pole was lifted into place using a light crane. A 0.4 m × 0.4 m × 1.2 m long concrete block was then cast at the foot of the 9.2 m pole (resulting in a final height of 8 m) and acted as the foundation. The pole weight was only 350 kg which represents 70% of the weight of a conventional steel reinforced concrete lighting pole with the same nominal height. The ground was then compacted around the foundation block and additional mortar used to secure the pole in position.

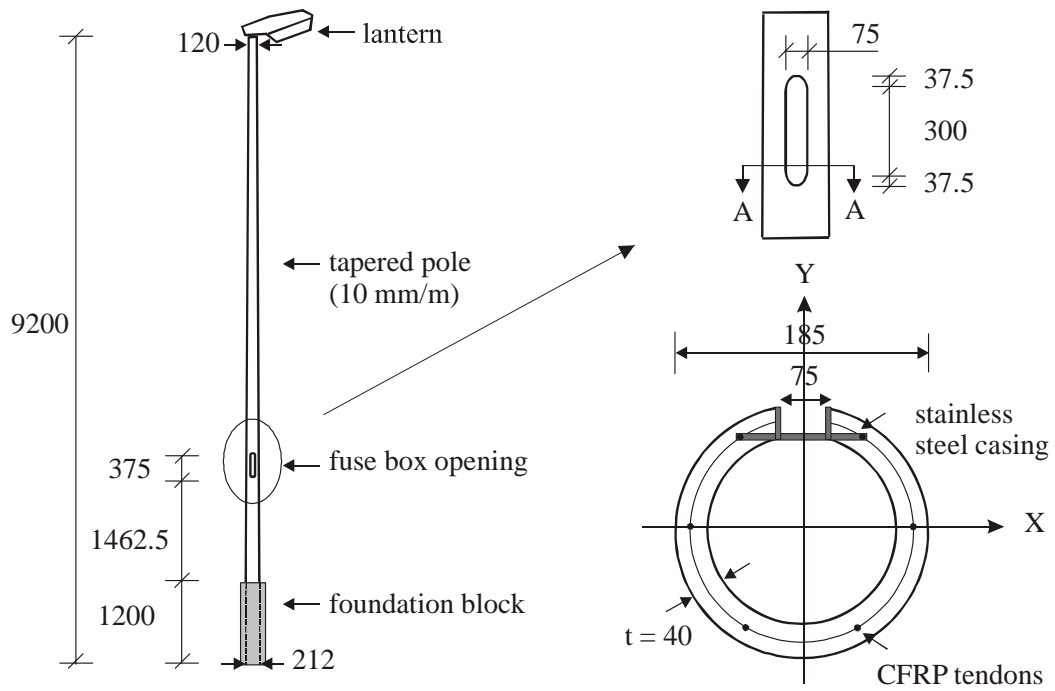
Figure 3

Figure 3: Pole details (all dimensions in mm)

The basic configuration and dimensions of the prototype 9.2 m (8 m nominal height) tapered cylindrical lighting columns (henceforth referred to as 'poles') are shown in Figure 3. A Quadralux-G lantern type was assumed since this is one of the most common luminaries for street lighting columns in Europe. The position of the fuse box opening, at 1500 mm from the end of the fixture, and the opening geometry (height = 300 mm, width = 75 mm) were chosen to reflect typical fuse boxes used in central Europe. The pole taper of 10 mm/m results in a variation of the outer diameter from 120 mm at the tip to 212 mm at the foot, the average wall thickness of the pole being 40 mm \pm 10 mm (measured at the tip and foot surfaces).

The poles were centrally prestressed with six CFRP tendons of diameter 4 mm (the tendon material properties are shown in Table 1). The tendons were pultruded rods and had a ceramic coating on the outer surface to improve the bond properties. The initial prestressing force of each CFRP tendon was 16.6 kN ($\sigma_{p0} = 1'320 \text{ N/mm}^2$) corresponding to a total central prestressing force in the pole of 100 kN (at prestress transfer). It is of note that due to the requirement of a fuse box, the tendons were deviated in this region. The opening was defined and reinforced by a stainless steel casing consisting of two deflector-beams to deviate the two tendons running through the fuse box region (see Figure 3).

Two weeks after production, a reinforced concrete foundation block with dimensions 360 × 360 × 1200 mm was cast over the foot region of each of the five pole specimens (see Figure 3) resulting in a 1.2 m fixture length for the planned cantilever tests (this length represents a medium fixture length for an 8 m nominal height pole as specified in EN40-2⁽³⁾).

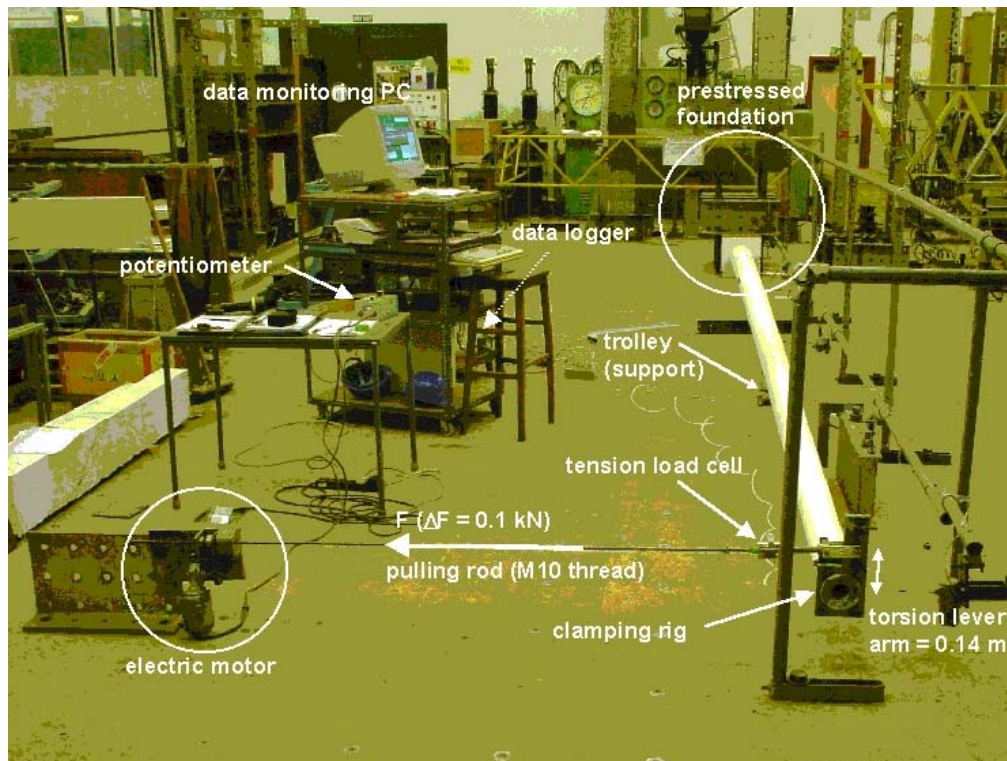
Figure 4

Figure 4: Experimental set-up

The five prototype specimens (poles 1-5) were tested in Cambridge, UK. Each pole was fixed to the strong floor by prestressing the end foundation block (over the fixture length of 1200 mm) using three spreader beams and threaded tensioning bars (see Figure 4). The total pressure on the foundation block was 45 tonnes.

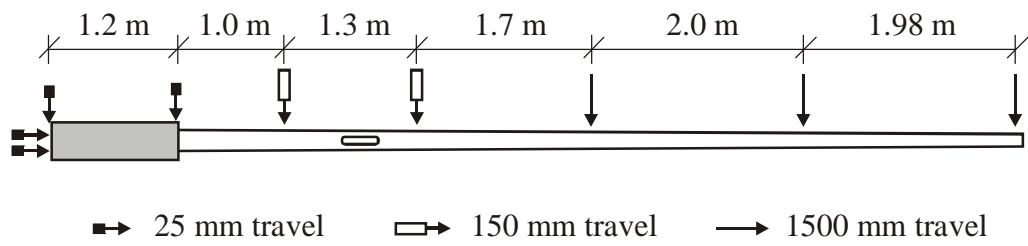
Figure 5

Figure 5: Plan view of displacement transducer locations (support conditions not shown)

For the five pole specimens, no slippage (draw-in) of the tendons, even at the maximum load, was recorded by the LRDTs monitoring the tendons' end-surfaces at the end of fixture (Figure 5). Transfer tests on a plate specimen with similar $\varnothing 4$ mm CFRP tendons and a concrete cover of 18 mm suggested that for a prestressing level of 1000 N/mm² the transfer length was only 70 mm ($17 \times \varnothing_{\text{CFRP}}$). Therefore the foundation length of 1.2 m was more than sufficient to anchor the tendons.

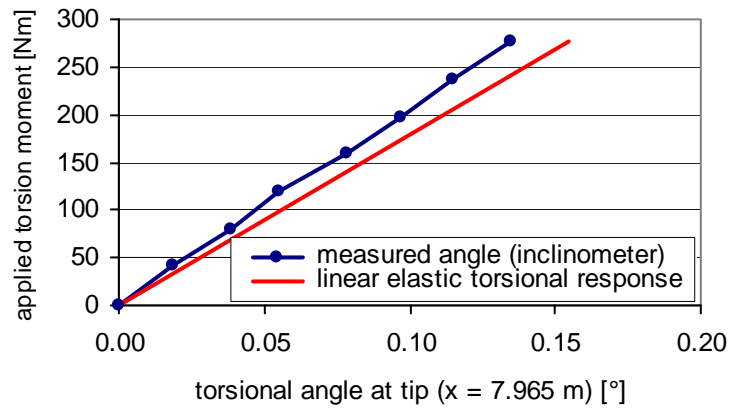
Figure 6

Figure 6: Torsional behaviour

In Figure 6, the measured response of pole 1 is compared with the predicted linear elastic pure torsion behaviour of a vertical, 10 mm/m tapered cantilever pure concrete beam (uncracked high strength concrete) with round cross section, outer diameter of 200 mm at fixture and constant wall thickness of 40 mm loaded with an eccentric point load. The fuse box opening and stainless steel casing were not taken into account in the calculation model.

The measured torsion angle of 0.135° at the maximum test load ($T = 276.6 \text{ Nm}$) is 12.7% lower than the calculated value of 0.155° . The slightly higher experimental stiffness can be attributed in part to a higher effective shear modulus for the pole than the assumed average value of $G = 16.4 \times 10^9 \text{ N/m}^2$ computed using a Poisson's ratio of $\nu = 0.175$ and an average Young's modulus of concrete $E_{co} = 38'550 \text{ N/mm}^2$ (at low stresses E_{co} is higher than the average value). Differences in wall thickness t (the taper of the production mould results in $t > 40 \text{ mm}$ in the pole foot region and $t < 40 \text{ mm}$ in the pole tip region) may also play a role.

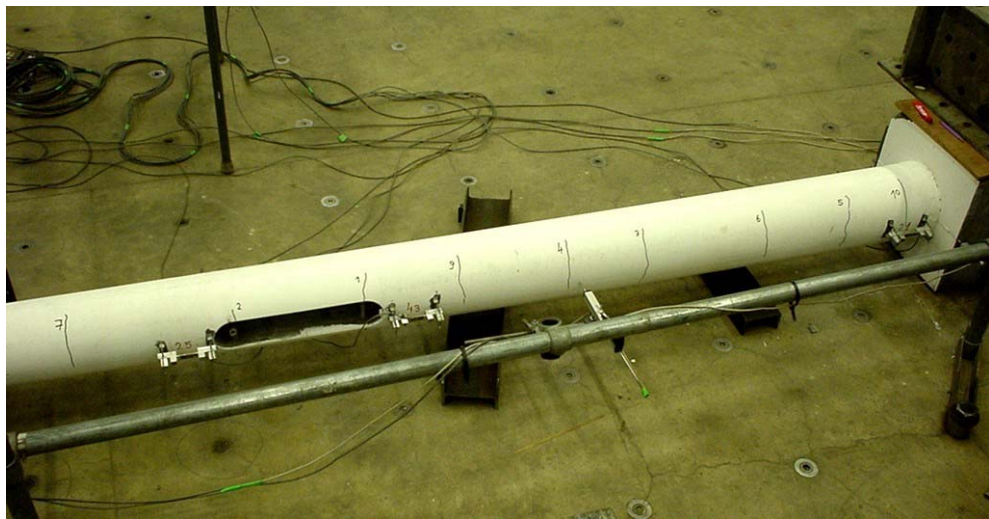
Figure 7

Figure 7: Crack pattern of pole 5 at reference load of 1.2 kN

The deflections started to increase rapidly after cracking of the pole occurred and the rotations concentrated in many thin and well distributed cracks near the fixture and the opening region of the pole. A crack mapping in the tensile region of each pole was carried out at a reference load of 1.2 kN. The fairly good bond between the ceramic coated tendons and the concrete matrix led to the formation of between 4 and 10 thin vertical bending cracks (of widths 0.01 - 0.20 mm) at regular spacings near the fixture and opening regions of the pole (see Figure 7). All the observed cracks were vertical bending cracks and had a maximum width of about 0.5 mm.

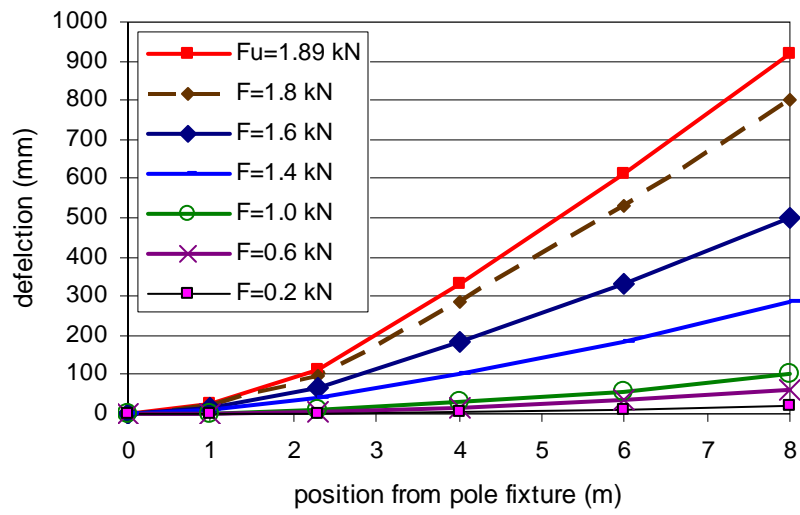
Figure 8

Figure 8: Deflection profiles of pole 3 plotted at selected loads

The deflected bending shapes of pole 3 at various stages of loading are shown in Figure 8. Large deflections were noted in the later stages of testing and the tip deflection was around 925 mm immediately prior to failure. The high rotation capacity came from the opening of the aforementioned thin bending cracks,

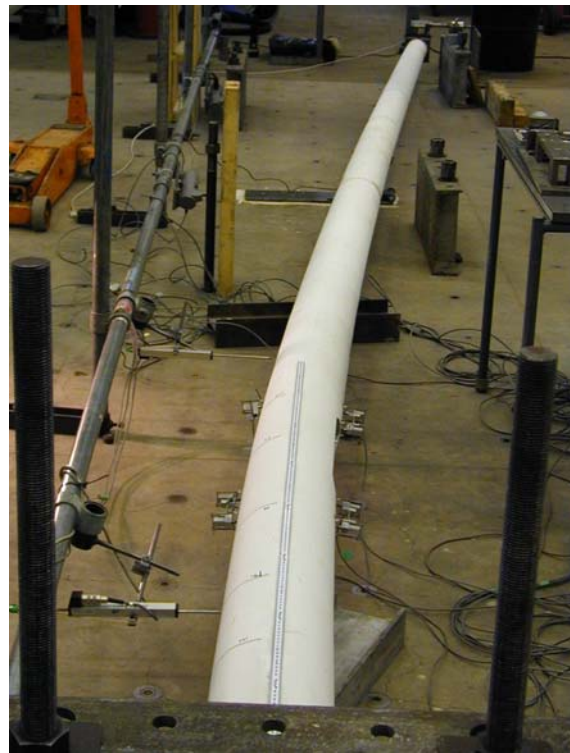
Figure 9: Deflection of pole 3 during testing

originating from the fixture/opening area. Figure 9 shows a photo of the large deflections experienced by pole 3 just before failure: A high deformation capacity in the cracked state could therefore be achieved, despite the use of two brittle material components (CFRP, HSSC). This can be interpreted as a further warning by the system of impending failure when loaded to unforeseen high levels.

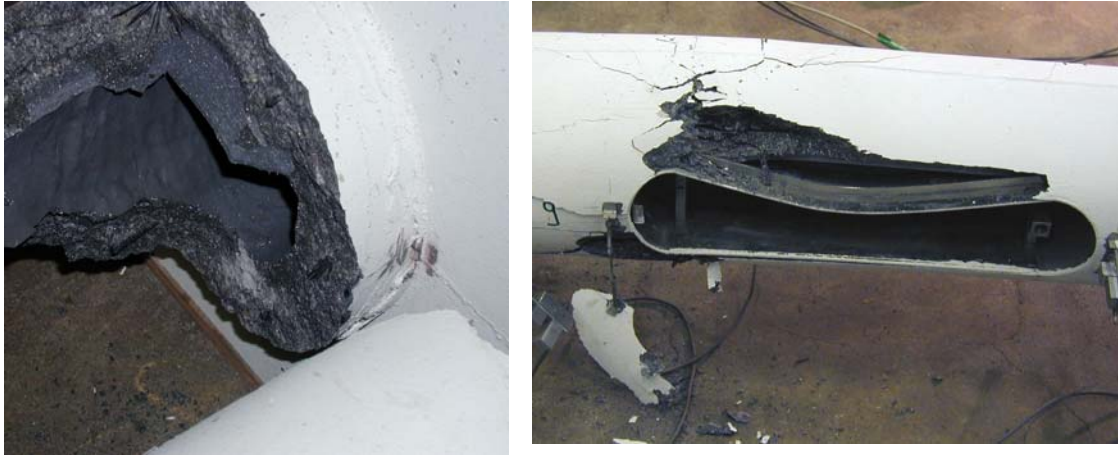
Figure 10 (a) (b)

Figure 10: Pole failure modes (a) tendon failure – pole 2 (b) steel buckling/concrete crushing – pole 3

Several failure modes were observed, depending on the testing position (bending plane considered) and on the reinforcement configuration (see Figure 10). Poles 1 and 2 failed by the sudden snapping of the CFRP tendons on the tensile edge at cross sections near the fixture (the corresponding moments are M_{u+x} (pole 1, $x = 0.28$ m) = 12.6 kNm, M_{uy} (pole 2, $x = 0.05$ m) = 14.2 kNm). However, while the failure for pole 2 was expected to be near the fixture (Figure 10(a)), pole 1 was predicted to fail in the concrete at the lower edge of the fuse box opening, which was not the case, possibly because of the reinforcing effect of the stainless steel casing that was neglected when determining the pole capacities and the inherent material partial safety factors. Pole 3 (with the opening on the compression edge) contained additional longitudinal passive reinforcement in the form of the PVA fibre bundles. This reinforcement acted to increase the tensile capacity of the cracked pole in the area of the opening and at the fixture and shifted the failure from the tensile to the compressive edge. The result was a combined failure with buckling of the steel casing and concrete crushing at a height 1.5 m from fixture (Figure 10(b)). The experimental failure bending moment was 12.3 kNm, which is 23% higher than that calculated for the HSSC crushing at the lower edge of the opening (Table 3). Again, the difference is attributed to the reinforcing effect of the steel casing and material safety factors. Poles 4 and 5 were tested with the box opening at the tensile flange, therefore the bending resistance of the area around the lower opening edge was reduced since the two CFRP tendons running next to the tensile edge were deflected inwards. Consequently, poles 4 and 5 failed by the sudden snapping of the CFRP tendons on the tensile edge at cross sections at $x = 1.23$ m and $x = 1.5$ m from the fixture respectively. The failure loads and failure locations were reasonably close to the predicted values taking into account the offset of the tendons. In general, the design computation models gave fairly good predictions of the ultimate load capacities.

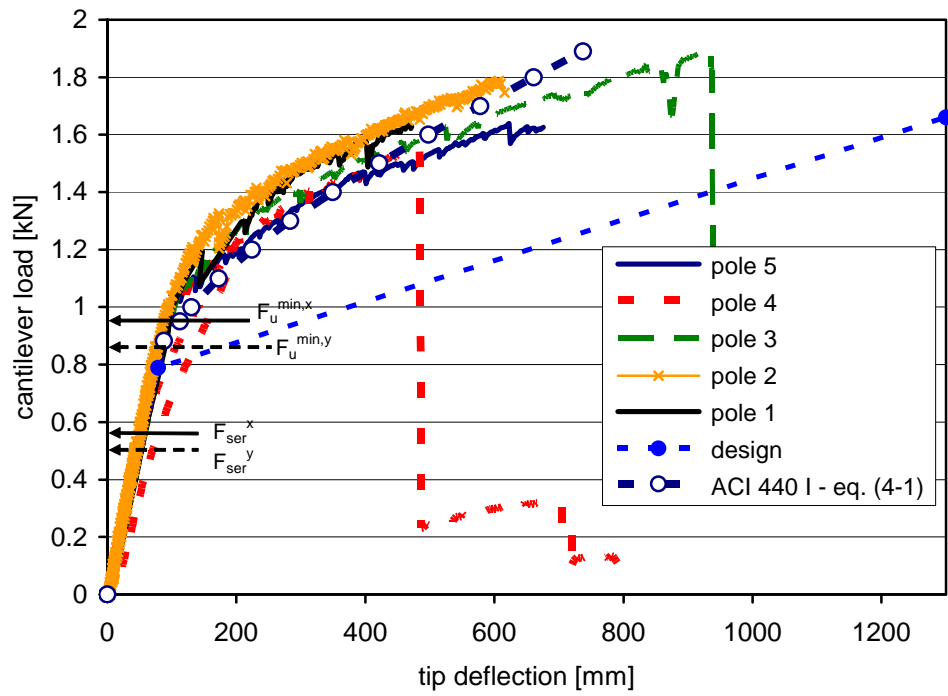
Figure 11: Load vs. tip deflection behaviour of the poles 1-5 tested in cantilever bending/torsion

The load vs. deflection behaviour of all 5 poles (see Figure 11) was nearly bilinear, with a high bending stiffness in the uncracked state and then a gradual loss of stiffness after cracking. The calculated bending stiffness for the uncracked state corresponded exactly to the experimental values. However, the design tip deflection at the ultimate load of 1'304 mm, was considerably higher than the measured values which ranged from $\delta_u^{\text{tip}} = 474.8$ mm (pole 4) to 920.8 mm (pole 3). The reasons for this overestimate of the deflection at failure were most likely due to the underestimation of the tensile strength of the HSSC and the neglect of the tension stiffening effect of the concrete between the bending cracks in the original design model.

In these equations, E_f and E_s are the modulus of elasticity of the FRP tendon and steel respectively, M_{cr} is the cracking moment and M_a is the maximum moment at the section where the deflection is considered. The pole cross-section tapers along its length, so to simplify the calculation, the ratio of the cracked moment of inertia I_{cr} to the gross moment of inertia I_g was taken to be constant throughout the cracked region. The total tip deflection was then determined by integrating the cracked curvatures $\kappa_c = M/E_c I_e$ (which takes into account tension stiffening) from the fixture to the end of the cracked region (x_{cr}) and then integrating the uncracked curvatures ($\kappa_e = M/E_c I_g$) from x_{cr} to the pole tip. The resulting curve has been plotted in Figure 11 and the analysis shows very good agreement with the experimental deflections.
