## **A multi-sensing monitoring system to study deterioration of a railway bridge**

### **Abstract**

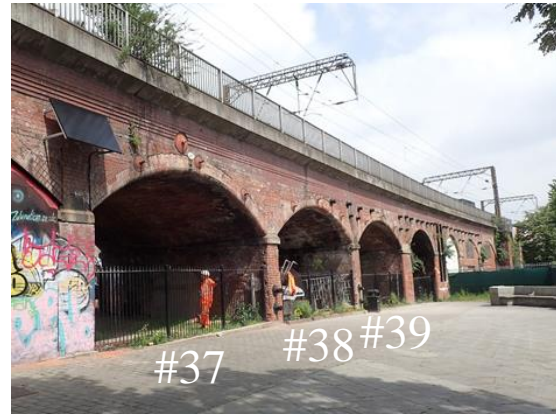
Fig. 1. The southern side view of the Marsh Lane Viaduct in Leeds, UK

The Marsh Lane Viaduct is located next to the Eastern entrance of Leeds Railway Station, in the centre of the city. The bridge was constructed between 1865 and 1869 (Hoole 1973). Today it carries two electrified tracks with a traffic load that exceeds 200 trains per day, ranging from typical passenger trains to multi-wagon freight trains. Fig. 1 shows the southern side of the investigated section of the bridge, which comprises the Arches 37, 38 and 39. Fig. 2 shows the main cracks observed under the arches. The most severe damages are concentrated over the relieving arches at the centre of the piers due to a spreading mechanism that forces the relieving arch keystone to descend and the walls to bow outwards (Acikgoz et al. 2018). For this reason, Network Rail, the owner of the bridge, conducted in 2015 an extensive repair by filling in the relieving arches with concrete and installing steel ties to arrest transverse movements of the piers and the spandrel walls. In addition, a longitudinal crack below the North track is observed in Arch 37, which is the most damaged arch of the bridge.

Fig. 4 shows the main parts of the Data Acquisition System (DAQ). The 4-channel sm130 Optical Sensing Interrogator of Micron Optics, Inc. used in this study offers up to 1 kHz sampling rate per sensor and 2-3 micro-strain ( $\epsilon\mu$ ) resolution. A National Instruments (NI) cRIO controller was used for the AE sensors, offering up to 1 MHz sampling rate. The accelerometers-controller connection was achieved through a CAN breakout box. The DAQ is permanently installed under Arch 37, inside a temperature controlled cabinet. The DAQ is connected to a laptop with a router, which remotely transmits daily data through a 4G internet connection. The system is powered up by the solar panel shown at the top left corner of Fig. 1.
