# The strength of aged glass

Kyriaki Corinna Datsiou · Mauro Overend

**Abstract** Glass is known for its excellent durability, but the strength of glass is very sensitive to the characteristics of its surface, which is known to accumulate damage during its service life. There is however, a lack of strength data on weathered or aged glass, particularly on thermally or chemically treated glass. In this study a carefully calibrated sand trickling test is used to produce surface damage equivalent to erosive action of 20 years of natural weathering on different types of glass: soda-lime-silica annealed, soda-lime-silica fully toughened and aluminosilicate chemically toughened. The soda-lime-silica glass specimens are tested destructively in their as-received and artificially aged form in a conventional coaxial double ring set-up, while the alumino-silicate chemically toughened specimens are tested in an improved coaxial double ring set-up. Fractography is subsequently used to identify and measure the critical flaw size on each specimen. The strength data are analysed statistically and the design strengths for each glass type are obtained. It is found that all glasses suffer a loss in

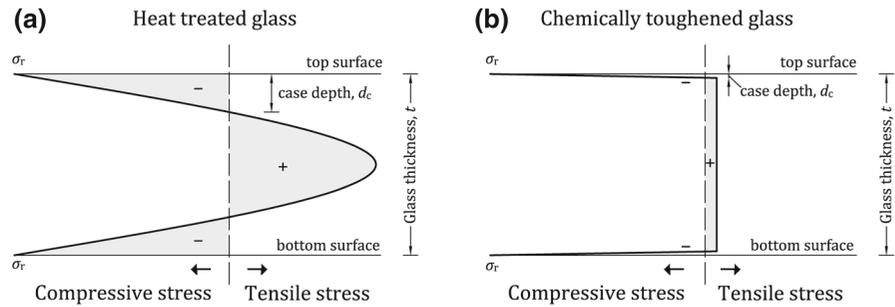
**Fig. 1** Residual stress profile through the glass thickness for: **a** heat treated and; **b** chemically toughened glass

Contemporary architectural trends frequently require glass to bear higher loads than those typically imposed on a traditional infill panel. This need is currently addressed with the use of high strength glass in the form of heat treated or chemically toughened glass. High strength glass is produced with toughening procedures that introduce an advantageous residual stress profile through the thickness of the glass, which is characterized by tensile stress in the core and compressive stress at the surfaces (as shown in Fig. 1).

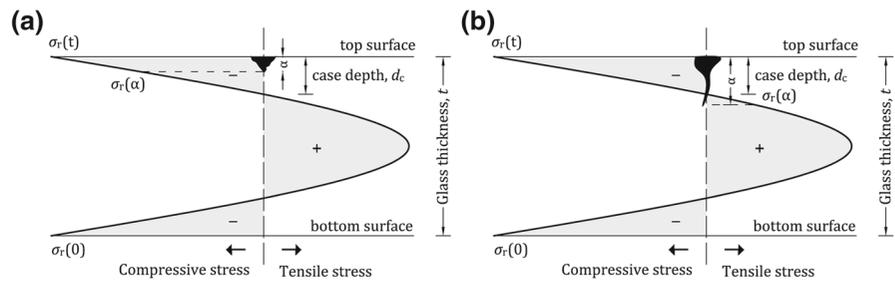
**Fig. 2** Flaw in fully toughened glass: **a**  $\alpha \leq d_c$ :  $|\sigma_r(\alpha)| < |\sigma_r(t)|$  and; **b**  $\alpha > d_c$ :  $\sigma_r(\alpha) > 0$

Fig. 2a). The residual compressive stress is ineffective when the flaw depth exceeds the case depth ( $\sigma_r(\alpha) > 0$ , Fig. 2b). In this case, the flaw is expected to grow under the influence of the residual tensile stress  $\sigma_r(\alpha)$  at the flaw tip and the stress arising from the external loads until the stress intensity factor at the flaw tip reaches a critical value and fracture occurs.

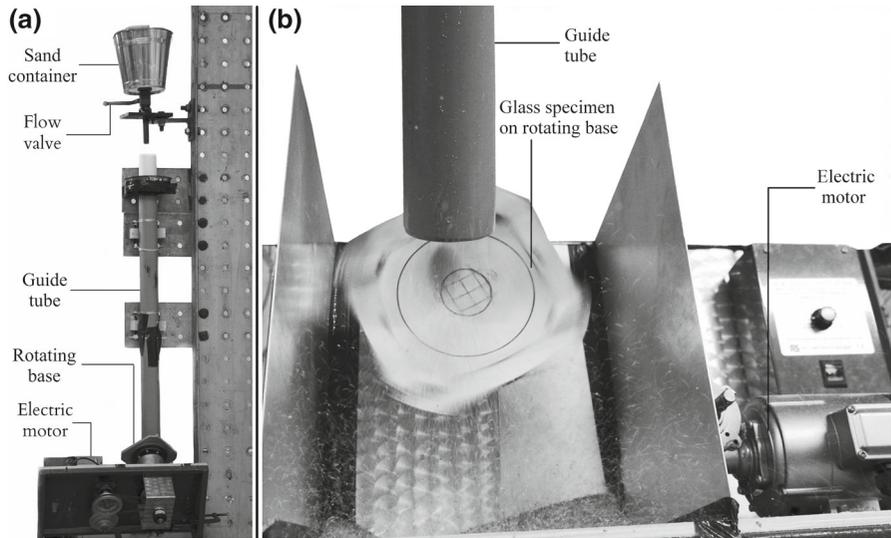
**Fig. 3** Artificial ageing of glass with falling abrasive method: **a** whole set-up and; **b** glass specimen abrasion

A falling abrasive method ([Fig. 3](#)) is used in this study for the artificial ageing of glass. The method involves dropping of abrasive medium (of specific mass,  $M$ , grain size range,  $GSR$ ) from a controlled drop height,  $H$ , on a single glass specimen that is fixed on an inclined rotating base ( $45^\circ$  to the floor). After abrasion and prior to their destructive testing, the glass specimens are stored for a specific amount of time,  $t_c$  in specific conditions (temperature,  $T$  and humidity,  $RH$ ). Further details on the method are available in [DIN 52348 \(1985\)](#) and [Datsiou and Overend \(2017\)](#).

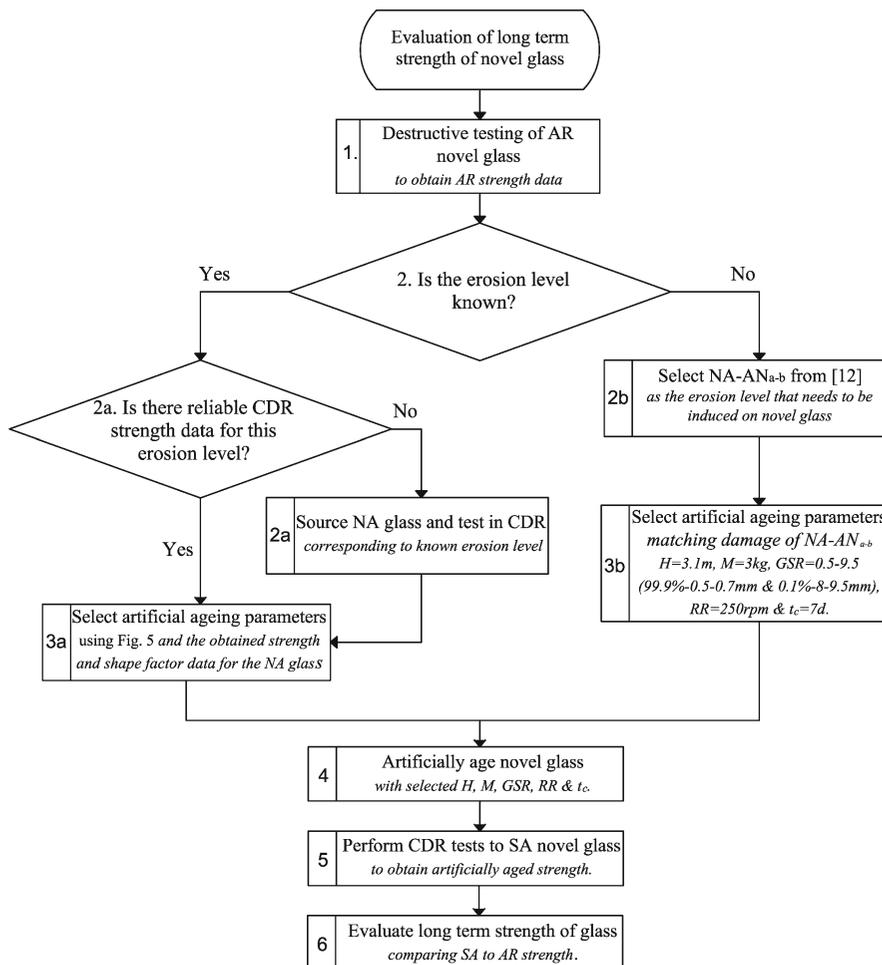
**Fig. 4** Procedure for the evaluation of durability of novel glass

The authors' previous research in [Datsiou and Overend \(2017\)](#) showed that artificial ageing of glass with the falling abrasive method has the potential to produce similar Weibull parameters and therefore, similar levels of damage to those found in naturally aged glass. These results are condensed in this section into a procedure for the assessment of the strength of aged glass ([Fig. 4](#)):

**Step 1** *Destructive testing of as-received glass:* Perform coaxial double ring (CDR) tests to obtain fracture strength data of the as-received glass. Fit a 2-parameter Weibull distribution to the data (as shown in [Datsiou and Overend 2017](#)) to obtain strength results at low  $P_f = 0.008$  complying with the recommendations of [ASTM E1300-12A \(2012\)](#) or mean  $P_f = 0.50$  probabilities of failure.

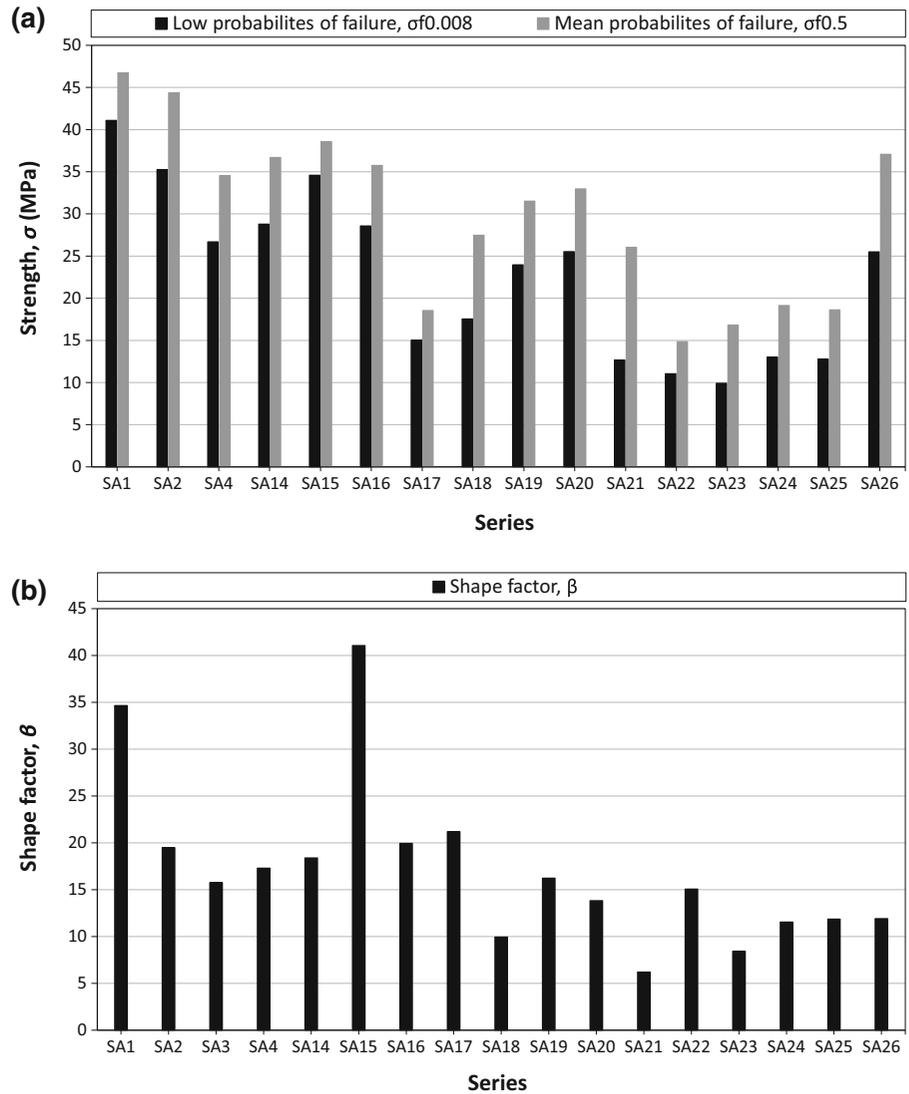
**Fig. 5** Artificially aged annealed glass: **a** strengths at  $P_f = 0.008$  and  $P_f = 0.50$  probabilities of failure and; **b** shape factor of the Weibull distribution (Table 1)

- (3a) *Known erosion level*: Refer to Fig. 5a–b to match the design or mean strength of naturally aged glass and the shape factor of the Weibull distribution obtained in step 2 with the strength of one of the artificially aged series in Datsiou and Overend (2017). Subsequently, refer to Table 1 to obtain the ageing parameters that were used for the selected artificially aged series.

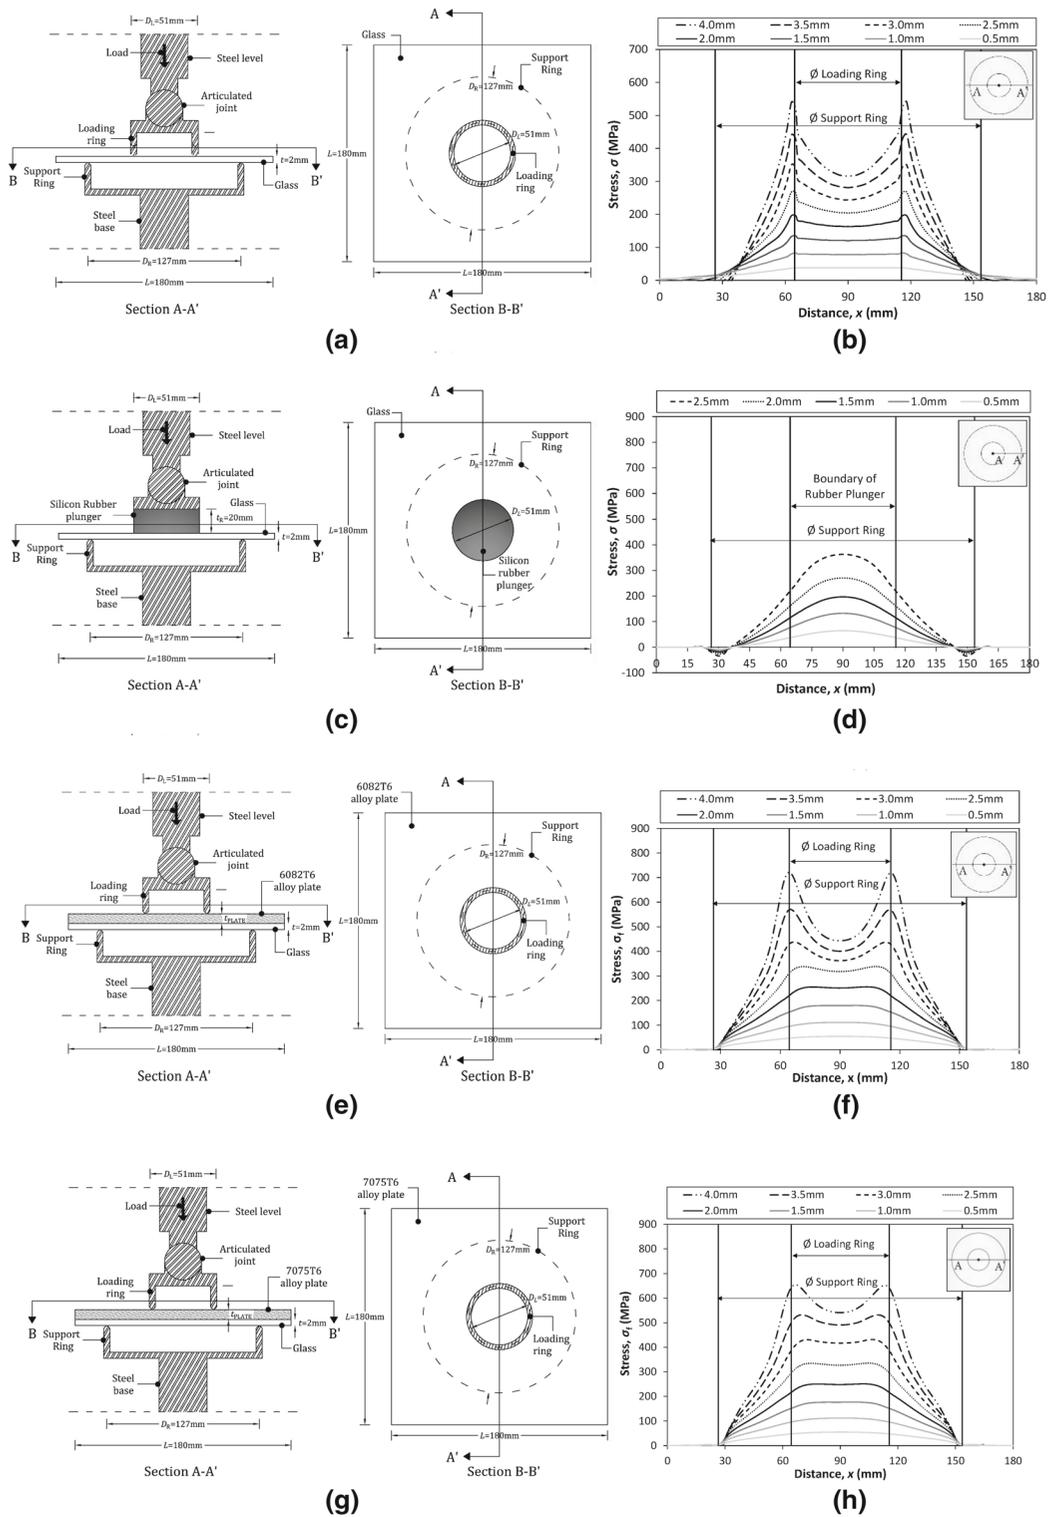
**Fig. 6** Set-up and max. principal stress along section A-A' for: **a, b** conventional CDR; **c, d** Set-up A: rubber plunger; **e, f** Set-up B: 6082T6 aluminium plate and; **g, h** Set-up B: 7075T6 aluminium plate

*Annealed and fully toughened glass* A coaxial double ring set-up (Fig. 6a) with a diameter of  $D_L = 51$  mm for the loading and  $D_S = 127$  mm for the support ring was used for the annealed and fully toughened glass. Fast stress rates of 20 MPa/s (13.6 mm/min) and 70 MPa/s (20 mm/min) were chosen for annealed and

*Set-up A—silicone rubber plunger:* Previous research suggests that application of a uniformly distributed load with a silicon rubber plunger over the loading ring area (Fig. 6c), can be used to create a uniform equibiaxial stress field for the destructive testing of thin photovoltaic panels (Blaumeiser and Schneider 2016). However, further numerical investigation of this set-up by the authors (details available in Datsiou 2017) for a Shore Hardness 60°, silicon rubber, shows that an almost uniform surface stress is only achieved for relatively low applied displacements,  $\delta_{\text{applied}} < 0.75$  mm (corresponding to  $\sigma_f < 100$  MPa, Fig. 6d) and a glass thickness of 2 mm. Other limitations of this set-up are: (i) excessive distortion of the rubber elements causing numerical convergence problems which require a computationally inefficient high density mesh; (ii) defining the rubber material properties is not trivial and requires very careful material characterization and; (iii) uncertainties associated with fitting a material model (Ogden, Yeoh, Mooney Rivlin etc) to describe the rubber stress - strain data.

The experimental and numerical results validate the initial assumption that an equibiaxial stress field can be created within the area of the loading ring up to an applied total of  $P = 36$  kN (Figs. 7b, 6f) for the 6082T6 alloy. However, as the applied

load/displacement exceeds  $P = 36$  kN /  $\delta_{\text{applied,D}} \approx 2.2$  mm, the 6082T6 alloy plate reaches its ultimate tensile strength. This increases the load sharing factor of glass and results in stress concentrations underneath the loading ring. The Grade 7075T6 aluminium plate reaches its maximum tensile capacity at a higher applied displacement,  $\delta_{\text{applied}} \approx 3.1$  mm and thereby, suppresses significant stress concentrations ( $(\sigma_{\text{max}} - \sigma_E) / \sigma_E > 10\%$ ) up to an applied displacement of  $\delta_{\text{applied}} = 3.5$  mm (Fig. 6h).

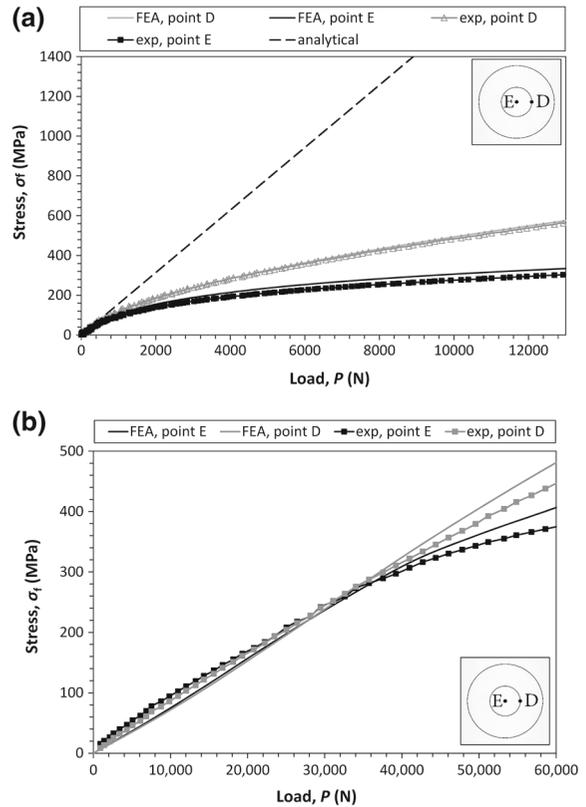
**Fig. 7** Max principal stress for chemically toughened glass at points E and D for: **a** conventional CDR and; **b** Set-up B

Aluminium ( $E_A = 70$  GPa and  $\nu_A = 0.30$ ) was chosen for the additional plate to suit the material properties of glass ( $E_G = 70$  GPa and  $\nu_G = 0.23$ ) and in particular, a medium strength and a high strength alloy conforming to Grades 6082T6 and 7075T6 respectively (BS EN 485-2:2013 2013 and BS EN 573-3:2013 2013). This set-up was investigated numerically (details available in Datsiou 2017) for an additional  $180 \times 180 \times 4.75$  mm aluminium plate (stress and plastic strain data available in Boller and Seeger (1987) for Grades 6082T6 and 7075T6). The model was validated with experimental strain gauge data for a 4.75 mm thick, 6082T6 Grade aluminium plate and a 2 mm thick glass plate (Fig. 7b).

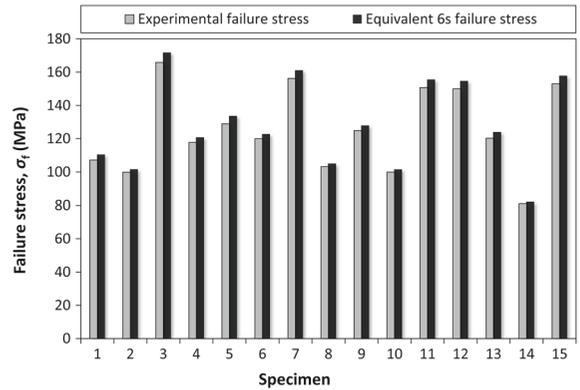
**Fig. 8** Experimental and 6s equivalent failure stress for annealed as-received glass

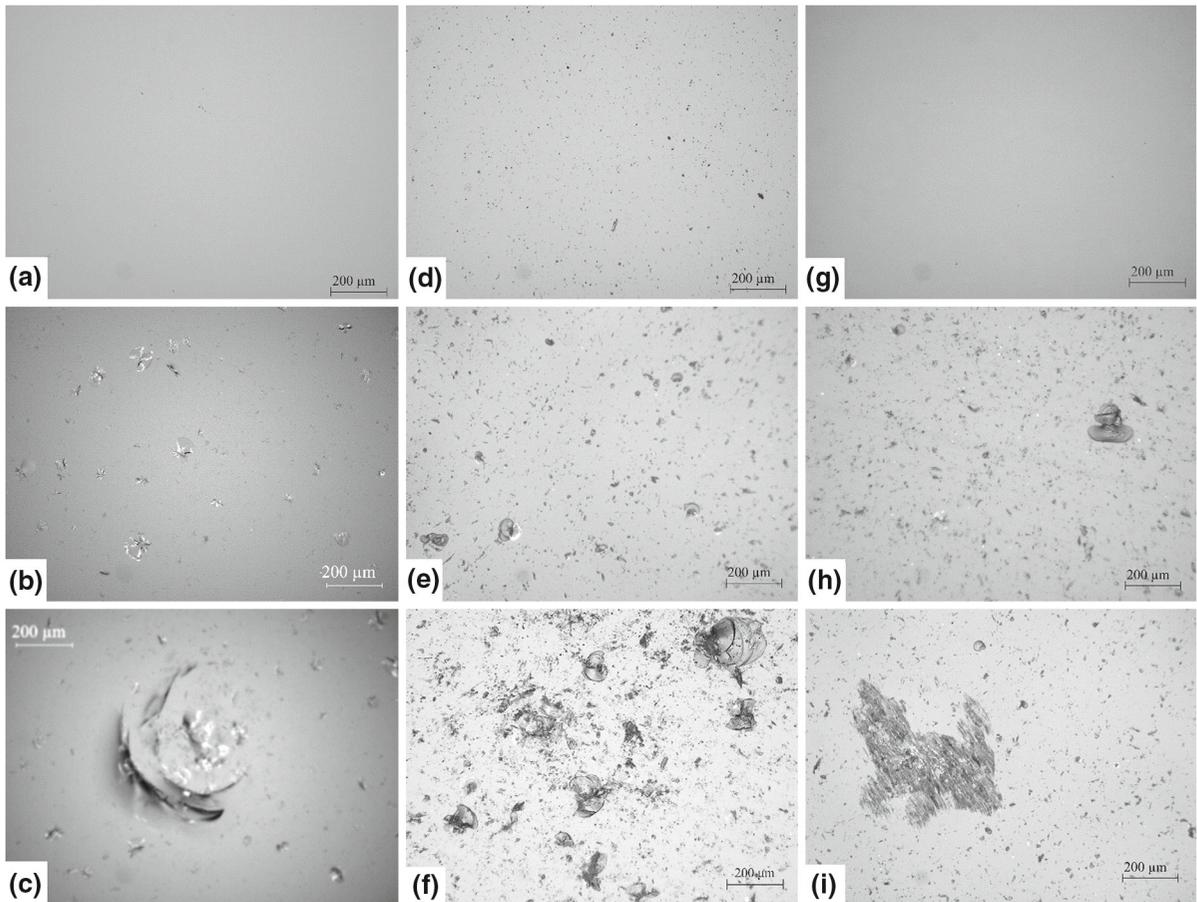
**Fig. 9** Micrographs of as-received, sand abraded-sand impacts and sand abraded-gravel impact of: **a–c** annealed; **d–f** fully toughened and **g–i** chemically toughened glass

Micrographs of the surface were obtained prior and after the artificial ageing for the three types of glass (Fig. 9). The surface of as-received annealed (Fig. 9a)

and chemically toughened glass (Fig. 9g) are almost defect free at a magnification level of  $100\times$  whilst as-received fully toughened glass has multiple digs on its surface (Fig. 9d) which were potentially introduced during manufacture and/or transportation of the glass.

Artificial ageing with sand abrasion results in digs and some lateral cracks in annealed, fully toughened and chemically toughened glass (Fig. 9b, e, h respectively). Flaws induced by impact of sand grains are similar in all types of glass (Fig. 9b, e, h). However, the flaws induced by the larger gravel particularly on the annealed and fully toughened glass differ from those in the chemically toughened glass as follows: (a) digs surrounded by lateral cracks that intersect with the glass surface are found in fully toughened and annealed glass. However, these flaws are larger in annealed (Fig. 9c) than fully toughened glass (Fig. 9f)

and; (b) gravel impacts do not form digs in chemically toughened glass but result in abrasive damage (Fig. 9i).

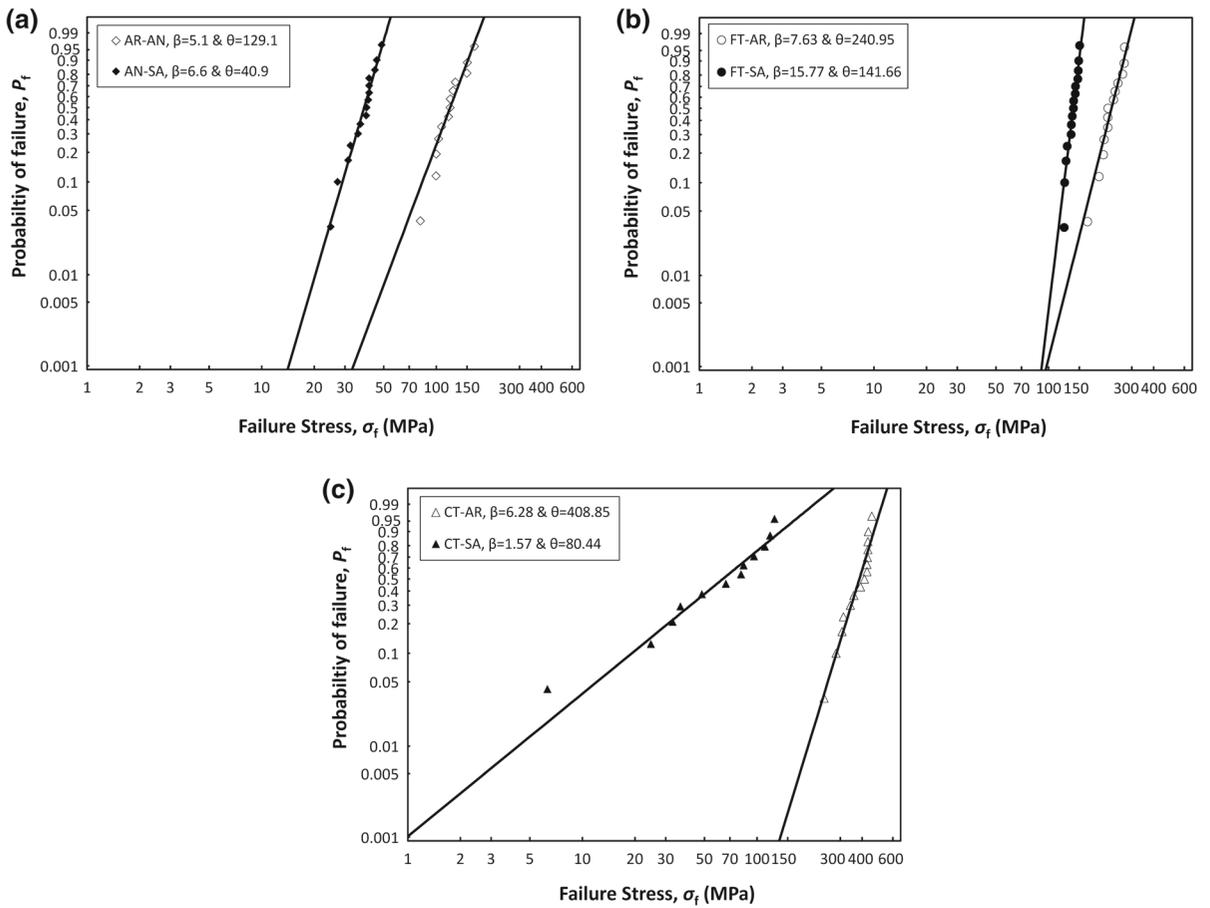
**Fig. 10** Cumulative distribution functions of strength for **a** annealed glass (as-received and artificially aged); **b** fully toughened glass (as-received and artificially aged) and; **c** chemically toughened glass (as-received and artificially aged)

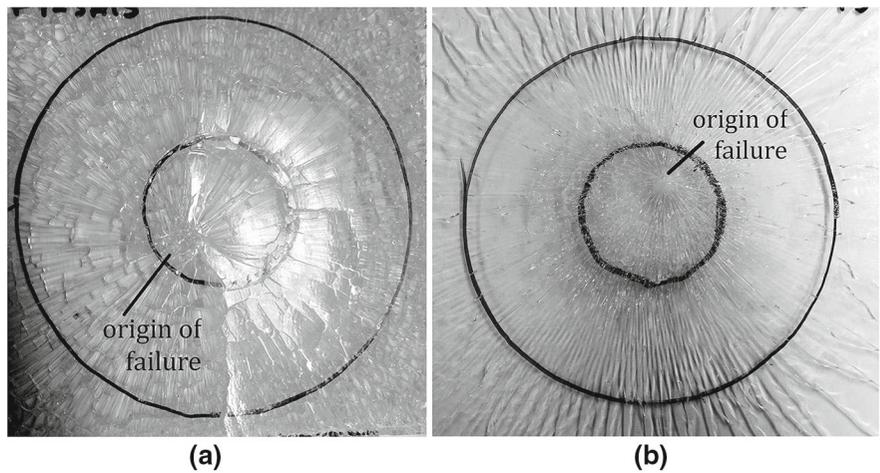
**Fig. 11** Fragmentation of sand abraded: **a** fully toughened and; **b** chemically toughened glass

compression, increase the elastic energy that is stored within the specimen. This energy is released upon fracture and is dissipated in opening new crack surfaces, resulting in a very dense fragmentation pattern (Fig. 11b). Therefore, post-fracture microscopy was only possible for the few chemically toughened glass specimens that failed at the “lower” stress tail of the Weibull distribution and thereby resulted in “larger” fragments. Specimens that fail at the lower stresses do so because they have relatively deeper flaws on their surface and therefore, post-fracture microscopy in those specimens is biased because it will only reveal the upper range (maximum depth) of critical flaws.

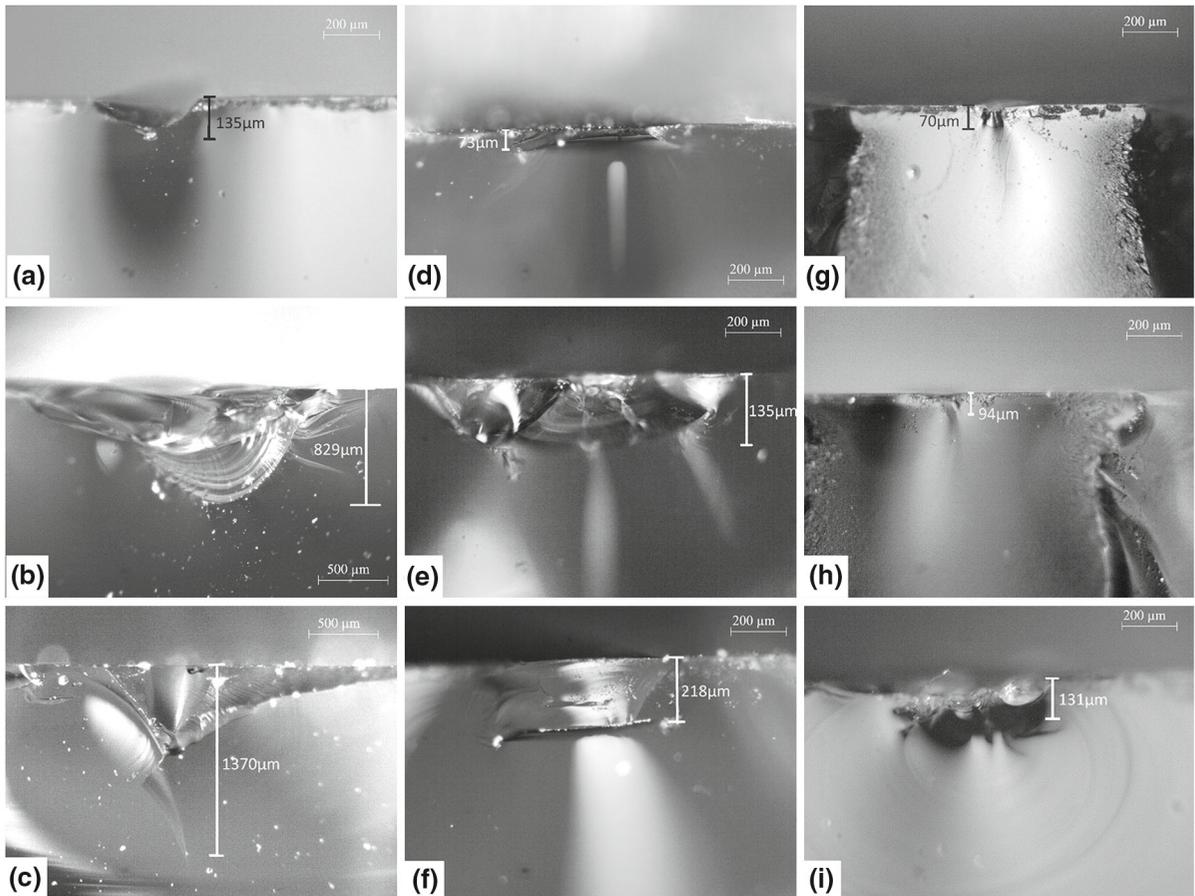
**Fig. 12** Critical flaws (of max, average and min depths) in sand abraded: **a–c** annealed; **d–f** fully toughened and; **g–i** chemically toughened glass

Optical microscopy reveals average critical flaw depths after sand abrasion of  $472 \mu\text{m}$  ( $132 \leq \alpha \leq 1370 \mu\text{m}$ ) in annealed glass,  $127 \mu\text{m}$  ( $72 \leq \alpha \leq 218 \mu\text{m}$ ) for fully toughened glass and  $96 \mu\text{m}$  ( $71 \leq \alpha \leq 132 \mu\text{m}$ ) for chemically toughened. Typical micrographs of the critical flaws are shown in Fig. 12a–i, representing the largest, average and smallest flaw for each type of glass revealed with the optical microscope.

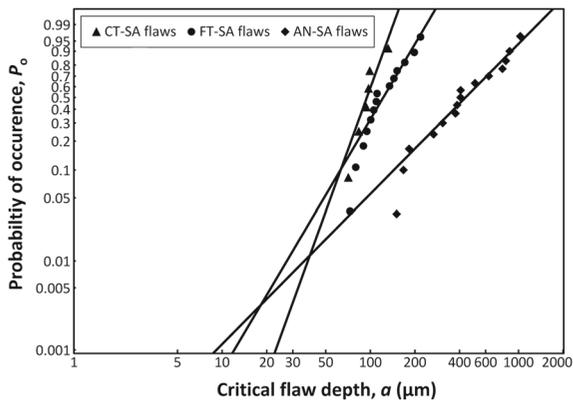
**Fig. 13** CDFs for critical flaw depths for annealed, fully toughened and chemically toughened, sand abraded glass

Statistical analysis of the flaw depths followed by fitting the data to a 2-parameter Weibull distribution (Fig. 13) producing acceptable goodness-of-fit. Larger critical flaws were therefore, found for annealed, followed by fully toughened and then chemically toughened glass. This implies that the degree of toughening/amount of residual surface stress has an effect on the critical flaw depth for the same artificial ageing procedure and thereby, the abrasive resistance of glass. In particular, higher residual surface stress results in smaller flaw depths under the same ageing conditions.
