*AUTOMATED IMAGE-BASED INSPECTION
OF MASONRY ARCH BRIDGES*

This thesis is submitted for the degree of Doctor of Philosophy

January 2022

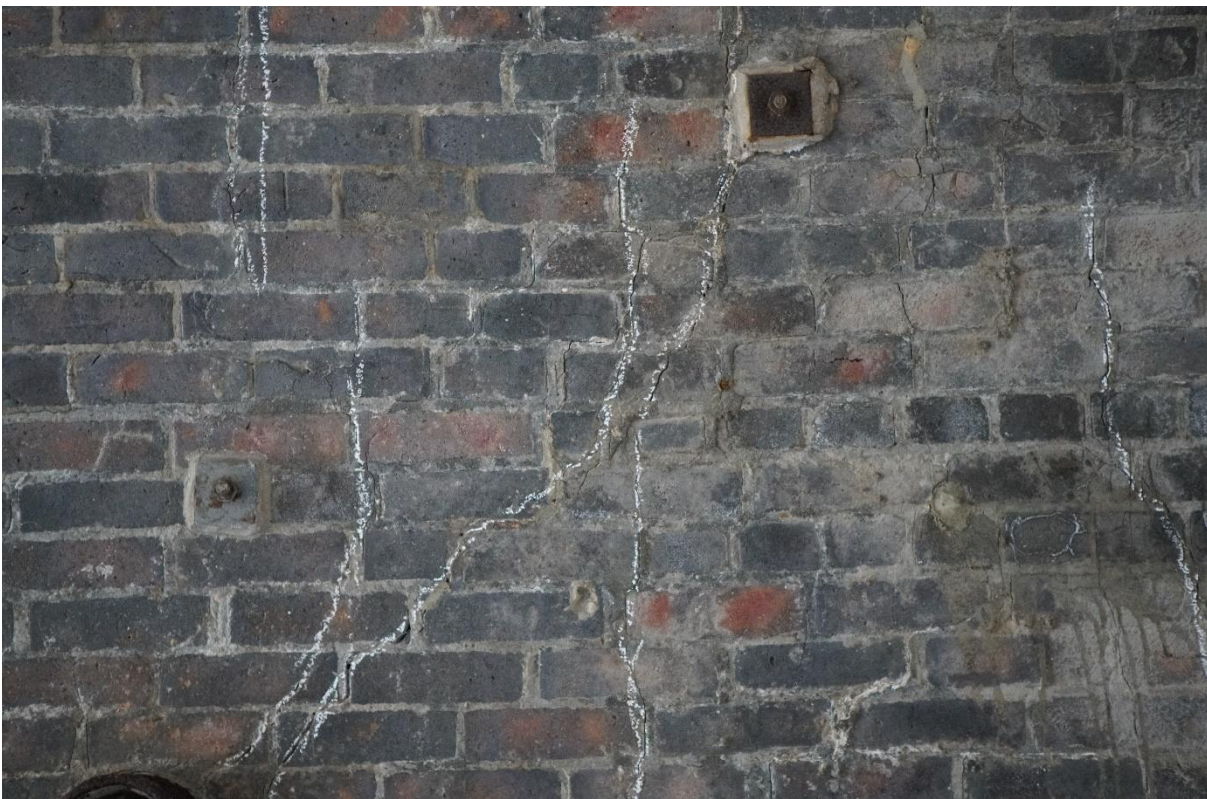
Figure 2-2: Image taken whilst collecting field data showing marking involved in manual visual inspection

As part of the investigations of this PhD, a general inspection of Harringworth Viaduct in Northamptonshire, UK was observed. This is much less detailed than the principal inspection detailed above in Peterborough. Here the inspector walked the length of the viaduct, both at ground level and track level, observing with binoculars and photographs the progression of defects that have been previously reported. A general inspection is therefore unlikely to detect any new defects on the structure.

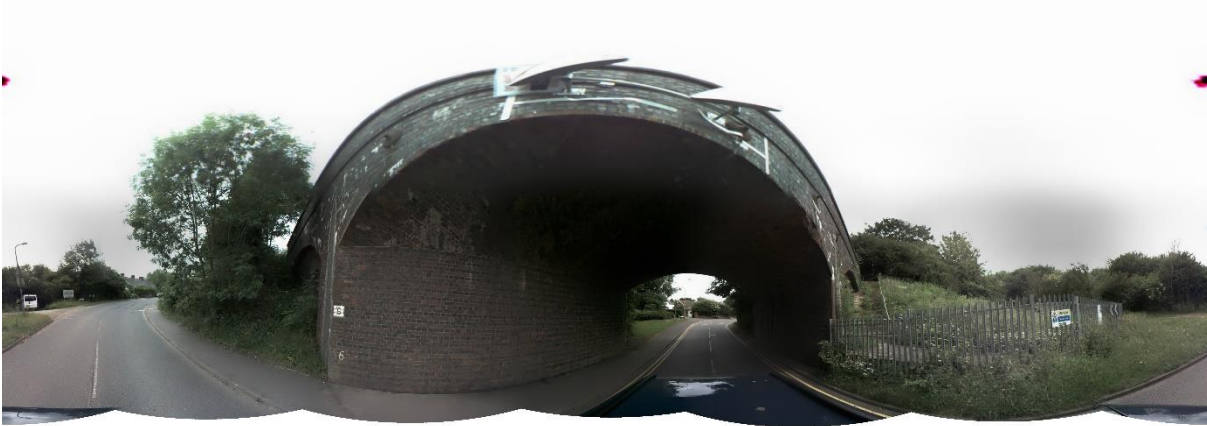
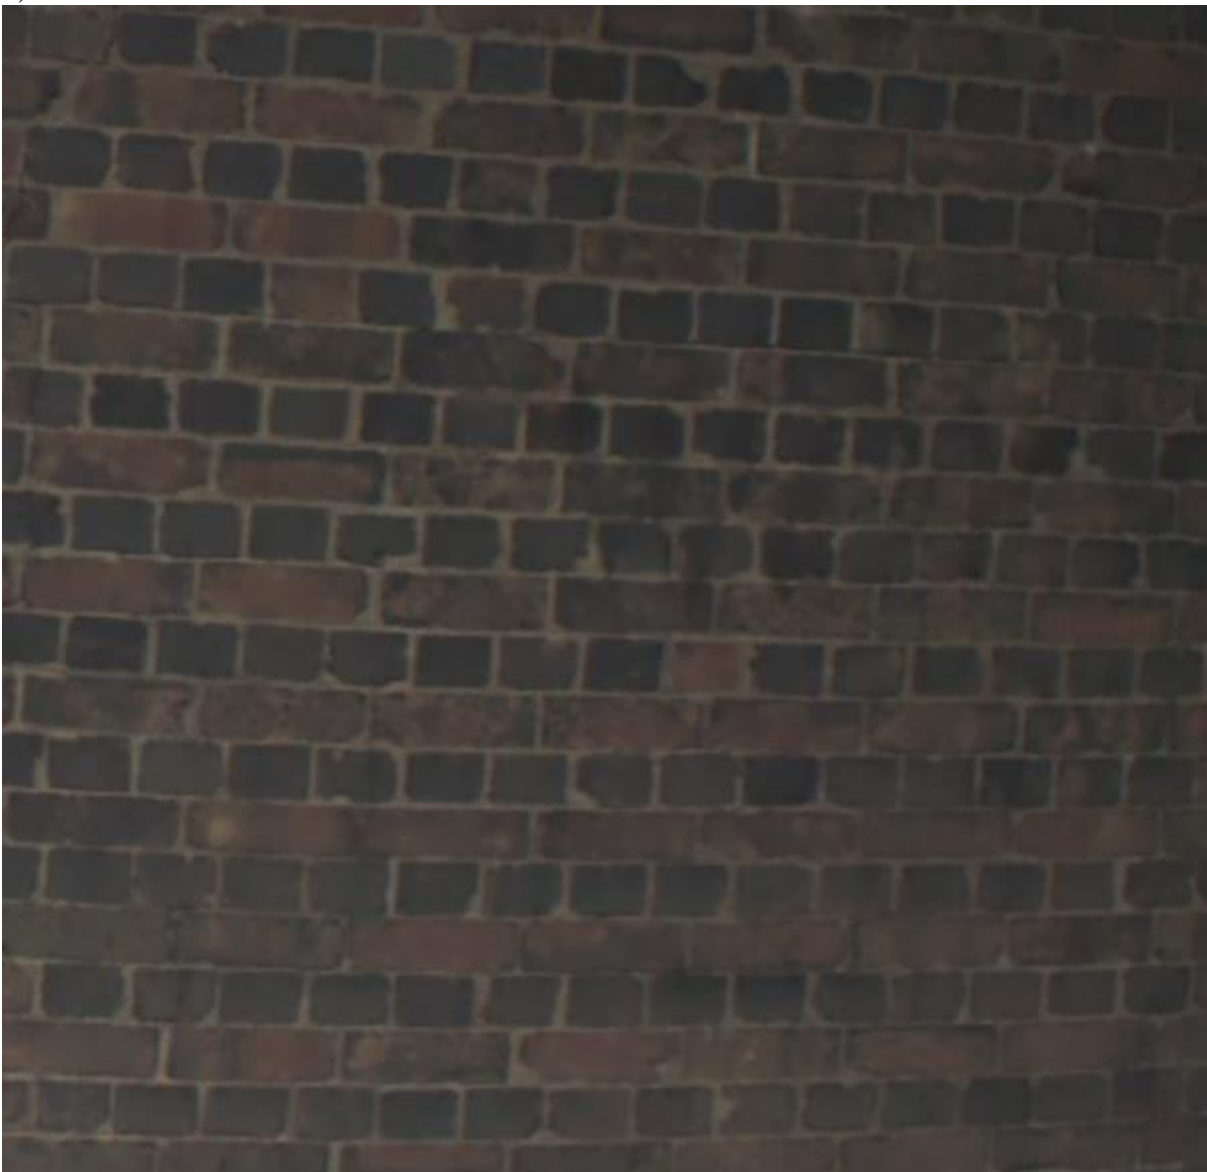
Figure 2-3: Leica Pegasus 2 visual data output at 30-40mph showing: a) a 360-degree image view, b) a full resolution view of the masonry on one of the bridge abutments

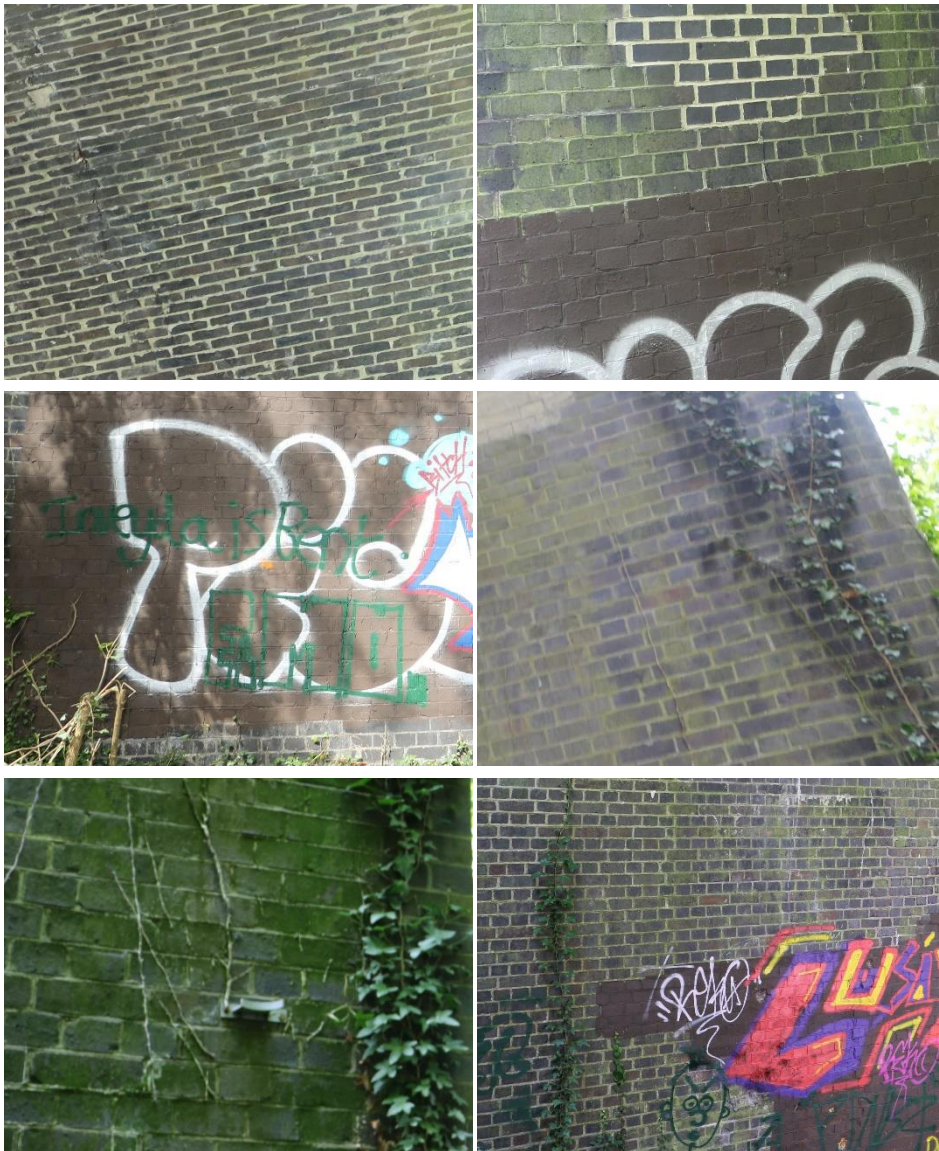
- Key features and distractors: Overall good condition masonry with well-defined and clean mortar joints. Some areas of graffiti and block sections of paint as well as vegetation obscuring mortar joints. Photos taken with neutral lighting and minimal shadowing.

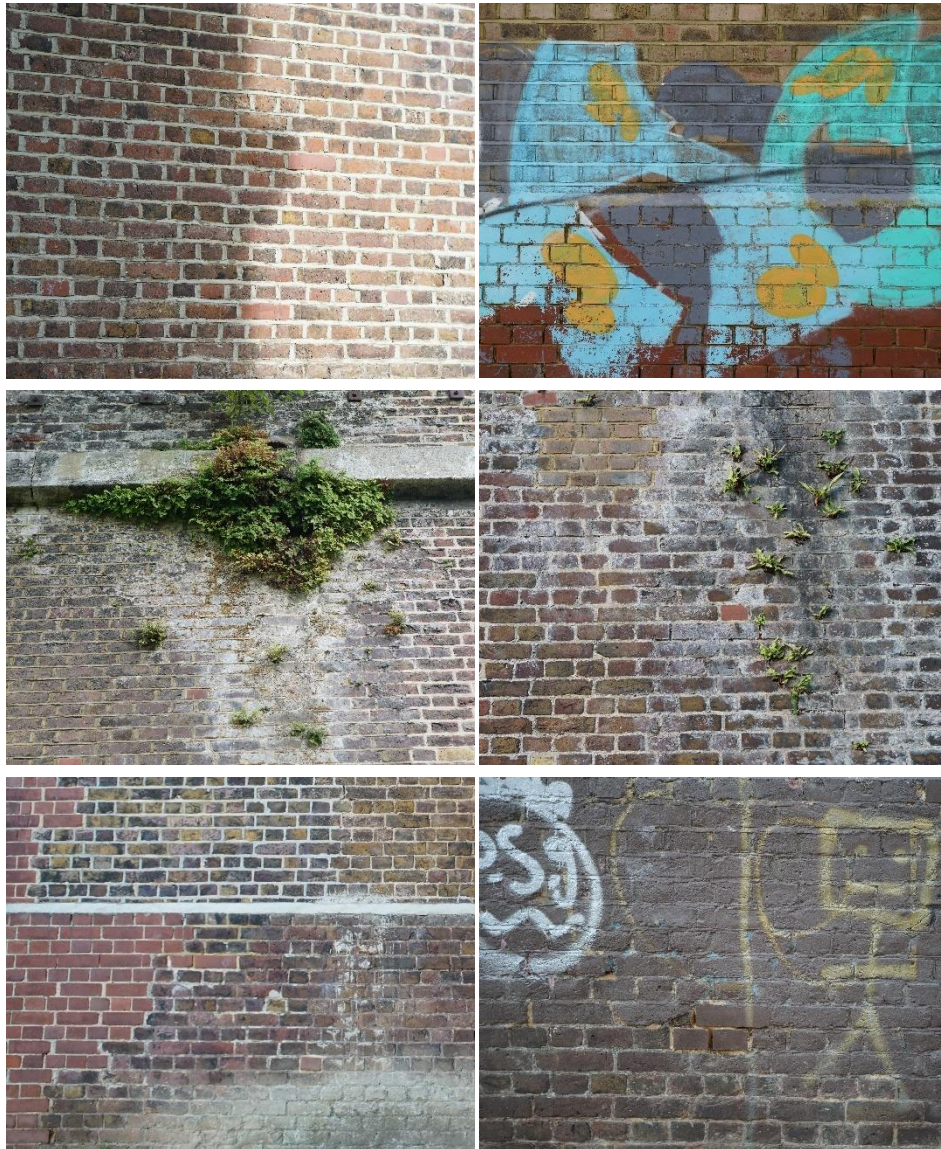
- Key features and distractors: Mostly good condition masonry with several areas having undergone repointing or replacing of bricks. A few areas have graffiti, or block paint to cover graffiti, and vegetation is present in some areas. Some photos show shadowing on the brickwork.

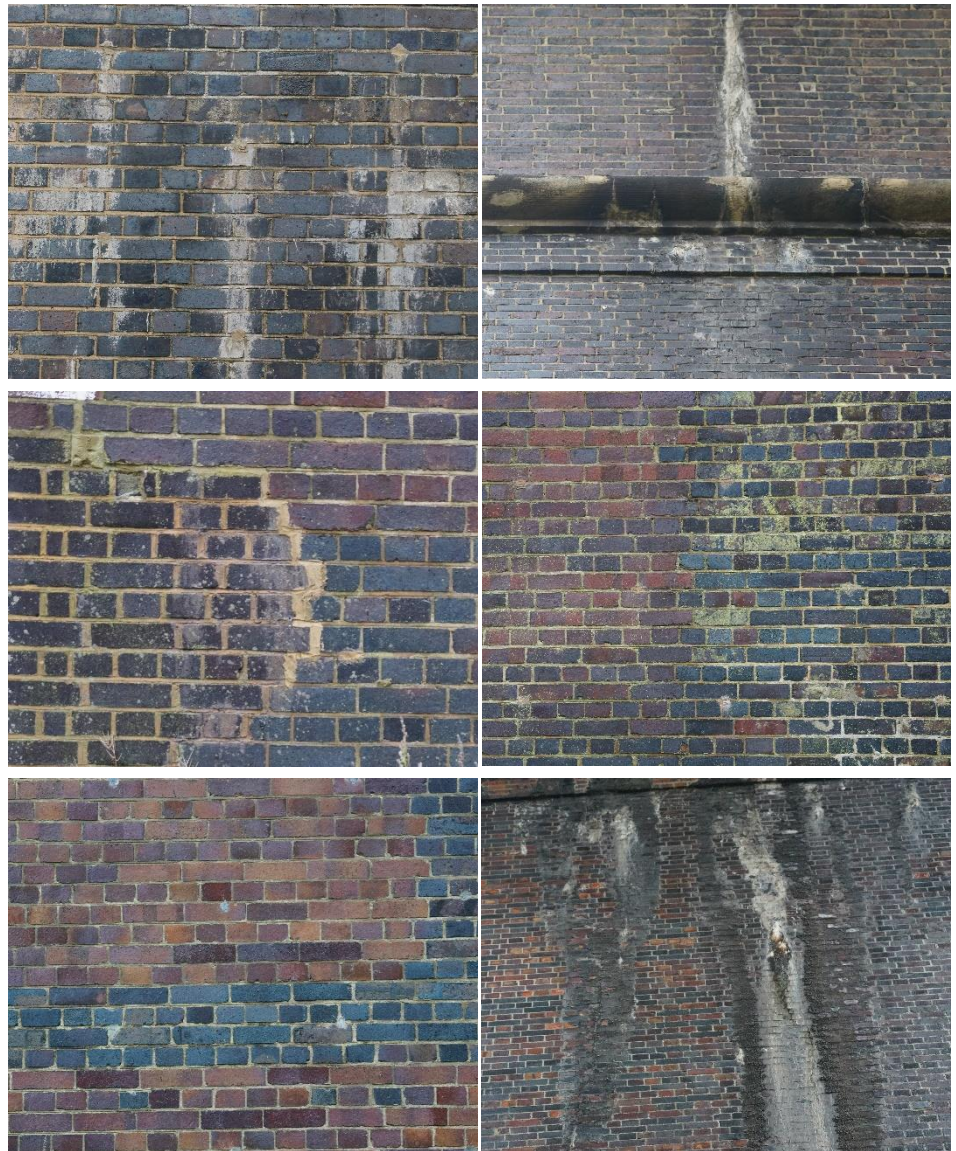
- Key features and distractors: Excellent condition masonry with well-defined and clean mortar joints and smooth brick surfaces. Almost no vegetation, though a few areas of efflorescence on arch barrels. Photos taken with neutral lighting and minimal shadowing.

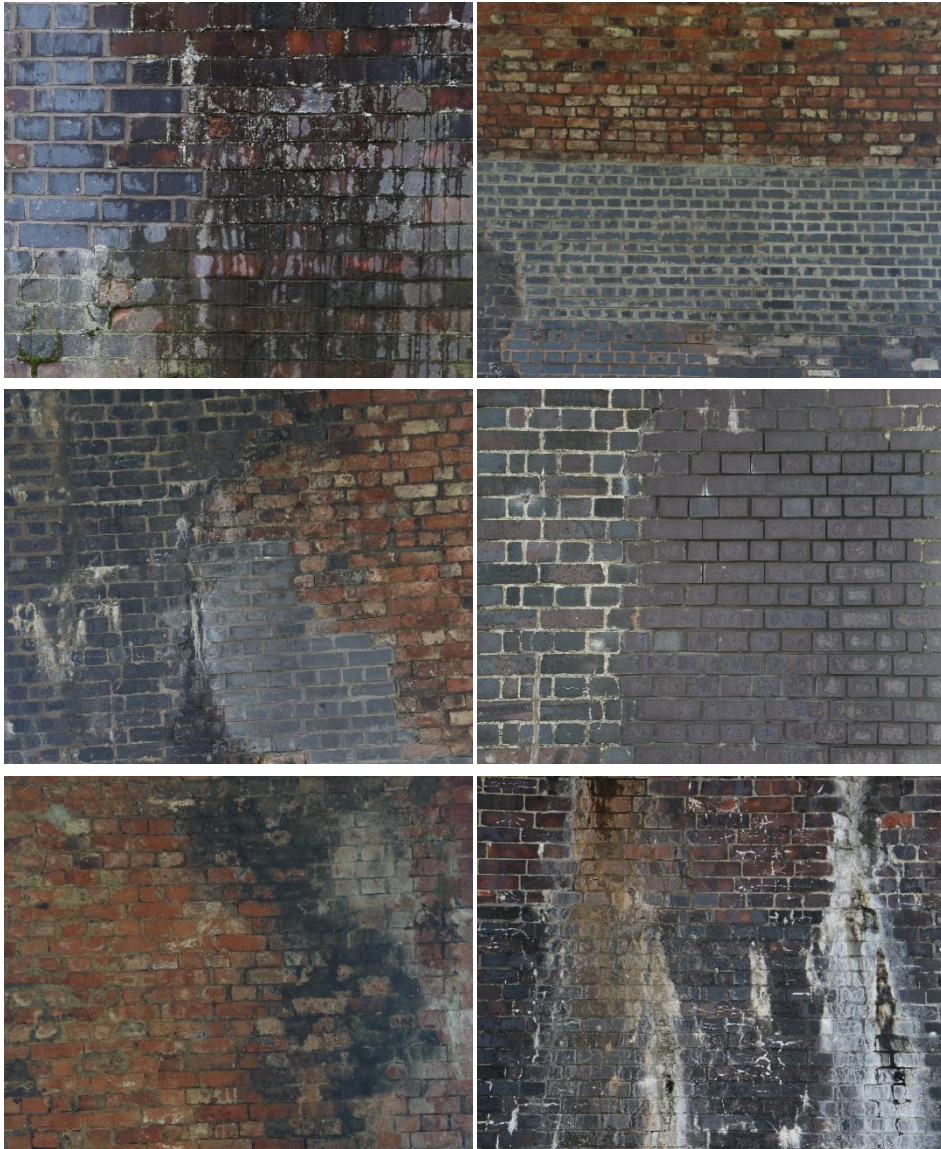
- Key features and distractors: Masonry in mixed condition with areas of wetness and surface deposits, though minimal vegetation. Some mortar recesses are deep and on the arch barrel mortar joints are less well defined. Photos taken with neutral lighting and minimal shadowing.

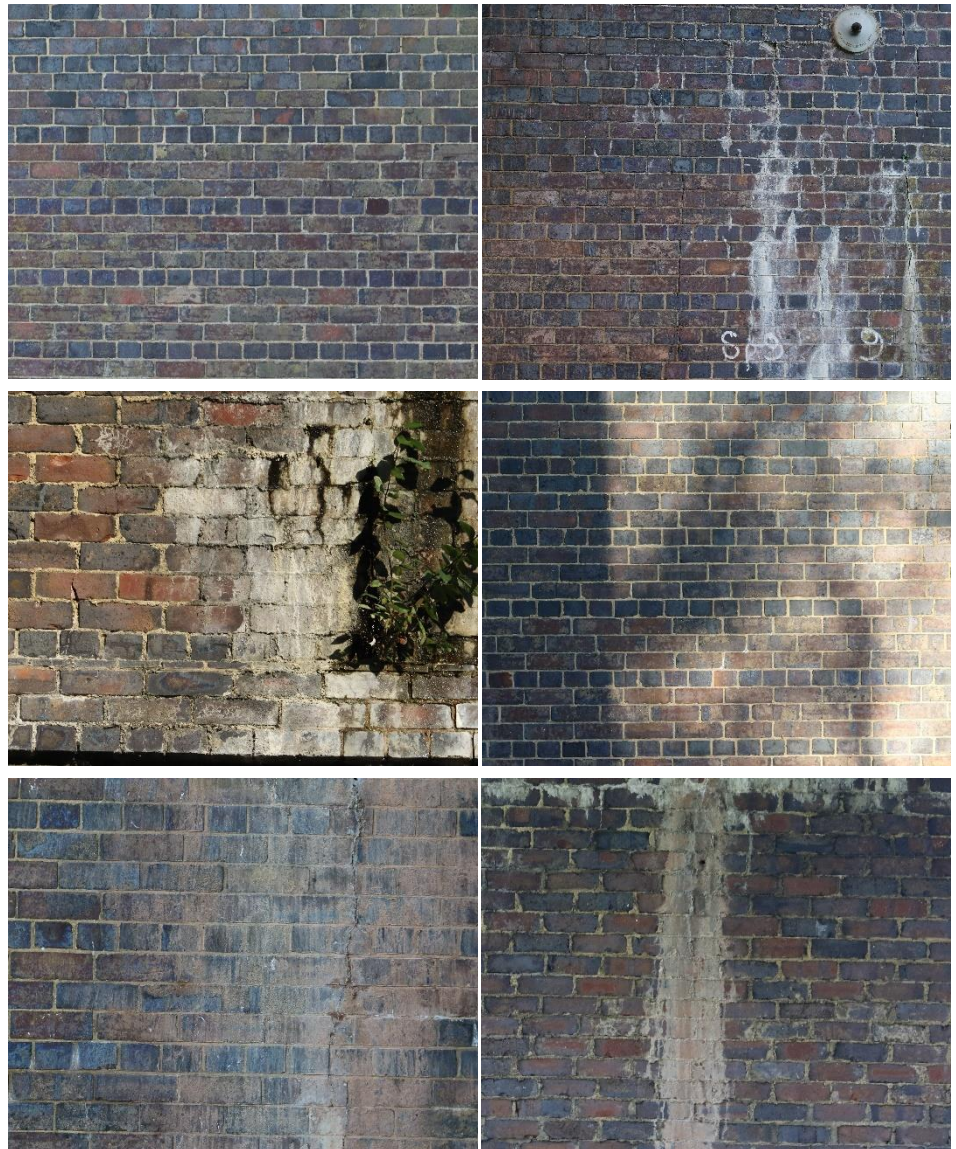
- Key features and distractors: Mostly good condition masonry with smooth brick faces and well-defined mortar joints. Some vegetation and surface deposits present. Photos mostly taken with neutral lighting, though some experience shadowing.

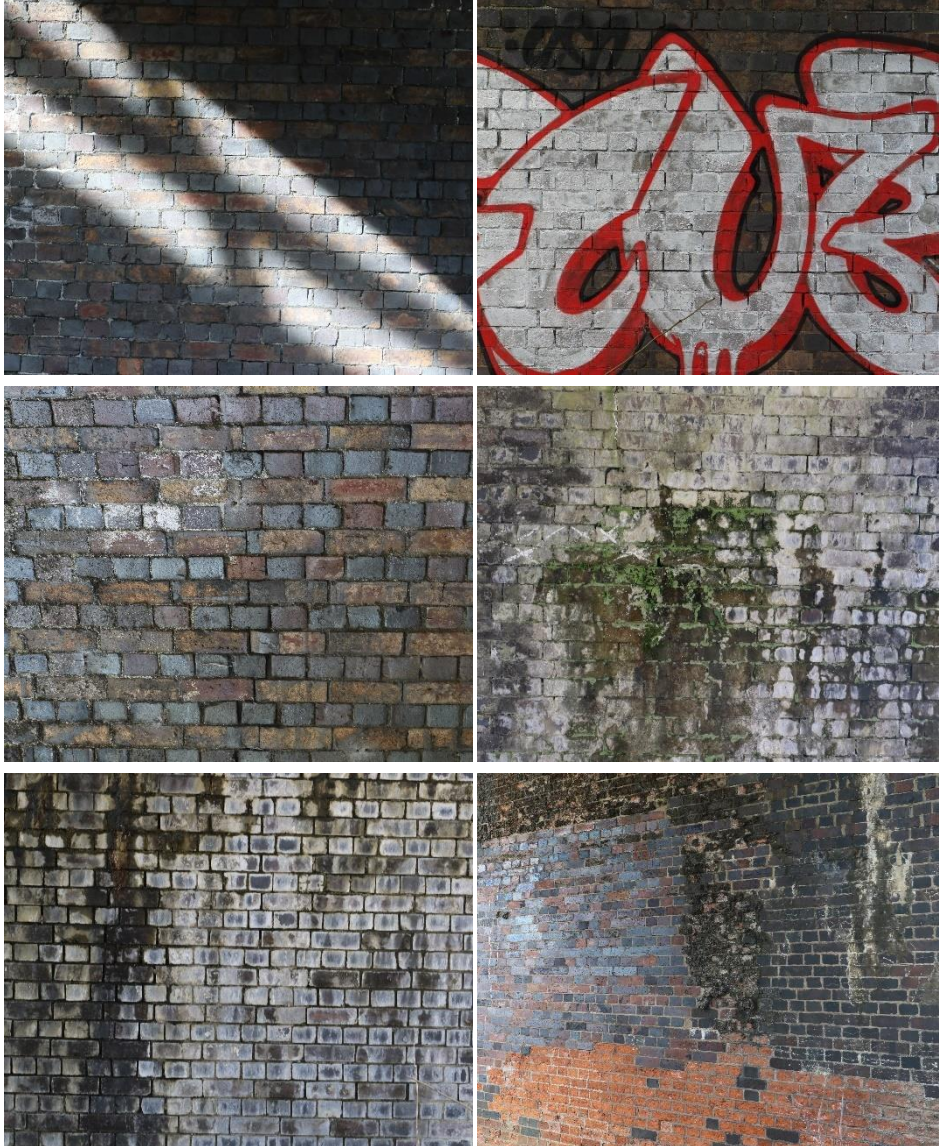
- Key features and distractors: Masonry in average condition with mostly smooth brick faces, though in some areas spalling is prevalent. Some mortar joints are very deep, whilst staining and wetness distracts from others. Some graffiti is present on the structure. Photos mostly taken with neutral lighting, though some experience shadowing.

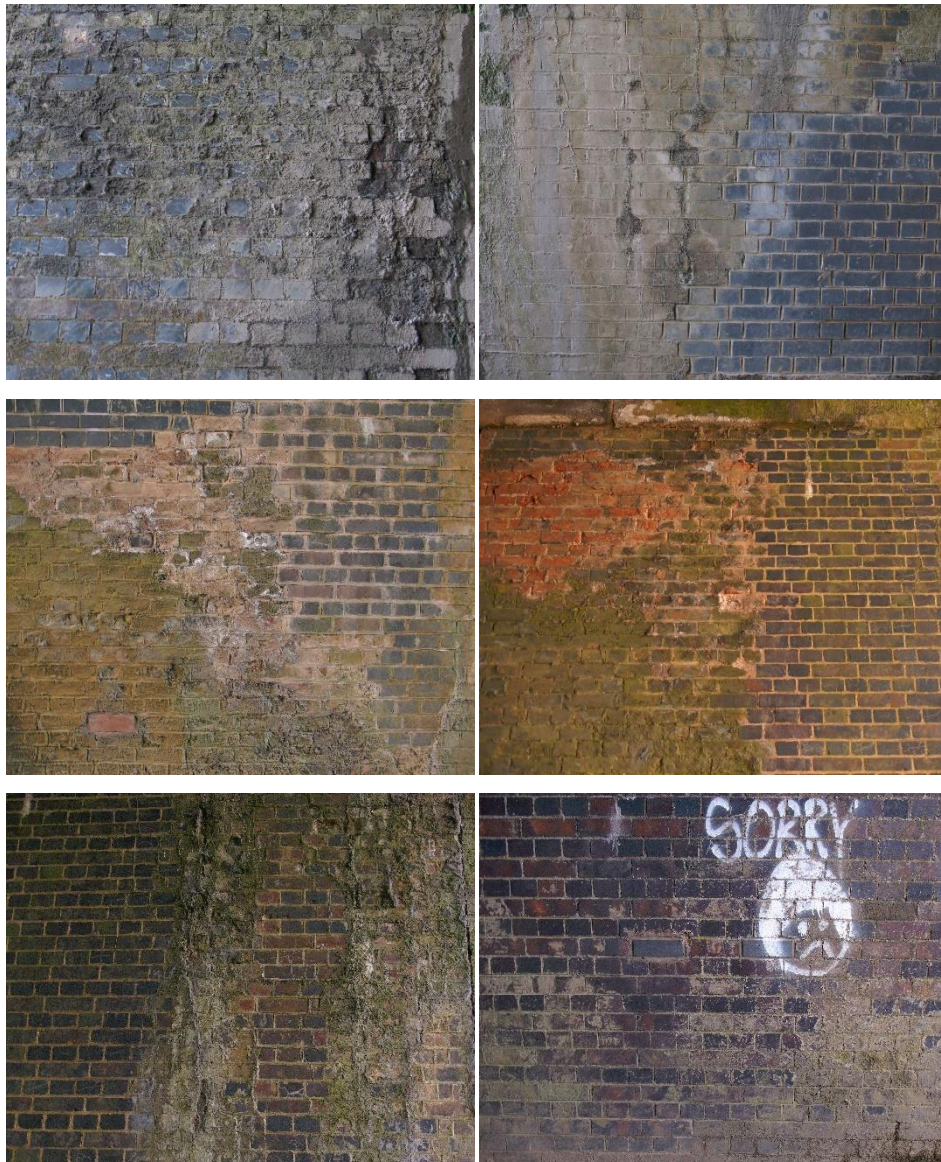
- Key features and distractors: Masonry in average condition, with mostly clear well pointed mortar joints and smooth brick faces. Some areas show spalling and other areas surface deposits. There is minimal vegetation and graffiti. Photos taken with neutral lighting and minimal shadowing.

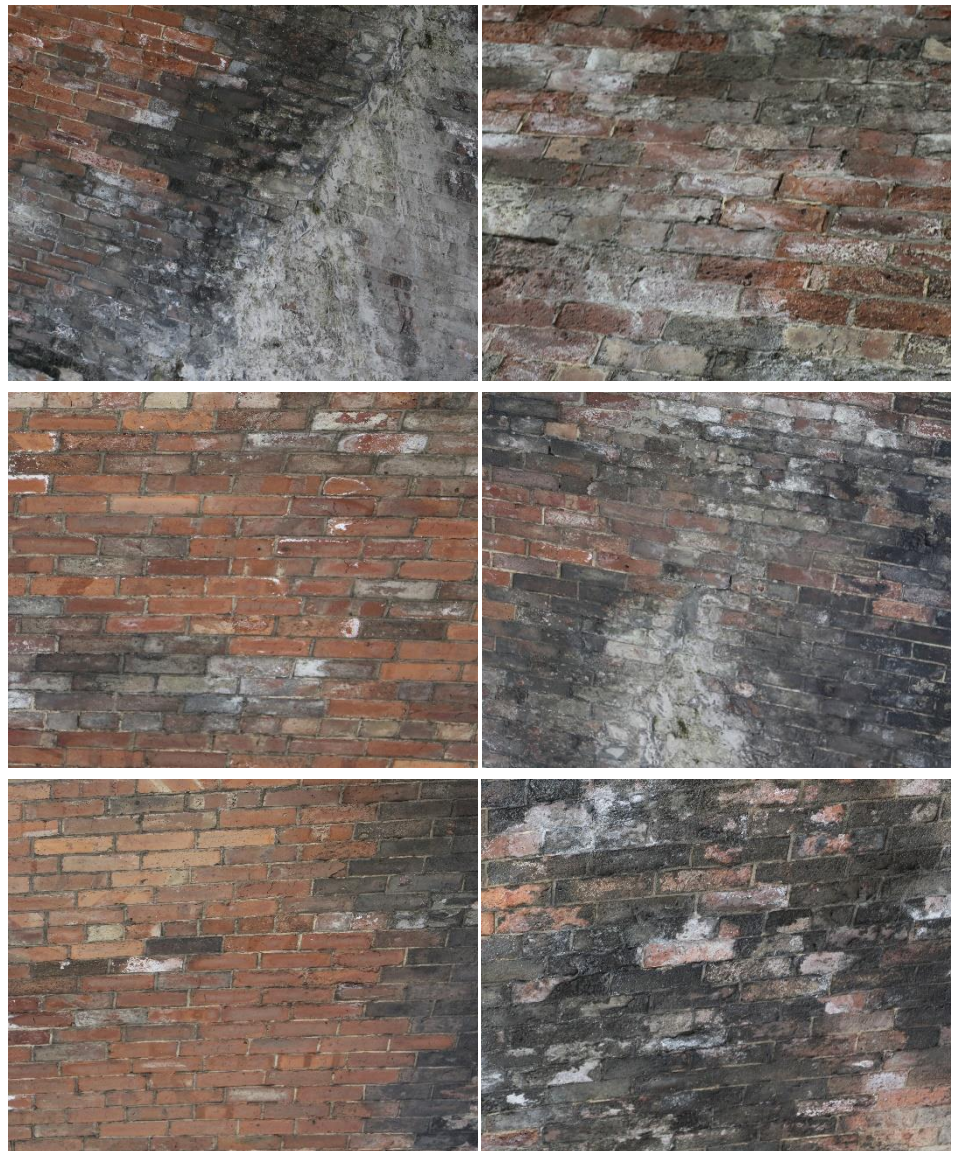
- Key features and distractors: Only the arch barrel contains brick masonry. In general brick masonry in good condition with clean mortar joints, and smooth brick faces, though towards the springing line there is the presence of leaching and deposits. Photos taken with neutral lighting and minimal shadowing.

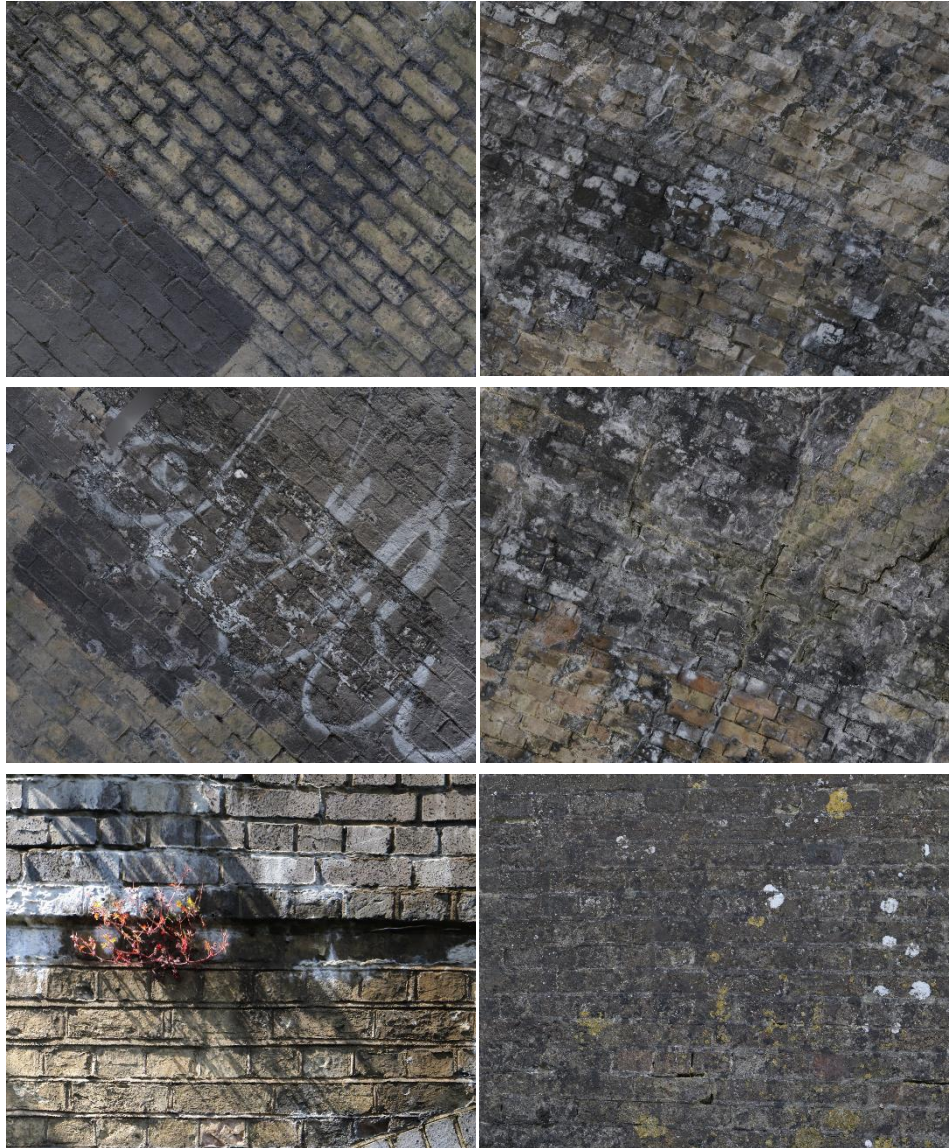
- Key features and distractors: Masonry generally in poor condition with rough brick surfaces and unclear mortar. Most of the masonry surface is covered in soot and other deposits. In some areas mortar joints are very deep. Photos mostly taken with neutral lighting, though a few experience shadowing, especially around mortar joints.

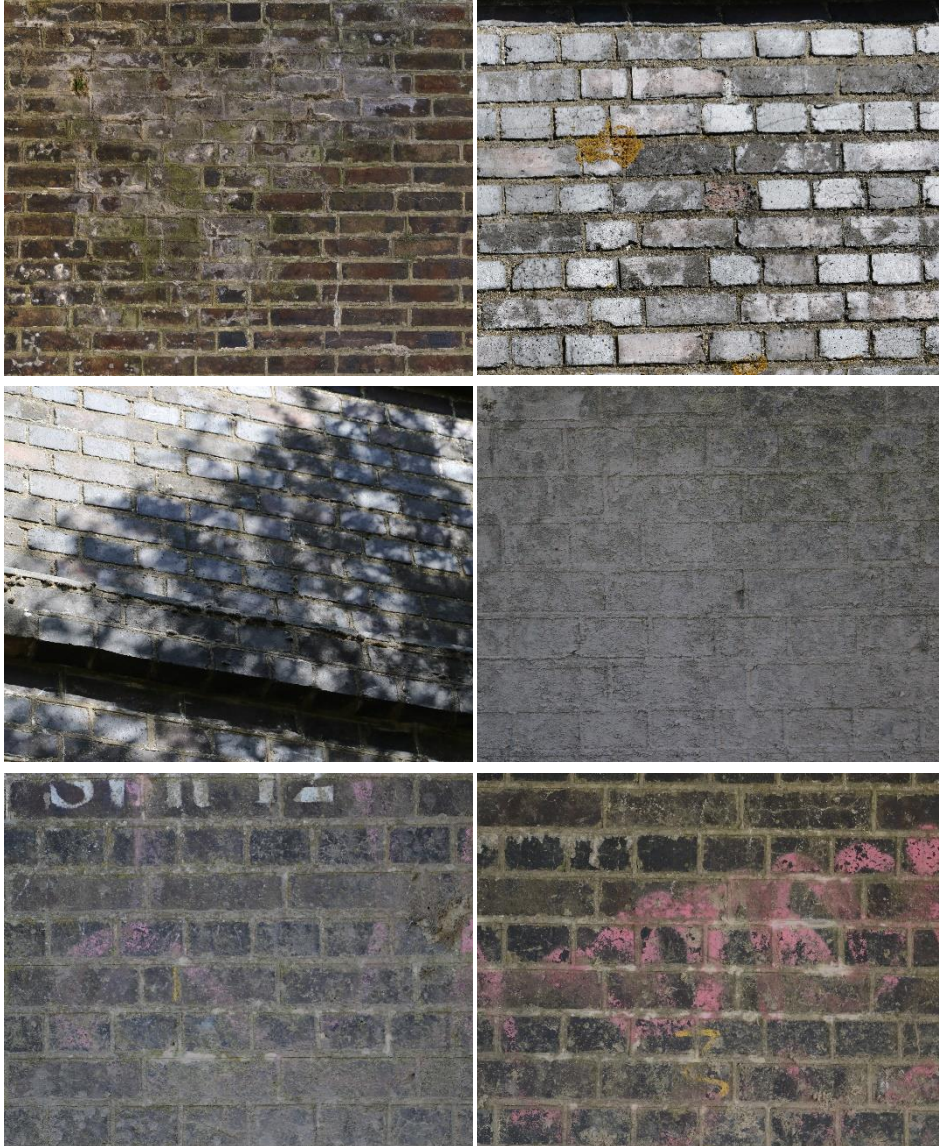
- Key features and distractors: Masonry generally in good condition with smooth brick surfaces, though the abutments have a covering of mud from farm traffic. Areas of the arch barrel also show significant efflorescence and deposits. Photos were taken with bright sunlight, so shadowing is prevalent, especially around mortar joints.

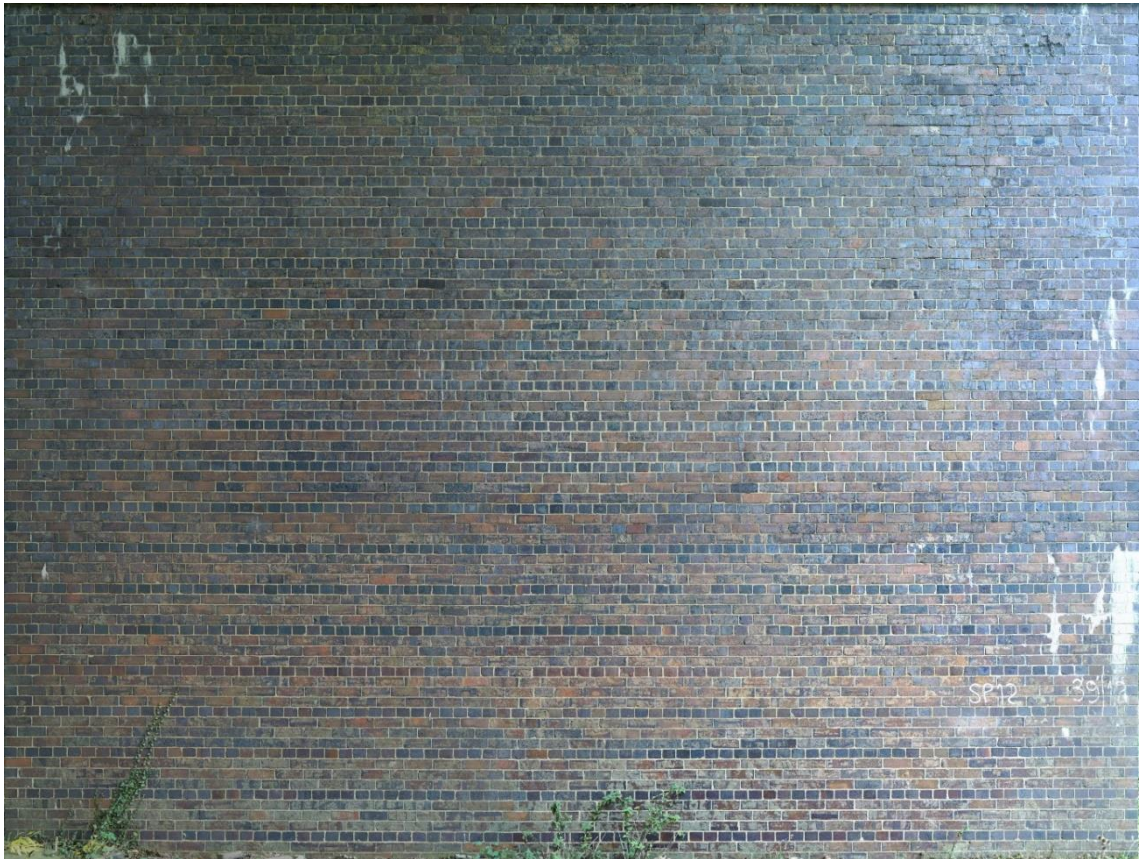
Figure 4-3: Orthographic stitched panorama for Hertford Viaduct

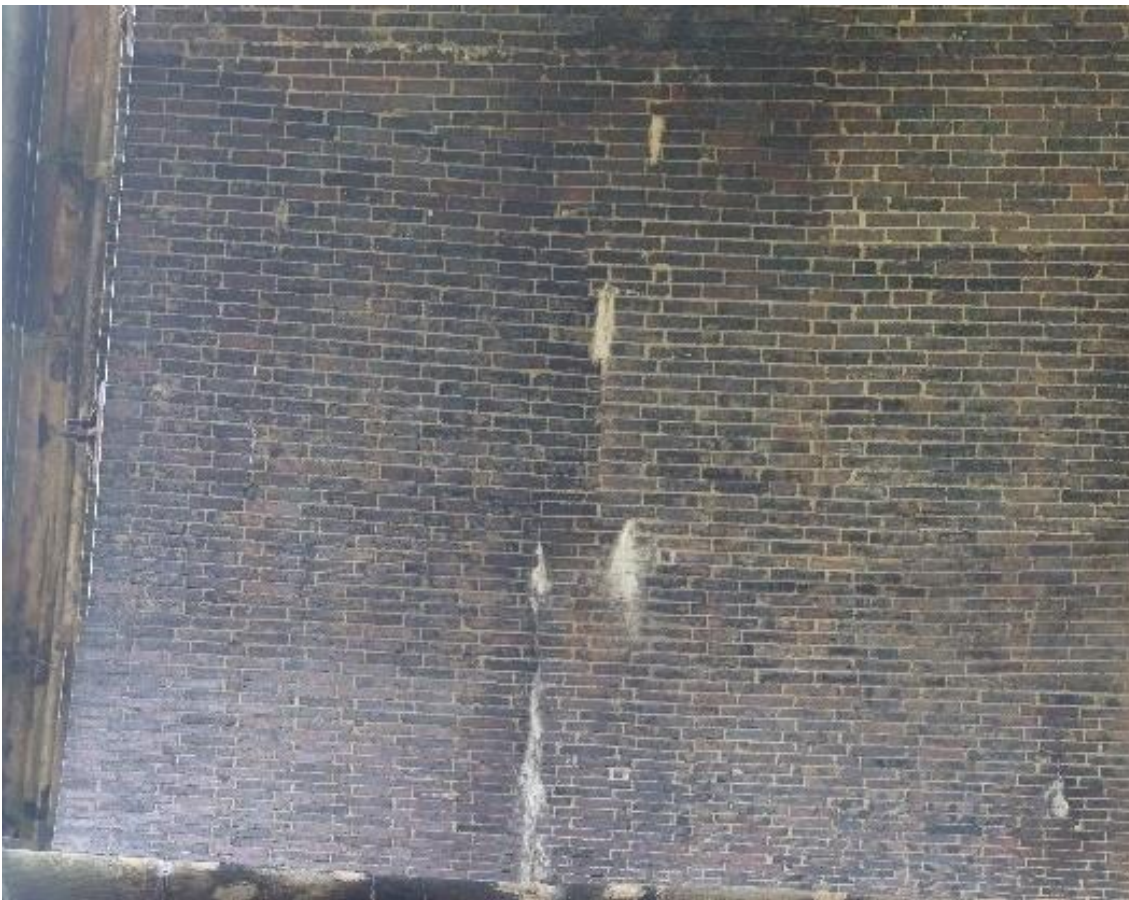
Figure 4-5: Misalignment in image stitching for Digswell Viaduct arch barrel

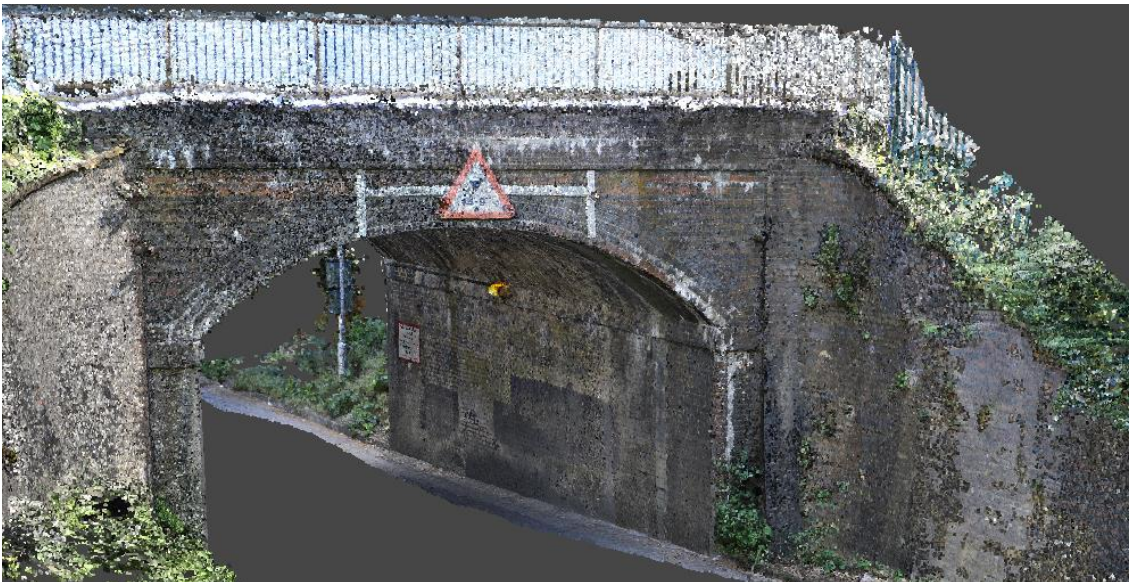
Figure 4-6: Photogrammetric model for Norton Road Bridge (SBR 8)

it would have been possible to import the point cloud that was developed through laser scanning instead of calculating a dense point cloud through photogrammetry. However, the increased accuracy of the laser scan derived point cloud was not required, so for simplicity the photogrammetric point cloud was used. A mesh of the surface is built from the dense point cloud, through triangulation of the points. This mesh surface is then coloured based on the projected image data to form a coloured texture, and a coloured 3D model of the bridge. Photogrammetry has been performed on: Spring Road Bridge (SBR 4), Norton Road Bridge (SBR 8), and Smythes Farm Bridge (SBR 12). These bridges are located by red markers in the map in Figure 4-2. The coloured 3D photogrammetric model for Norton Road Bridge (SBR 8) is shown in Figure 4-6 for reference.

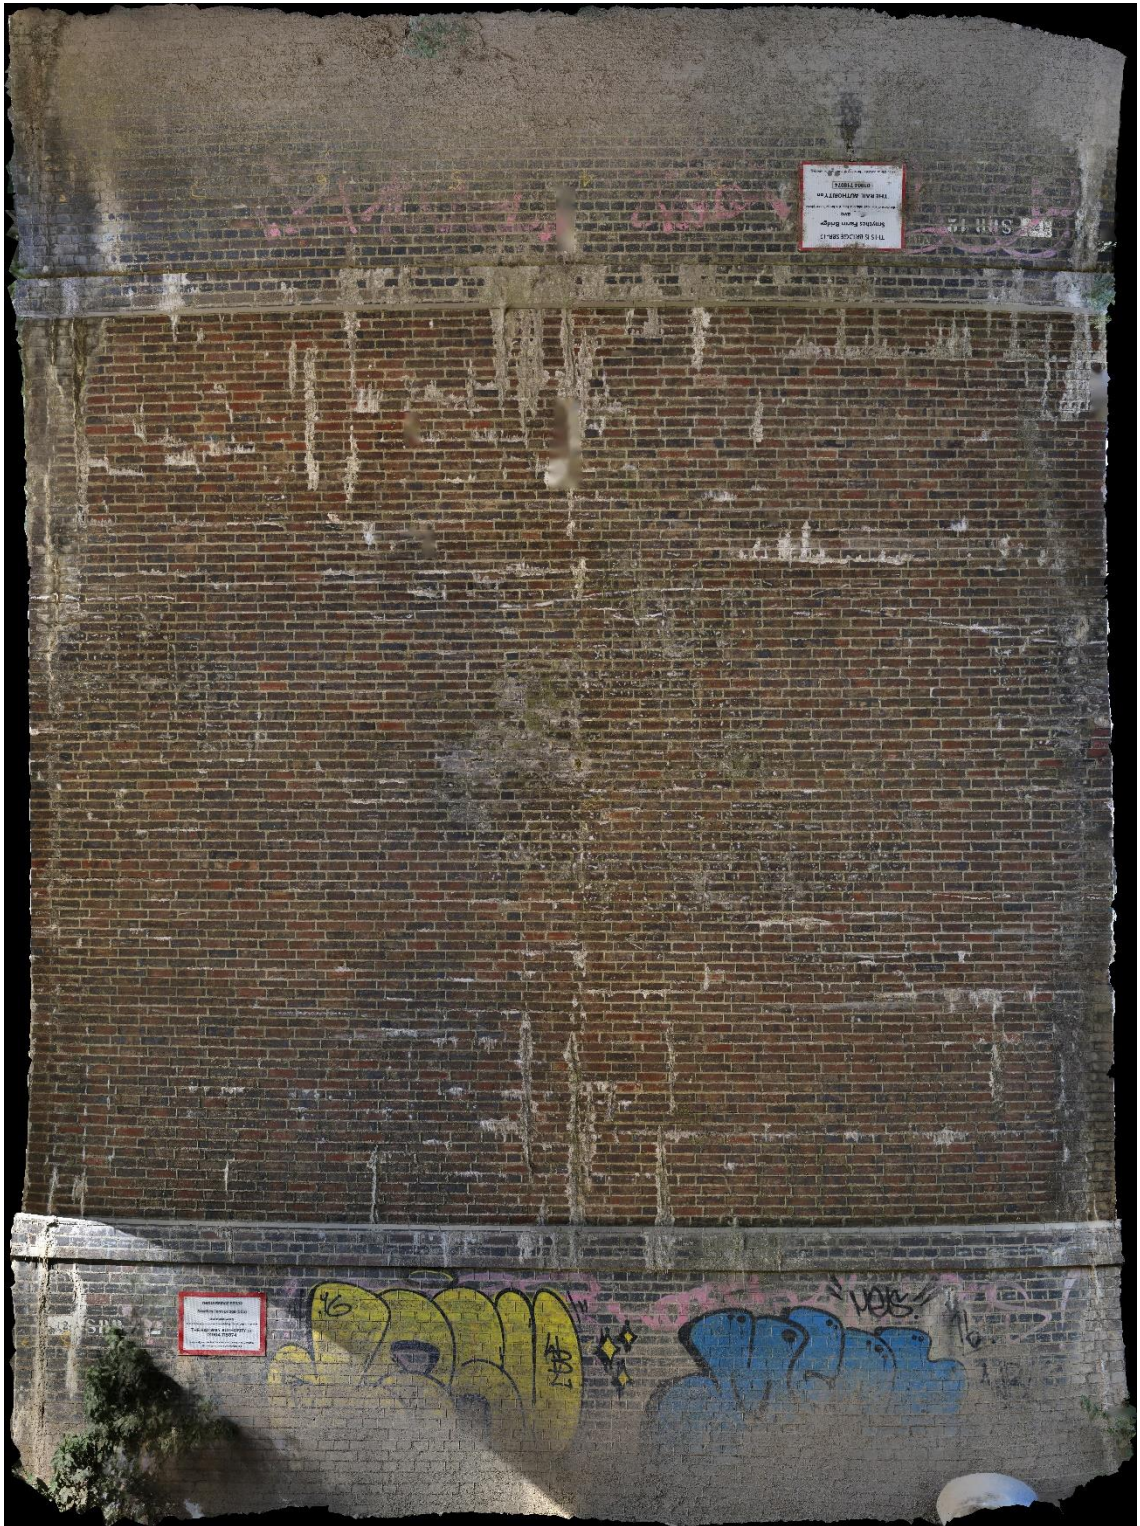
Figure 4-8: 2D texture for unwrapped UV from textured 3D geometric model of the arch barrel and abutments of Smythes Farm Bridge (SBR 12)

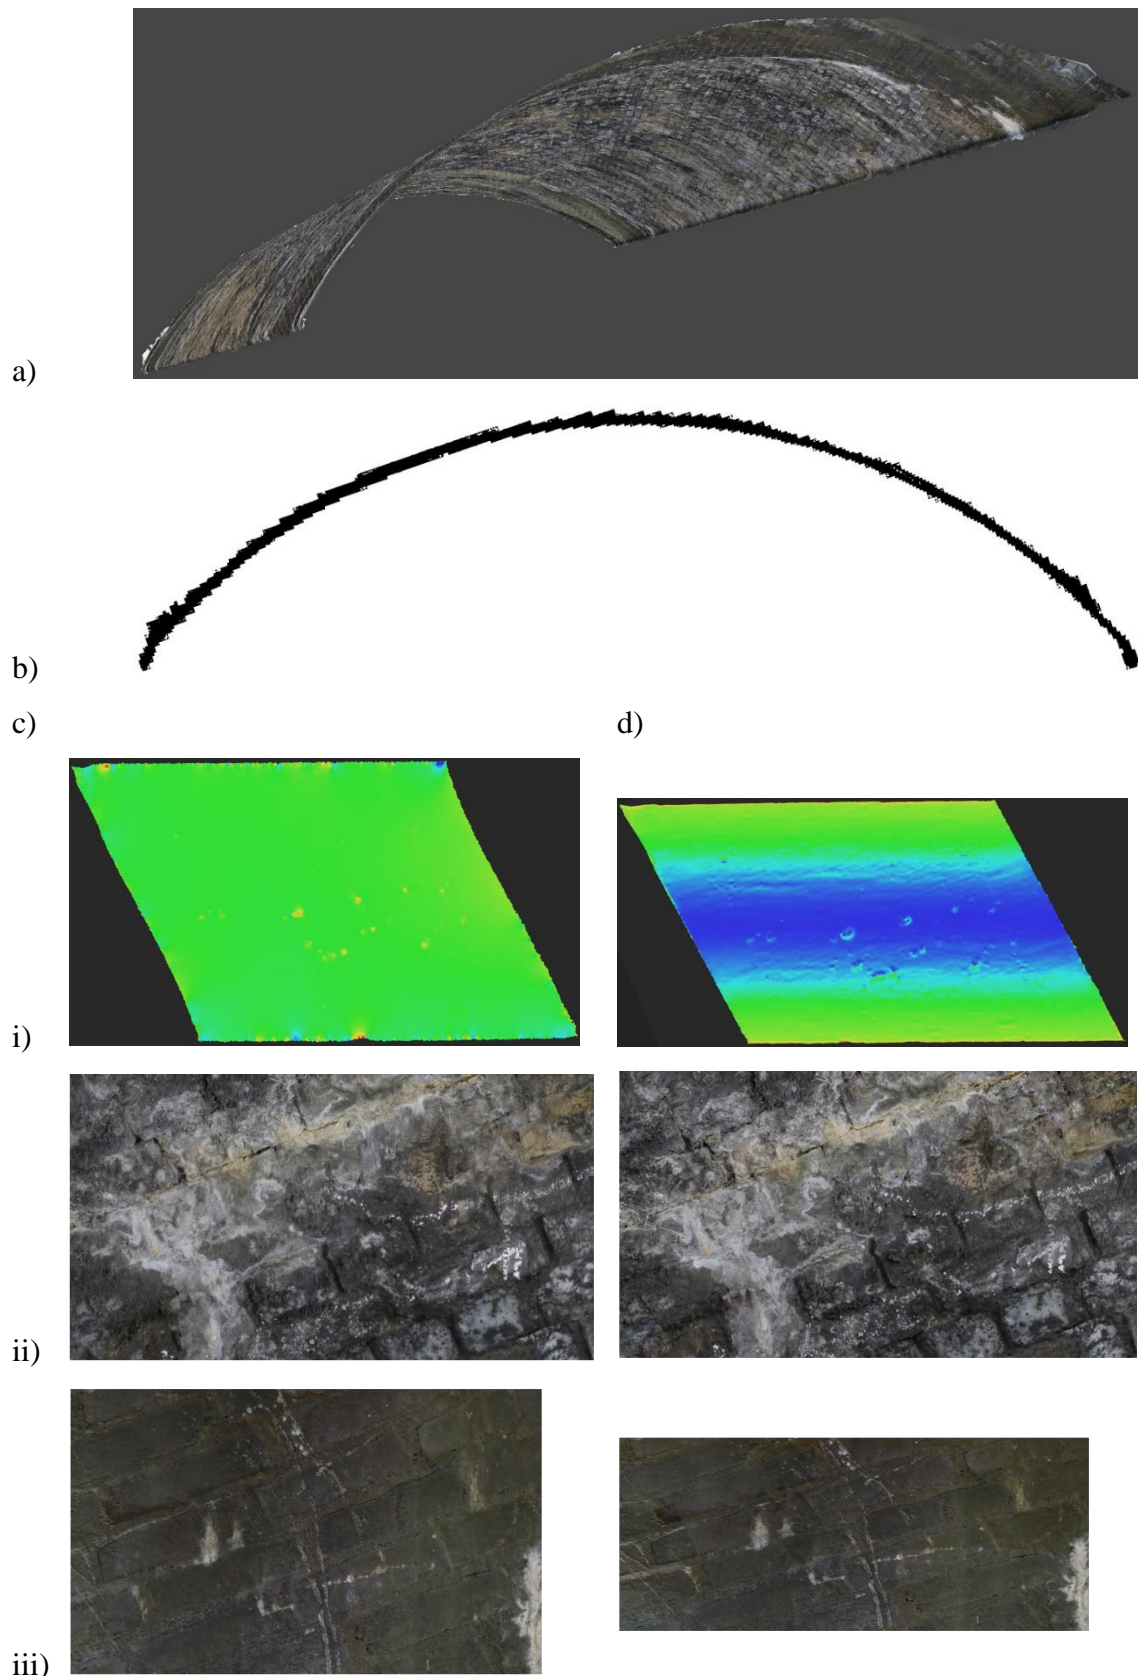
Figure 4-9: UV Map scaling effect on arch barrel of Norton Road bridge (SBR 8): a) Barrel model, b) Barrel profile, c) UV unwrap mapping, d) Orthothophoto UV mapping; i) barrel scaling, ii) texture at barrel crown, iii) texture close to barrel springer

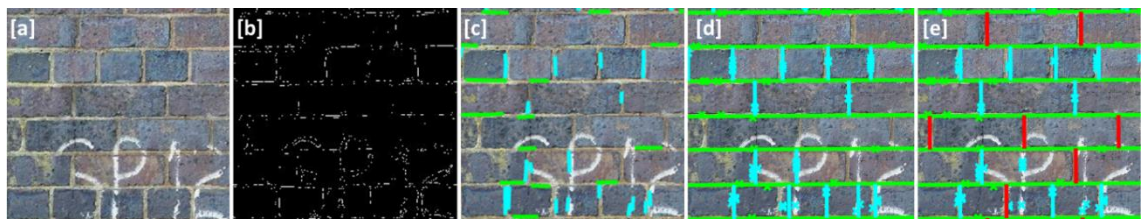
Figure 5-2: Stages of mortar line detection: a) input image data, b) edge detection, c) horizontal and vertical straight-line detection, d) mortar line plotting, e) pattern detection and mortar line detection correction

Image intensities rather than colour thresholding were chosen as the feature for extracting mortar joints. This was chosen as in some masonries, particularly older masonry such as on arch bridges, there is no clear colour differentiation between mortar and bricks due to coverings of for example dirt or paint. Therefore, Sobel edge detection is performed to detect the changes in image intensity experienced at bed joints. In many masonry arch bridge images, bed joints are much more prominent in some regions than others due to noise on the bridge surface. Therefore, the image is divided into smaller regions, each only a few bricks in size, and edge detection is performed on each image region separately. This means that a tailored threshold for edge detection can be set locally for each image region, based on the detected intensity of the bed joints. Figure 5-2b shows the edge-detected output of a masonry image.

The Hough transform is used to detect regions of straight lines in the edge detection mask. This finds straight lines in an image using a voting procedure to select the most likely candidates. To account for the local variation in the prominence of bed joints, the Hough transform is performed separately on the same image regions used for the edge detection. The straight lines detected are then filtered so that only those forming a part of a bed joint are retained. This is done by removing all straight lines which are not orientated horizontally relative to the masonry angle determined pre-processing the image. These detected straight horizontal lines are shown in green in Figure 5-2c.

Bed joints are then plotted by fitting a linear polynomial equation to the length-weighted positions of straight lines in each group. As bed joints run parallel to one another, the gradient of each bed joint is then weighted by those surrounding it using an exponential decay process. The exponential decay factor is assigned based on the confidence in the positioning of the bed joint, such that the gradient of a bed joint with low confidence will be based heavily on those surrounding it and less so on its own initially calculated gradient. Conversely for a bed joint with high confidence, the value of its initially calculated gradient will carry a large weighting in determining its final gradient. The plotted bed joints detected are shown in green in Figure 5-2d.

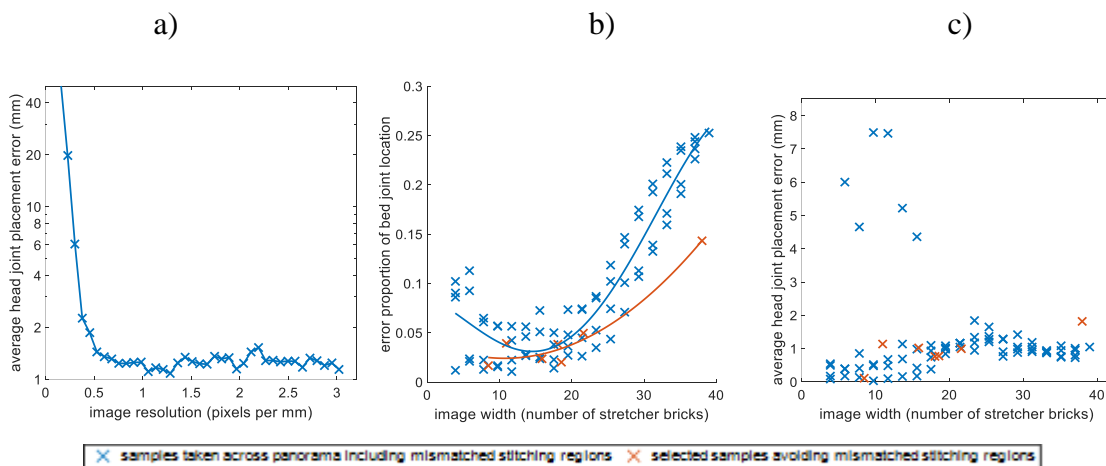
Figure 5-6: Mortar line accuracy: a) head joint placement varying image resolution, b) bed joint placement varying image width, c) head joint placement varying image width
