*AUTOMATED IMAGE-BASED INSPECTION
OF MASONRY ARCH BRIDGES*

This thesis is submitted for the degree of Doctor of Philosophy

January 2022

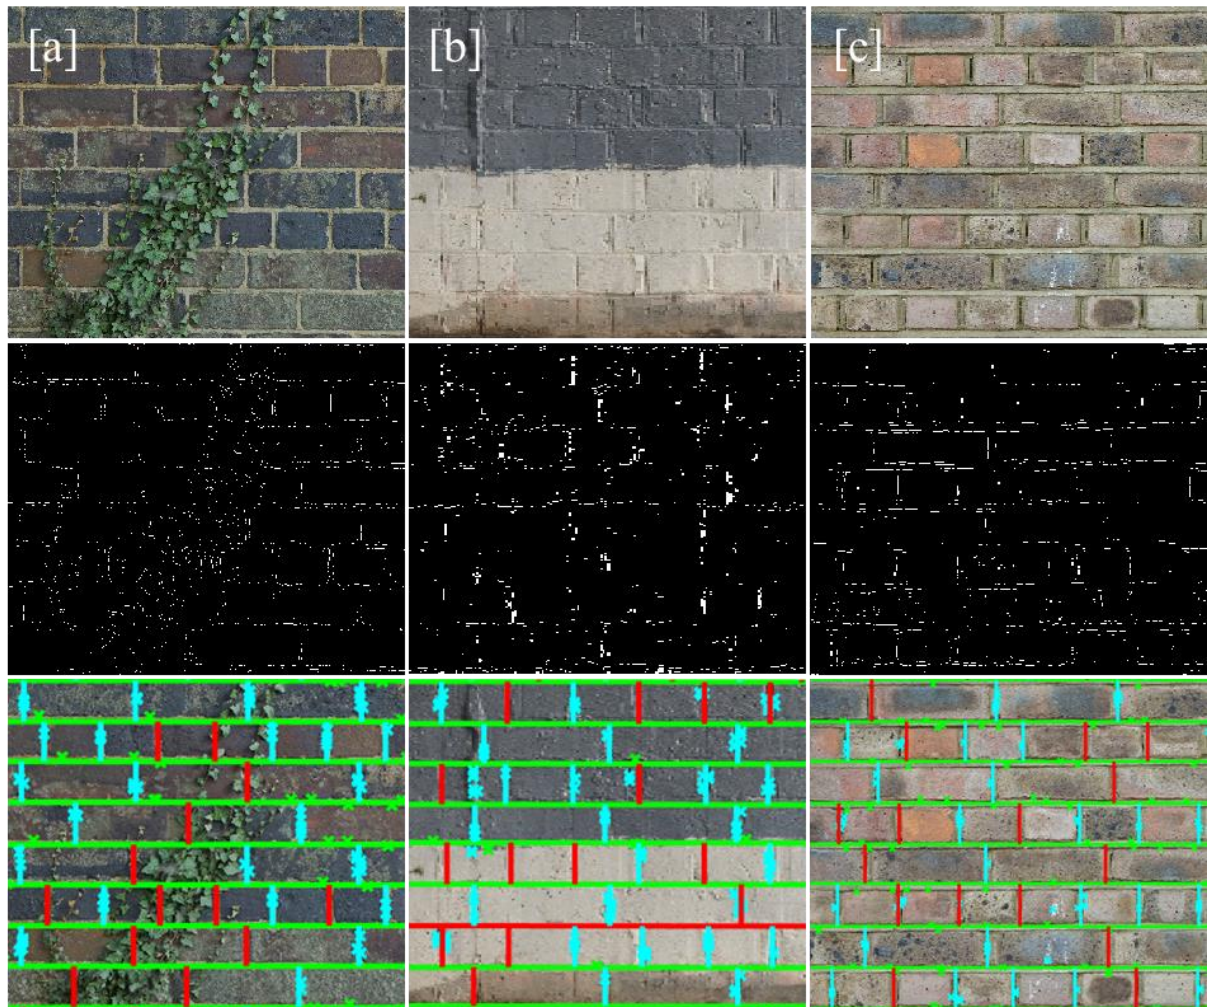
Figure 5-7: Closeup images from testing on different bridges showing input image, edge detection and output, for: a) Hertford Viaduct, b) Peterborough Viaduct, c) Chelmsford Viaduct

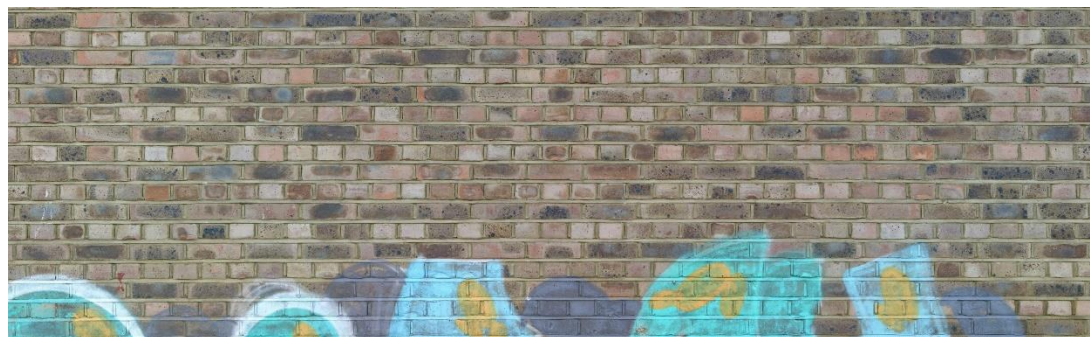
Figure 5-10: Image window mortar joint classification for image from Chelmsford viaduct pier with image window size of: a) 30 pixels and b) 10 pixels. c) depicts the tested image

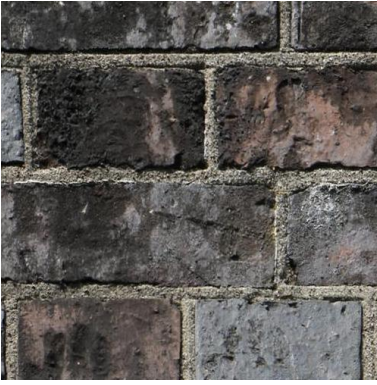
Figure 5-12: Example of image patch size used for training and testing

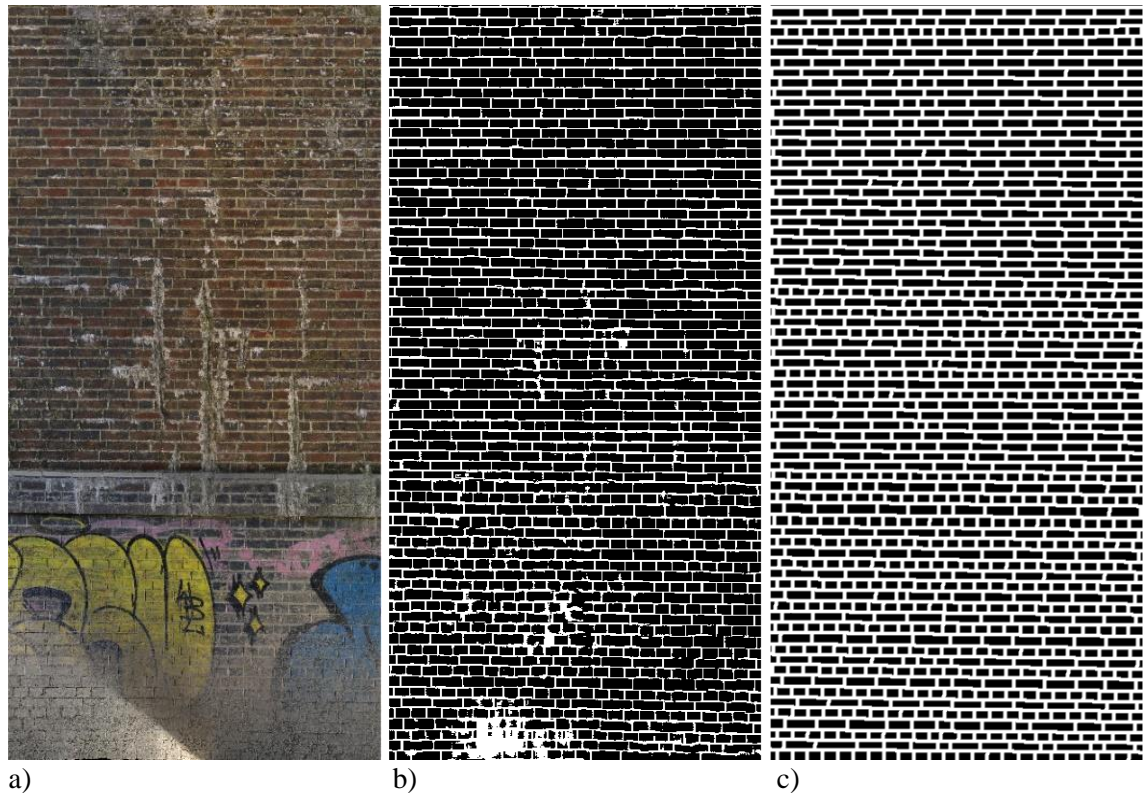
Figure 5-13: Semantic segmentation output for one section of Smythes Farm Bridge (SBR 12) depicting part of the arch barrel and pier showing: a) input image, b) semantic segmentation output, c) deterministic mortar joint detection applied to semantic segmentation output

As discussed, the developed semantic classifier has been tested on the second dataset described in Chapter 4.6, i.e., those bridges with red markers in Figure 4-2. This dataset contains complete 2D textures for all the surfaces of 3 different underline bridges, developed through photogrammetry and UV mapping. A section of one of these bridges is shown in Figure 5-13 where the output of the semantic segmentation is shown in b. It is apparent that the semantic segmentation has effectively ignored image noise in the form of, shadowing, light patches, block fill painting, thin line painting, steps in the brick courses, efflorescence and staining, gouges, and thick dirt deposits. In almost all locations, mortar joint locations have been accurately classified except in a patch towards the bottom of the image where the surface texture is covered in thick dirt deposits, which has resulted in confusion. However, the mortar joints are almost impossible to manually discern from the image in this area. This therefore shows the potential benefit in applying a pattern recognition procedure to a semantic output. This has been done in Figure

5-13(c), where the erroneous mortar joint region from the semantic output has been corrected. For this, the same methodology as used before in Chapter 5.1 is applied. Here however, the semantic methodology segments the whole width of the mortar joints rather than both edges as before with edge detection. Therefore, the semantic output has been used directly to detect the position of mortar joints using a kernel distribution as in Figure 5-4.
