GFRP durability appraisal: mechanical testing of naturally aged composite panels

Gates, Ibell, Darby and Evernden

ice | proceedings

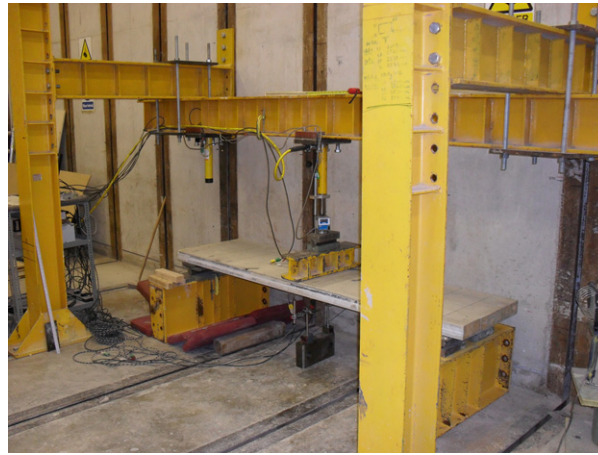
Figure 3. Three-point loading test rig set-up

A three-point bending set-up was used so that a significant proportion of the resulting displacement was attributable to shear deflection and, as a consequence, the accuracy of the value obtained for shear modulus was improved.

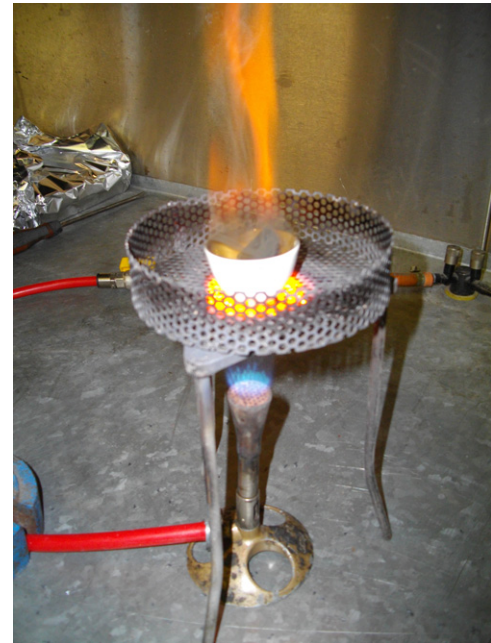
Figure 5. Sample ignited using a Bunsen burner (a), and then placed in a muffle furnace (b)

For both the aged and new material, resin burn-off to establish the fibre weight fraction was conducted according to ASTM D 2584-02 (ASTM, 2002). After weighing to find the initial mass of each of the 25 mm square samples, each sample was ignited by heating in a crucible over a Bunsen flame and left until the volatiles had cleared (once the smoke had stopped) and only fibres, ash and carbon remained. Each sample, in its own crucible, was then placed in a muffle furnace at 565°C for 6 h until all the carbonaceous material had disappeared (Figure 5). Re-weighing of the remaining

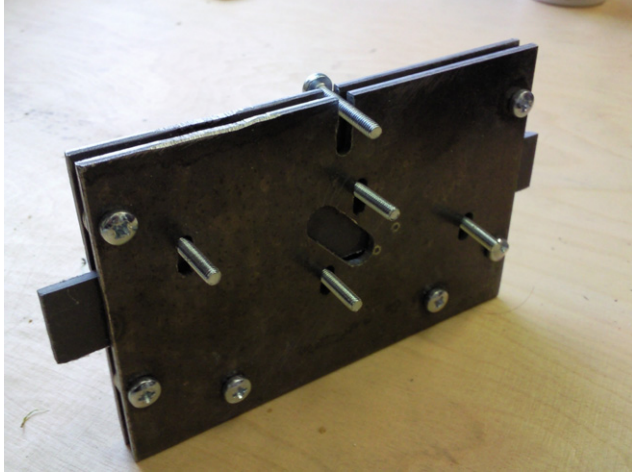
Figure 9. (a) and (b) Iosipescu shear rig set-up (all dimensions in mm). (c) Schematic diagram showing how loads on specimen are achieved and shear is derived at zero moment location

Shear testing is a resin-dominated mechanical test of the composite material. The Iosipescu shear test (VPG, 2008) procedure was adopted to perform testing. A custom rig was designed to accommodate suitable coupon sizes and to apply a shear force in line with the Iosipescu methodology, as

shown in Figure 9. Principal (0°) fibres were once again aligned parallel with the longitudinal specimen direction (perpendicular to the load direction). Two steel plates provided out-of-plane stability to the test specimen. The specimens were 20 mm wide \times 100 mm long. Top and bottom steel loading bars, together with a pin arrangement, enabled loading to be applied to produce the maximum shear and zero moment at the centre point of the test coupon. An observation window cut-out allowed strain gauges to be located. The pins were located within long slotted holes to guide them, avoiding the need to notch the sample at the pin locations, which could otherwise have caused unwanted stress concentrations due to the notch inhibiting lateral movement of the pin across the surface under flexure. The specimen was loaded by means of a mass hanger and weights, with the load applied through the top pin of the rig. Loading was limited to 80 kg by the strength of the loading system, and it was found that this could be applied accurately without damaging the rig. The geometry of the loading arrangement resulted in a shear force in the measured region of 80% of the applied load, as shown by Equation 2 and illustrated in Figure 9

where ϵ_1 and ϵ_2 are strains from the two perpendicular gauges inclined at 45° to the horizontal and τ_{xy} is the shear stress at mid-depth of the section found from the section dimensions, and the shear force as per Figure 9. Equation 3 is true for any inclination of the shear plane in the specimen (as a result of variation in the specimen depth), provided that the gauges are centred at mid-depth at the point of contraflexure of the specimen.

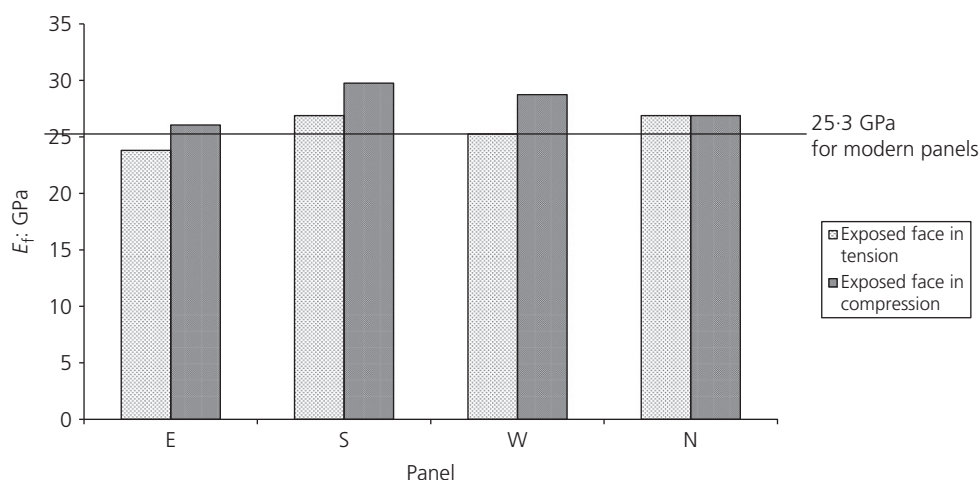
Figure 10. Flexural elastic modulus for each of the building panels and the manufacturer’s testing-derived value of 25.3 GPa

with the exposed external face in tension. The north-facing panels did not show this behaviour. This suggests that degradation attributed to UV exposure or cyclic wetting and drying is of greater detriment to material stiffness when compared with damp conditions alone. It also suggests that in tension the matrix is compromised, however, in compression it is not.

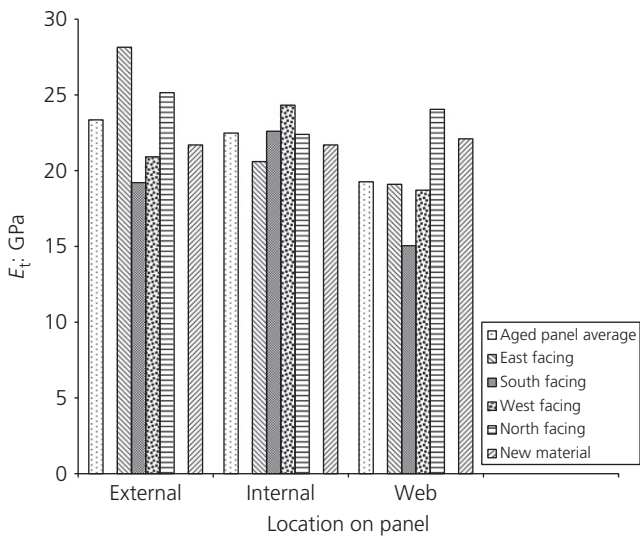
Figure 12. Tensile elastic modulus as a function of coupon origin

Figure 12 shows the results for coupons taken from the panels and tested in tension. The web material of the aged panels appears to have a lower tensile modulus than the flanges, although this difference was not evident in the new material. This is as predicted by resin burn-off and hand calculations. The lowest value of tensile elastic modulus established during testing was 15 GPa (for the south-facing panel web coupons). This correlates well to the established reduction in the fibre content of these elements, as illustrated in Table 2. The coupons of the internal material outperformed those of the external material from both the south- and west-facing panels

subjected to the prevailing estuary wind. Coupons from the north- and east-facing panels did not exhibit this trend. A large variance across the tests was observed, particularly for the webs (as already discussed) and external material, prompting further investigation. In Figure 12, each result represents the average from three coupon tests.

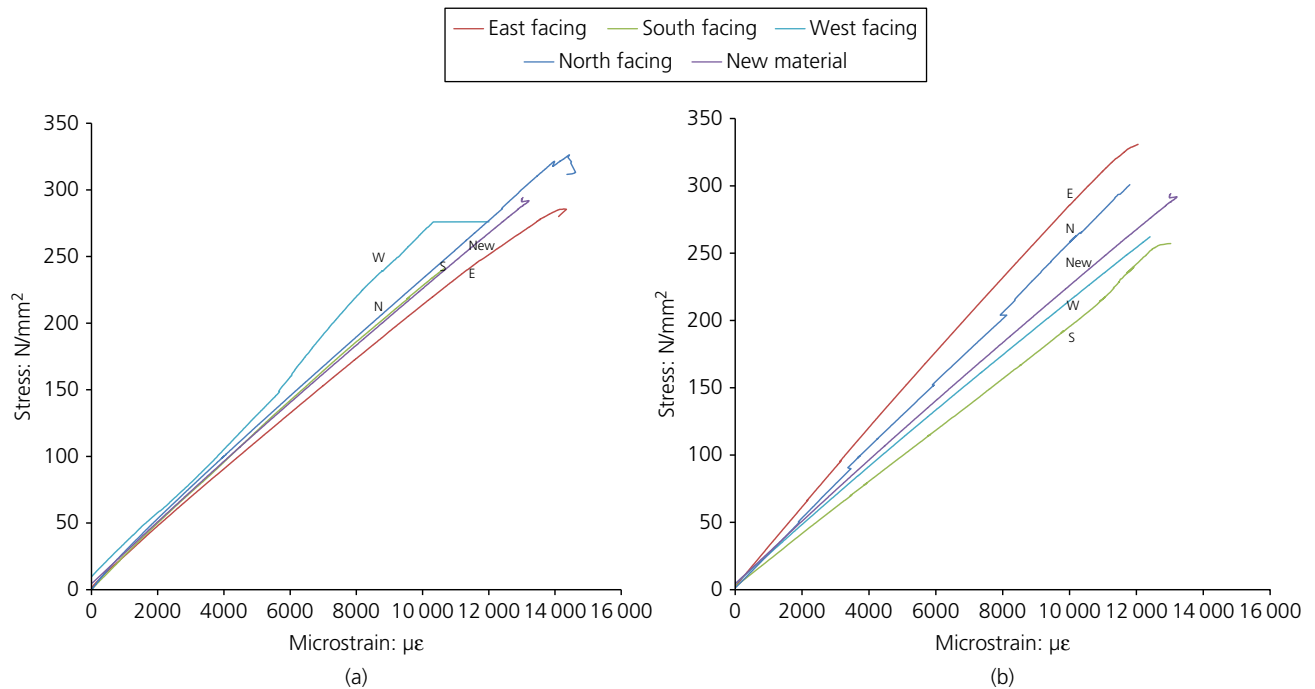
Figure 13. Stress–strain plots, for internal (a) and external (b) panel material

Figure 13 shows a high degree of linearity to failure in the stress-strain response of the pultruded GFRP to axial tensile load. It should be noted that not all of the plots presented

in this figure represent the material load to failure due to strain gauges going off-scale or breaking from the specimen. The tensile elastic modulus was calculated using a strain of $2000 \mu\epsilon$.

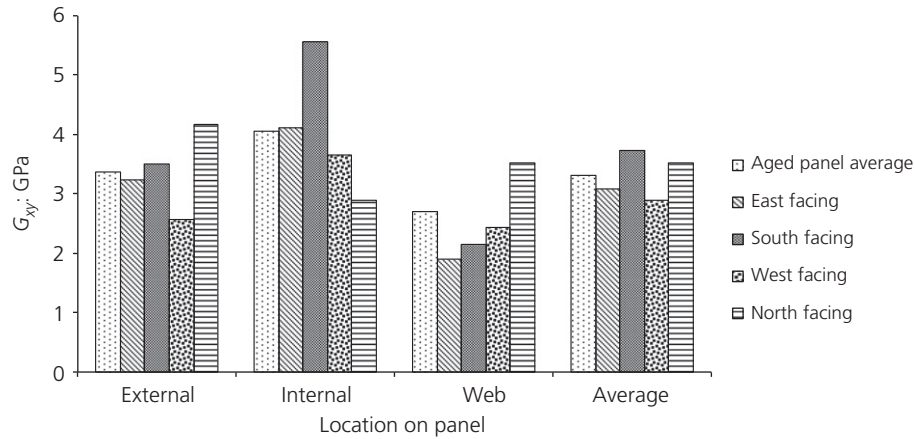
Figure 16. Shear modulus as a function of coupon origin

Figure 16 shows the results of the shear modulus coupon tests. It can be seen that the west-facing panels exhibited the lowest average shear modulus. The lack of stiffness of the webs in this panel is not likely to be attributed to deterioration with age, as the exterior material maintained good integrity. Internal coupons were observed to be stiffer than external coupons by 17%, although the averages displayed were significantly affected
