# Explosion Hazards of Aluminum Finishing Operations

Jérôme Taveau <sup>a,b</sup>, Simone Hochgreb <sup>c</sup>, Saul Lemkowitz <sup>d</sup>, Dirk Roekaerts <sup>b,e</sup>

<sup>a</sup> Fike Corporation, Blue Springs, MO, USA

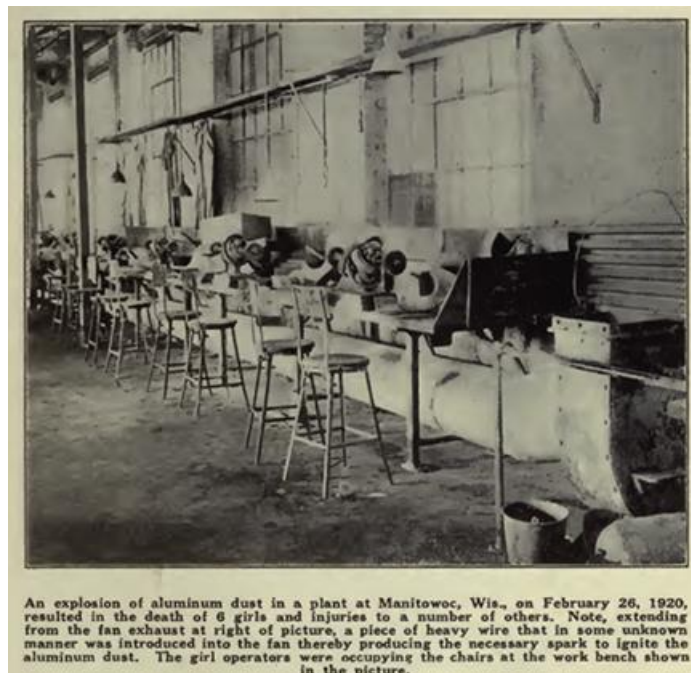
One of the first documented aluminum dust deflagration was reported by Price and Brown (1922) in the USA. The accident took place in the polishing workshop of a manufacturing plant located in Manitowoc, Wisconsin, on February 26<sup>th</sup>, 1920. Aluminum dust was drawn away from the polishers into a suction system which discharged into the open air. A heavy piece of steel wire fell into the exhaust pipe and struck the fan, striking sparks which ignited the dust. The explosion propagated back through the suction system and into the room (Figure 2), causing an explosion which was so violent that it was heard at least two miles from the plant, killing six operators.

Figure 2. Picture of the manufacturing plant located in Manitowoc, Wisconsin (Price & Brown, 1922) showing the work stations

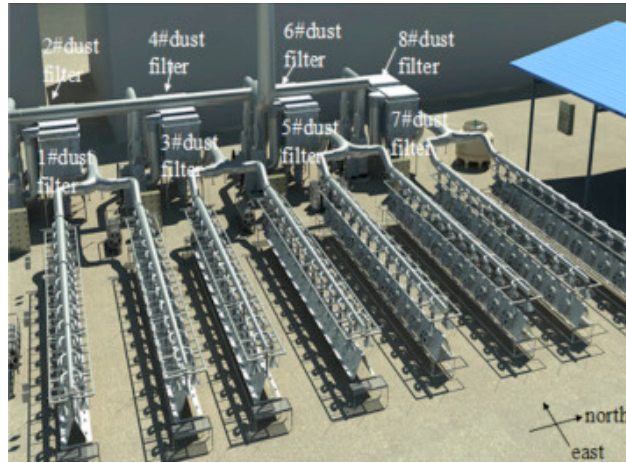
On August 2<sup>nd</sup>, 2014, an aluminum dust deflagration took place in an automotive parts factory of Jiangsu province, killing 146 people and injuring 114 people (Li et al., 2016). The explosion was heard several kilometers away, and shattered glass up to 500 meters away (Figures 7).

Figure 7a: Production lines with work stations (Li et al., 2016)

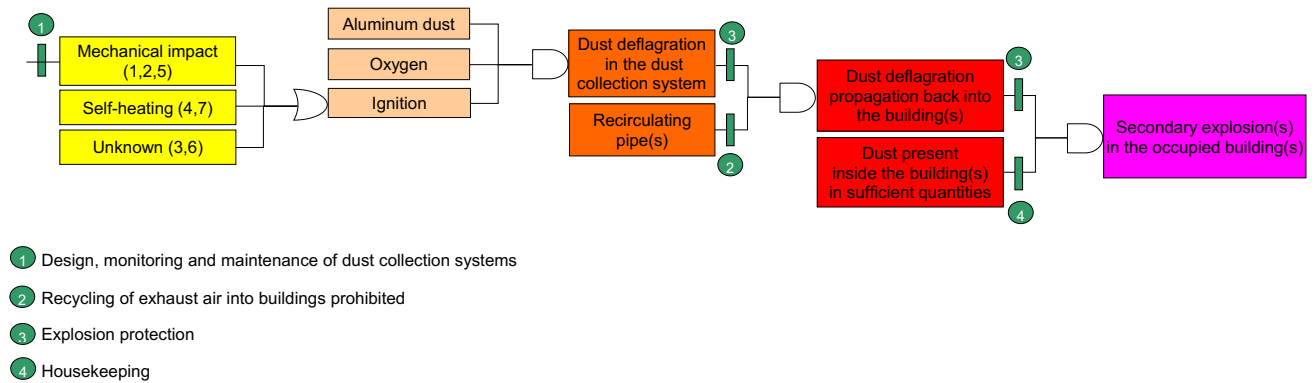
Figure 9 gathers these seven case studies into a single diagram, starting from the assumed ignition (left, in yellow) down to the final consequences of the accident. Numbers in brackets indicate the case study under consideration, while potential safeguards are represented as green barriers along the diagram, and will be discussed one by one in the following paragraphs.

Figure 9: Simplified representation of the seven case studies

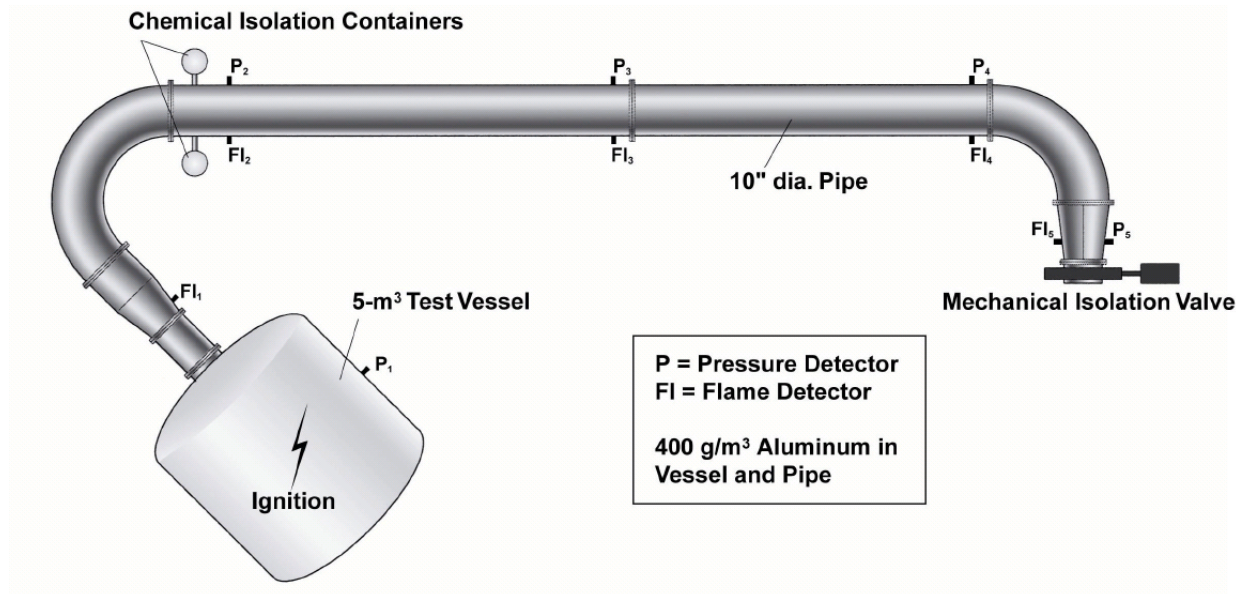
Tests were conducted by Fike Corporation at DMT GmbH testing site in the system shown in Figure 12 (Going and Snoeys, 2002). This layout was based on a 5 m<sup>3</sup> initiating vessel, a DN 400 pipe, an aluminum dust with  $K_{St} > 300$  bar.m/s and a maximum valve placement distance of 14 m. Tests indicated that the deflagration transitioned into a detonation within the pipe between the vessel and the explosion isolation valve; pressures up to 30 barg and flame speeds over 450 m/s were measured. The explosion isolation valve did stop the explosion flame from propagating down the pipe; however flames escaped through pipe gaskets and valve parts as a result of the excessive heat and pressure.

A combined system was developed by adding 2 chemical isolation containers at 4 m from the vessel, each containing 8.2 kg of SBC (sodium bicarbonate). This chemical barrier suppressed enough of the flame front so that the pressure at the isolation valves was decreased to an acceptable level, 15 barg, thereby allowing the isolation valve to completely block the flame without being damaged. This combination of chemical and mechanical isolation techniques was therefore proven to be a method to safely isolate a metal dust explosion without release of flame or combustion products.

Figure 12: Test layout for 5-m<sup>3</sup> initiating vessel and pipe isolation

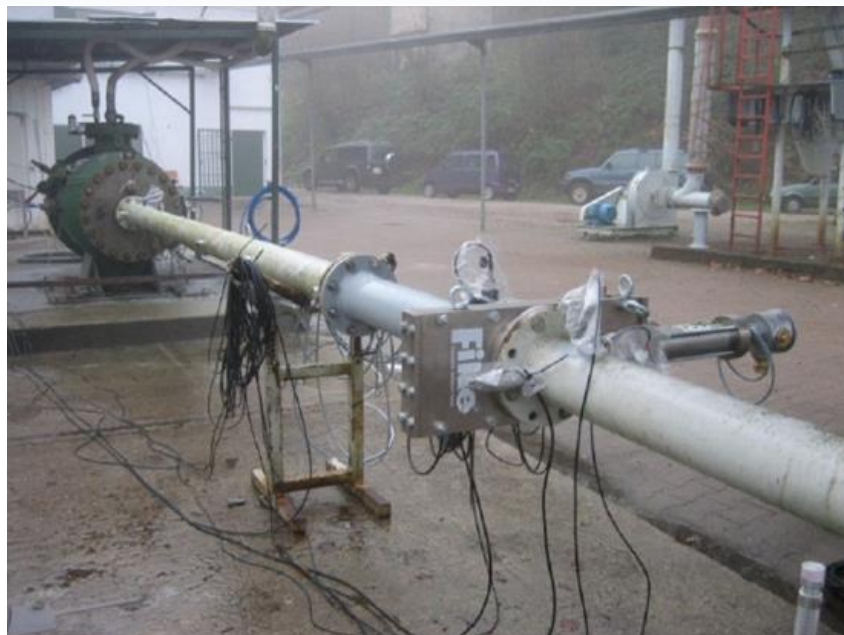
Further tests (Taveau et al., 2013) have been performed with aluminum dust ( $K_{St} = 680 \text{ bar.m/s}$ ,  $P_{\max} = 11.6 \text{ barg}$ ) using a new version of the gate valve (with a stronger design and better sealing capabilities at high temperatures) first on a DN 150 pipe connected to a 1-m<sup>3</sup> contained vessel (Figure 13). The valve was able to stop the explosion both for ignition near the pipe and ignition at the vessel center, without chemical isolation. Pressure spikes up to 40 barg were measured just upstream of the closed valve, but did not damage it.

Figure 13: Mechanical explosion isolation of an aluminum dust ( $K_{St} = 680 \text{ bar.m/s}$ ) deflagration initiated in a 1-m<sup>3</sup> contained vessel (Taveau et al., 2013)

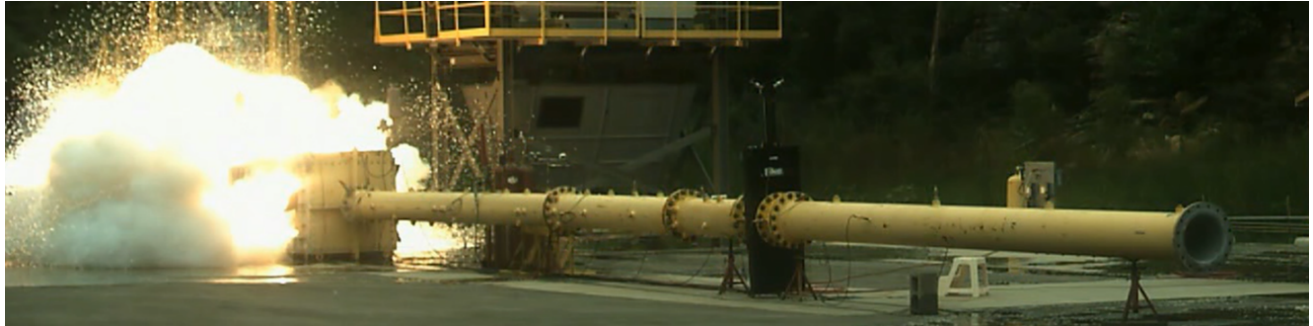
The most recent large scale tests involving a 5-m<sup>3</sup> vented vessel (for a  $P_{red}$  up to 0.9 barg) connected to a DN400 pipe and conducted with aluminum dust ( $K_{St} = 450$  bar.m/s,  $P_{max} = 10.1$  barg) were also successful (Figure 14).

Figure 14: Mechanical explosion isolation of an aluminum dust ( $K_{St} = 450$  bar.m/s) deflagration initiated in a 5-m<sup>3</sup> vented vessel (Fike Corporation)
