Prestressing in Coventry Cathedral

Chris Burgoyne*

Abstract

Keywords: Prestressed Concrete, Corrosion

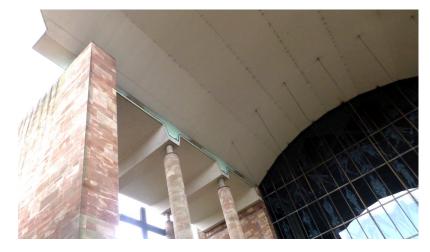
Figure 6: Underside of porch vault, showing the wires attached to West Screen

Great Glass Screen. The porch is divided from the baptistry by a glass screen that runs the full height of the building, and often referred to by its liturgical direction as the "Great West Screen". It seems to have been assumed that the glass at the bottom could not take the weight of the glass above, so the etched glass panels are held in a bronze framework, the mullions of which are supported at mid-height by six pairs of deltoid manganese-bronze ties to the porch roof outside and the baptistry roof inside (Blee, 2014; Crittall, 1962). Each cable was tensioned to 29.7 kN (see Figure 6) which supposedly took all the weight of the screen so that it was free to slide in a slot in the floor. The thickness of the concrete in the porch vault was increased locally where the cables are anchored. This arrangement allowed a lighter and more refined framework to be used while still being able to resist significant wind forces. These ties have been retensioned at least once since the cathedral has been in service (Clarke, 2000), most recently in 2006 when it was noted that they were completely slack. They have been tightened to act as braces to the centre of the screen but not to carry the weight of the glass which now passes directly to the ground (Fisher, 2014). The loss of tension is presumably due to creep in the concrete in the
