# The Marsh Lane Railway Viaduct: 2 years of monitoring with combined sensing and surveying technologies

Abstract. Marsh Lane viaduct is a typical example of a 19th century brick masonry railway arch in the UK. It frequently carries passenger trains to and from Leeds Station. This paper broadly discusses the sensing techniques and associated analysis procedures used to (i) identify the reasons for existing damage, (ii) quantify their impact on the dynamic response of the structure and (iii) measure degradation of the response over a period of one year. To identify existing damage, distortions in geometry of the structure are examined with new point cloud processing techniques. With the aid of limit analyses, these distortions are interpreted, and past support movements which may have caused the distortions are identified. Then, to measure the dynamic response of the bridge, quasidistributed fibre optic strain sensing and digital image correlation displacement measurement techniques are used. These highlight the increased dynamic response around locations of existing damage, and point out to the global mechanisms of response that could propagate damage. Continuous fibre optic strai

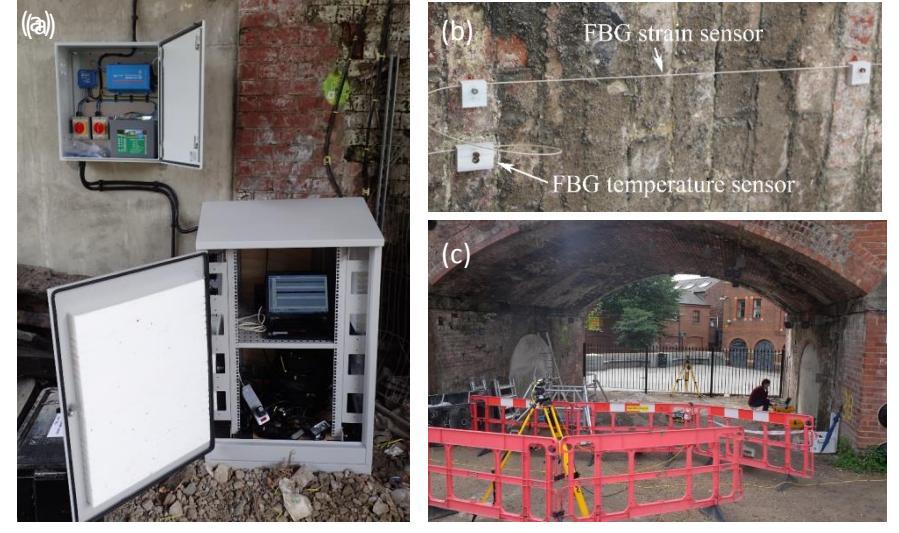
**Fig. 3.** (a) The fibre optic data acquisition system permanently installed under Arch 37, inside a temperature controlled cabinet, where it is connected to a laptop with a router, (b) FBG strain and temperature sensors, and attachment clamps, and (c) configuration of cameras for DIC monitoring.

FBGs were placed in the longitudinal and transverse directions over ~1m gauge lengths to measure dynamic strain. Temperature was measured and its effects on strain were compensated (Fig. 3b). Only a few measurements are discussed in this paper, detailed results can be found in [1]. Fibres strung across piers allowed measurement of span opening and closing, denoted by  $\Delta$ (WP-EP). Strains across cracks in Arch 38 were monitored:  $\epsilon$ (A2-A3) measured longitudinal strains over the transverse crack while  $\epsilon$ (T4-T5) measured transverse strains at the tip of the longitudinal crack.

Meanwhile, the cameras were positioned centrally in line with the crown of the arches at a suitable distance (Fig. 3c). This setup allowed monitoring planar movements of Arches 37 and 38 in the vertical plane directly under the tracks, aligned with the bridge longitudinal axis. A useful measurement is the vertical crown displacement,  $\Delta Y(A5)$ . Relative displacement measurements could also be obtained from the cameras, such as the measurement of span opening and closing,  $\Delta$ (WP-EP), that could be directly compared to the FBG data.

[4] describes a solar panel powered Data Acquistion system (DAQ) that was permanently installed under Arch 37 inside a temperature controlled cabinet in July 2018 (see Fig. 3a). The DAQ features the fibre optic interrogator connected to a laptop with a router, which remotely transmits daily data through a 4G internet connection. A bespoke signal processing code was written to identify the type of train loading (train direction, velocity, number of carriages, relative axle distance) and determine statistical variations in dynamic strain under the same type of load.
