UNIVERSITY OF CAMBRIDGE
DEPARTMENT OF ENGINEERING

**RESPONSE OF PILED BUILDINGS TO THE
CONSTRUCTION OF DEEP EXCAVATIONS**

MANDY KORFF
Jesus College

A dissertation submitted for the degree of Doctor of Philosophy at the
University of Cambridge

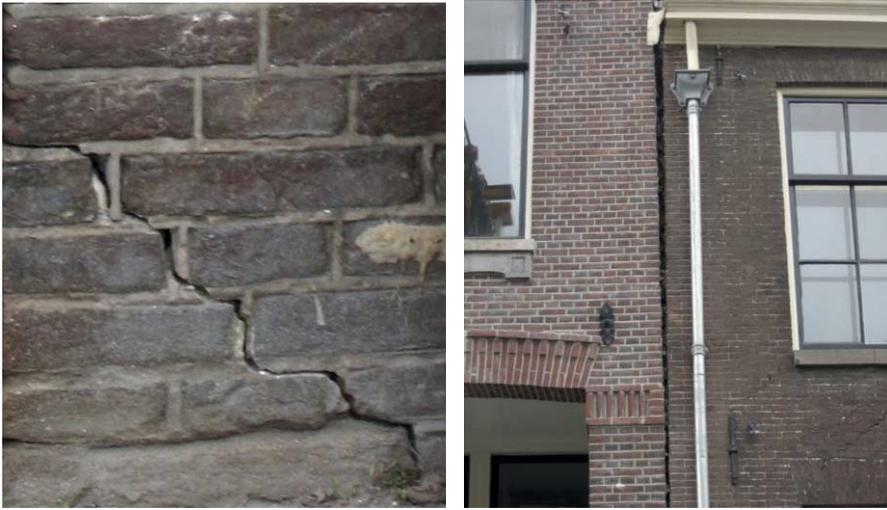
Figure 2.16 Crack due to shear deformation (left) and relative rotation of one building to the other (right)

The location and the direction of the crack are directly related to the deformation mode (hogging, sagging). Other damage might include broken windows and jamming doors because windows and door openings are distorted, sloping floors and tilting walls (see Figure 2.16 for tilting walls).

BRE (1995) shows how to identify cracks by their nature and divides between tensile cracks, compressive cracks and shear cracks. Compressive cracks often show small flakes of brick squeezed from the surface or localised crushing. Shear cracks (Figure 2.16) show relative movement of points on opposite side of the crack. When the cracks originate from foundation movement, they tend to concentrate in areas where maximum distortion occurs, or at weak points in the structure.

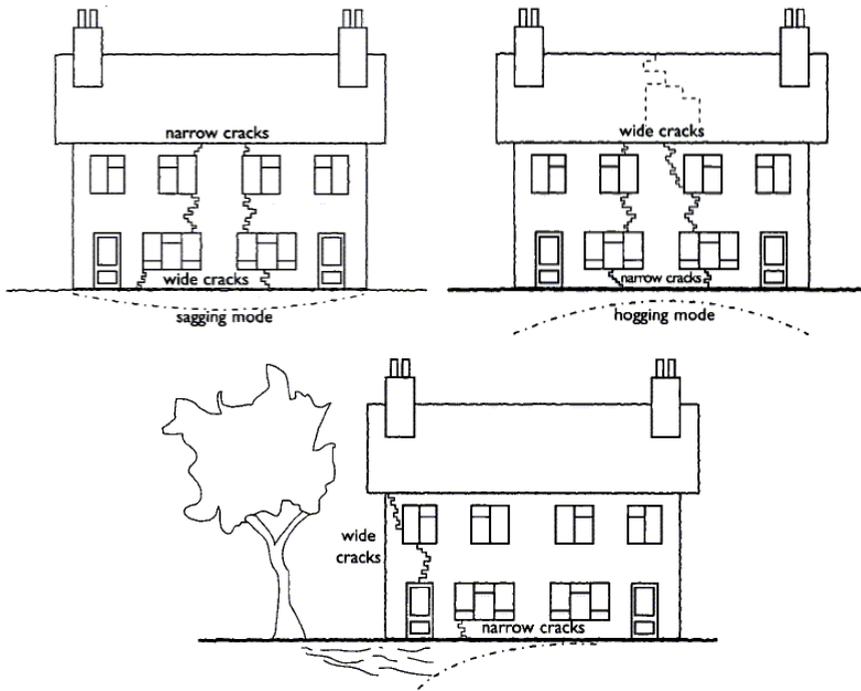
Figure 2.17 Crack patterns due to different deformation modes (Bonshor and Bonshor, 1996)

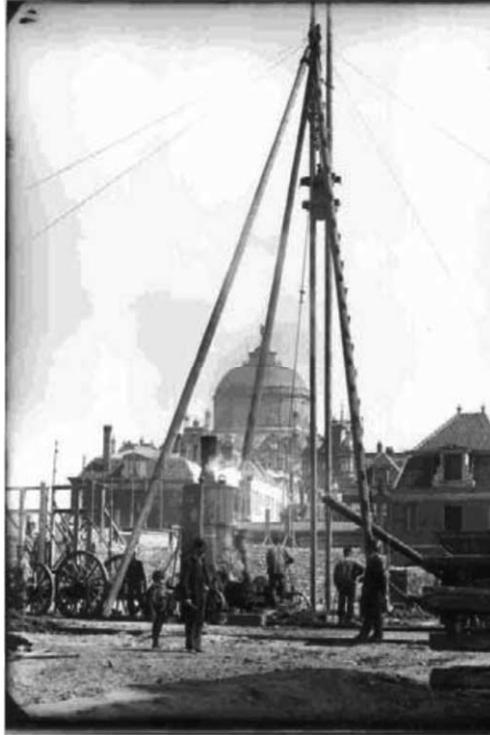
Figure 4.5 Installation of wooden pile by steam engine (picture taken in 1891 by Jacob Olie)

The oldest pile foundations still present in Amsterdam (and rather typical for the old cities in the Western part of The Netherlands) date from the 17th century. Most of the buildings around the deep stations rest on a foundation of timber piles in the First Sand Layer (Eerste Zandlaag). Pile installation was done by hand using a tripod and weight lifted by several men at that time. Since approximately 1870 steam engines were used, see Figure 4.5.

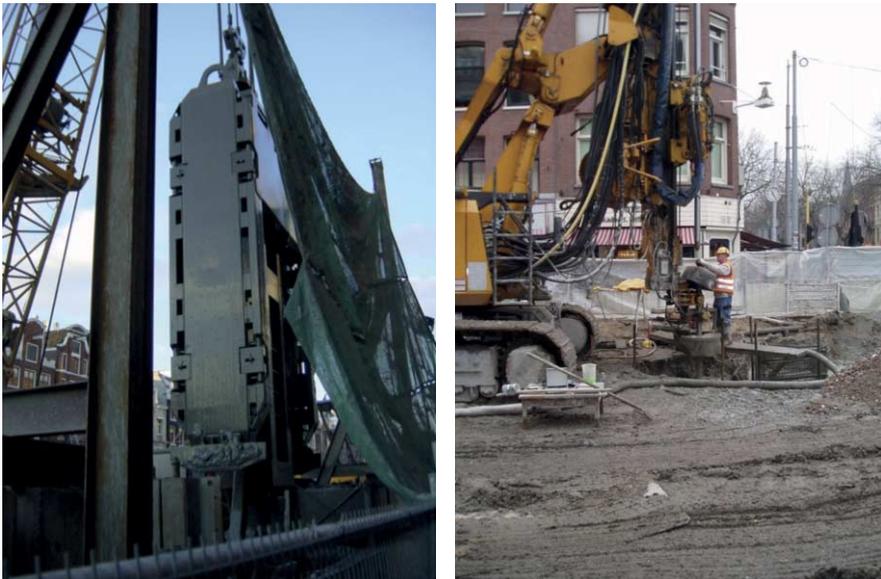
The diaphragm walls were constructed in panels, see Figure 4.15. The individual panels have a width of 1.2m and a length of about 3.6m-6.6m along the wall, the bottom level is found at NAP-38m. The stabilizing fluid (bentonite) has a volumetric weight of about 10.5kN/m^3 minimum.

Figure 4.15 D-wall construction and jet grout strut installation

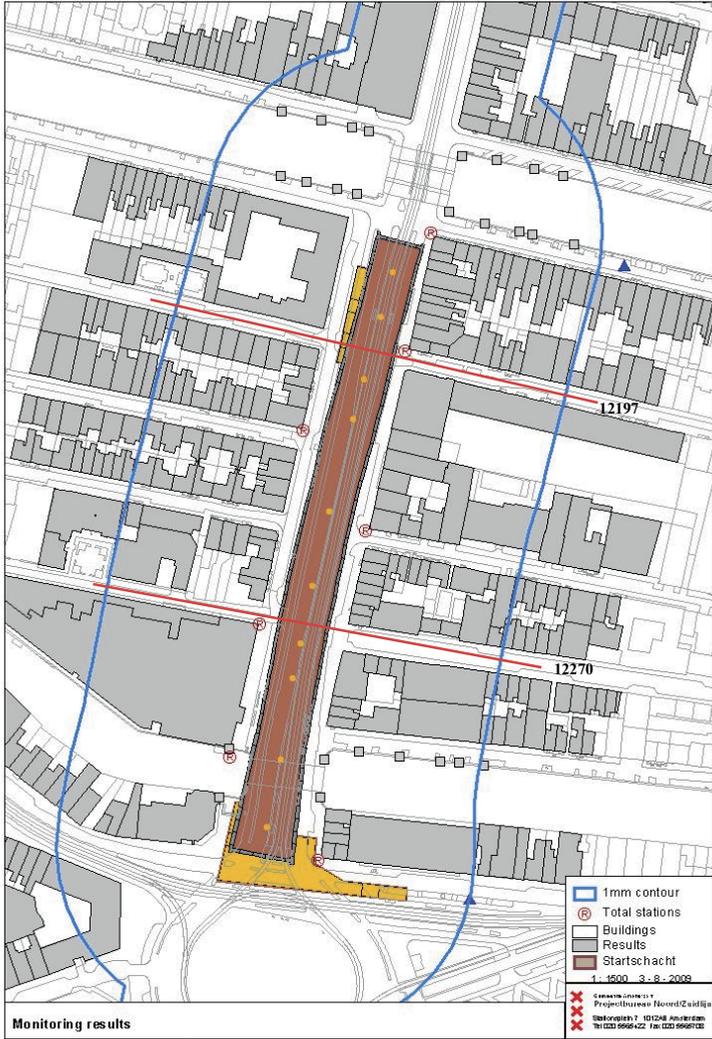
Figure 4.17 Locations of cross sections with subsurface monitoring

Vijzelgracht Station is the second of the Deep Stations for the North South metro Line in Amsterdam. The station is 250 m long, 22 m wide and reaches a maximum depth of NAP - 29.5 m. It is built by means of a top down construction, with 1.2m thick diaphragm walls extending to a depth of NAP - 44.5 m. Adjacent buildings are found at 3.2m from the diaphragm wall or further away. Station Vijzelgracht has two arrays of measurements perpendicular to the station (numbered 12270 and 12197), see Figure 4.17.

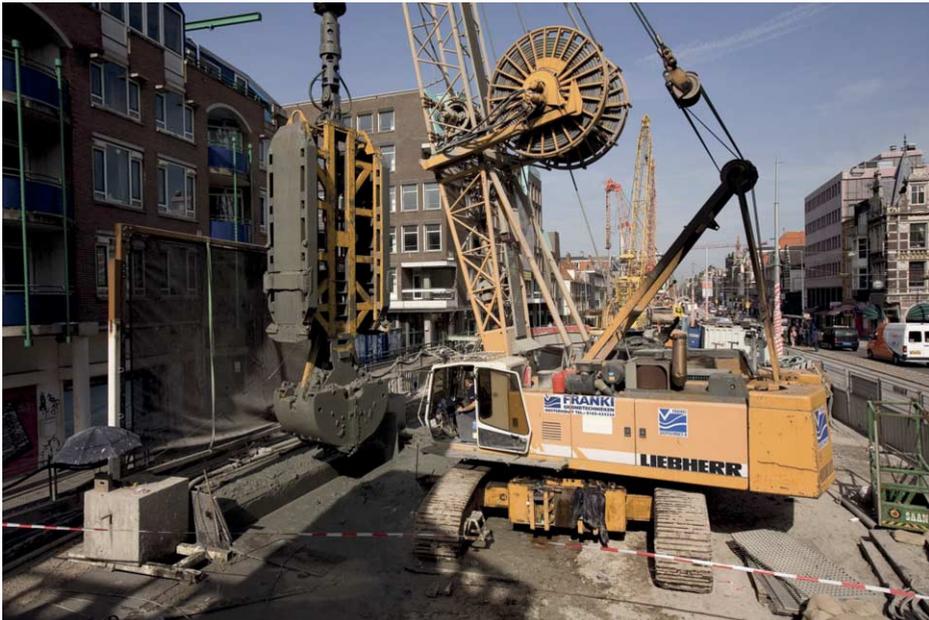
The diaphragm walls were constructed in panels. The individual panels have a width of 1.2m and a length of about 2.6m (panels 21 and 43) or 3.7m (the other panels) along the wall, the bottom level is found at NAP - 45m. The stabilizing fluid (bentonite) has a volumetric weight of about 10.5kN/m³ minimum. Figure 4.21 shows the equipment and the guide walls used for the diaphragm walls.

Figure 4.21 Construction of D-wall Vijzelgracht Station

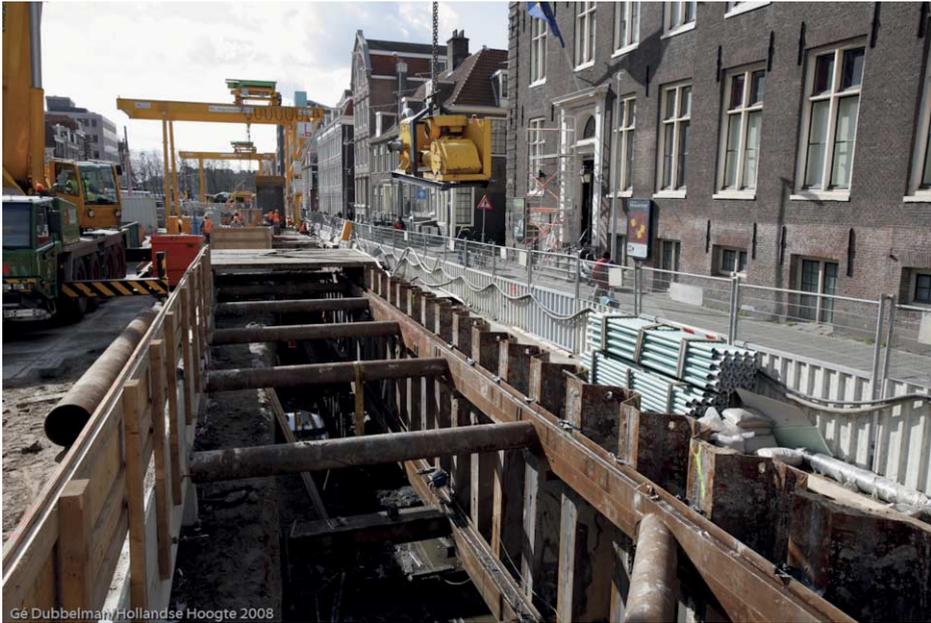
A sheet pile has been installed at cross section 12197 to a depth of NAP - 17.00m. The location of this temporary sheet pile is indicated in Figure 4.23.

Figure 4.23 Sheet piles for entrance of Vijzelgracht Station (photo Hollandse Hoogte)

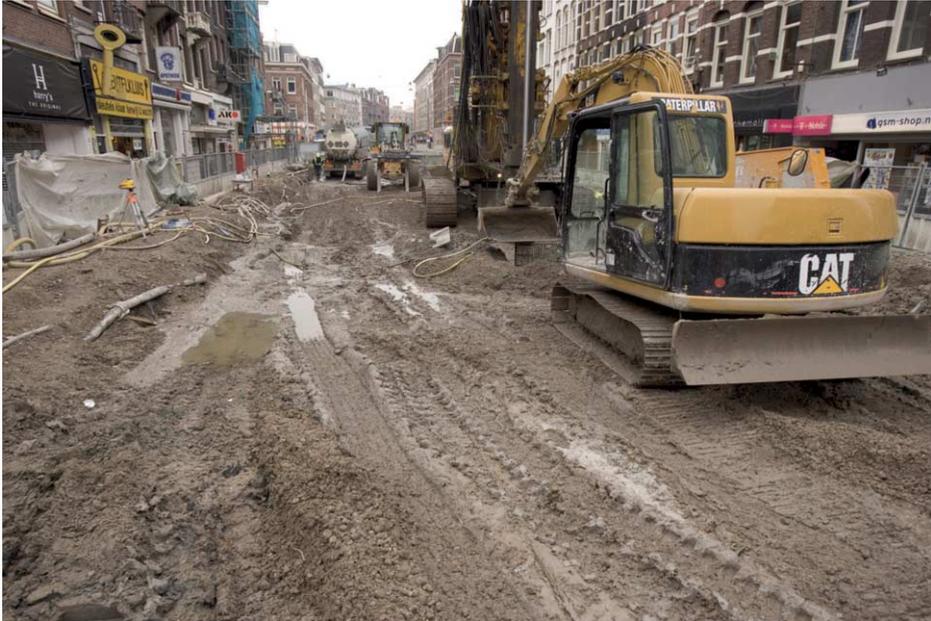
Figure 4.28 Back fill at Ceintuurbaan Station

The green field level is raised by 0.7 m of sand to provide working level for the installation of the diaphragm walls, see Figure 4.28. The distance of the sand layer to the buildings is about 3m.

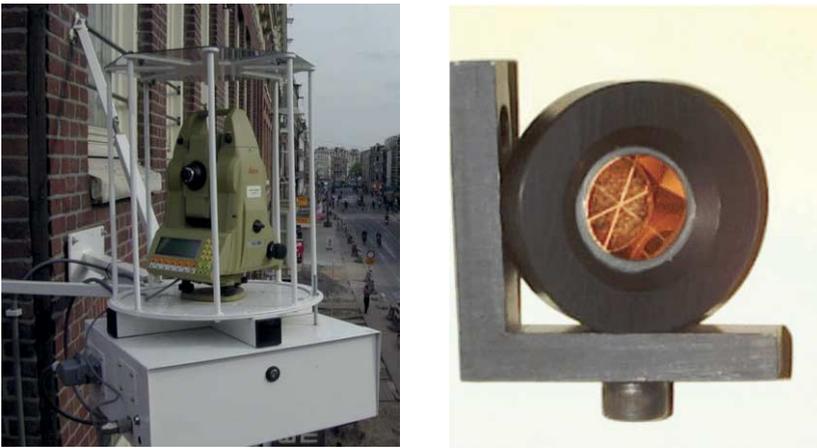
Figure 4.31 Robotic Total Station and prism

An automatic or primary monitoring system follows the buildings in the influence zone of the project. Primary instrumentation comprises of 74 Robotic total stations (RTS, see Figure 4.31) installed on key building facades, which take readings from the prisms on the buildings. These buildings are selected for their good quality foundation, but are in the influence zone. Measurements made with the RTS are related to other RTS locations outside the zone of influence. These again are related to stable reference points, with their foundations either in the second or third sand layer. Prisms are located on the fronts and the sides of the buildings, usually a minimum of 4 per building. Each robotic total station monitors about 50 to 100 prisms. Prisms are usually made of glass and have a diameter of 25 mm, see Figure 4.31.

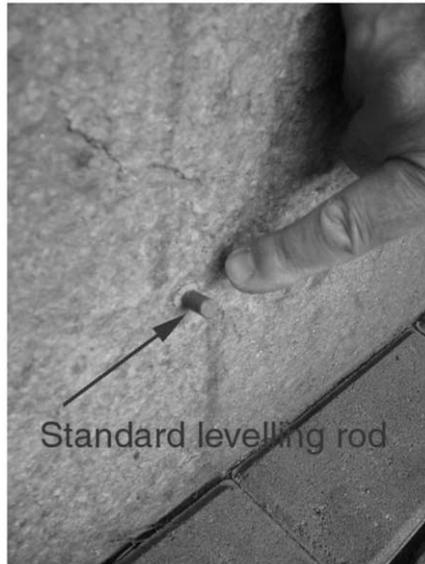
Figure 4.33 Manual levelling point

measured at intervals of 6-12 months. The precise levelling points have been attached to the buildings with a stainless steel socket, fixed with epoxy (see Figure 4.33). At the start of the project problems were noticed with the accuracy of the manual levelling points, which contractually should be 1.0mm maximum. These problems were solved later on and the data of the precise levelling points could be used in the analysis.

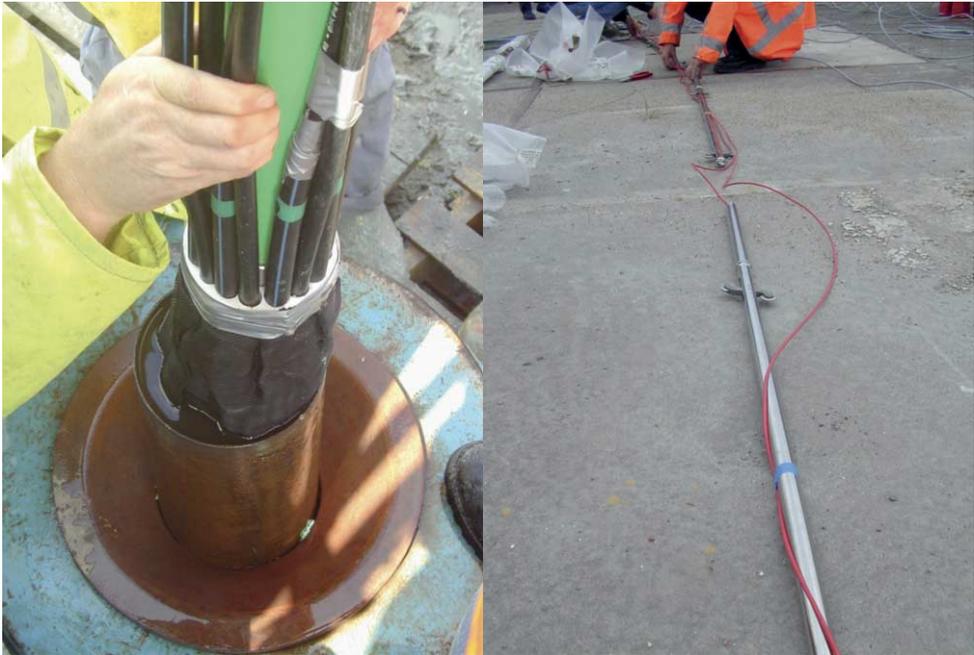
Figure 4.37 Combined inclino- and extensometer (a) and assembled inclinometer instrument (b)

Automatic inclinometers are placed along the same locations and depths of the extensometers, see Figure 4.39. A combined inclinometer/extensometer system is used, see Figure 4.36 and Figure 4.36.

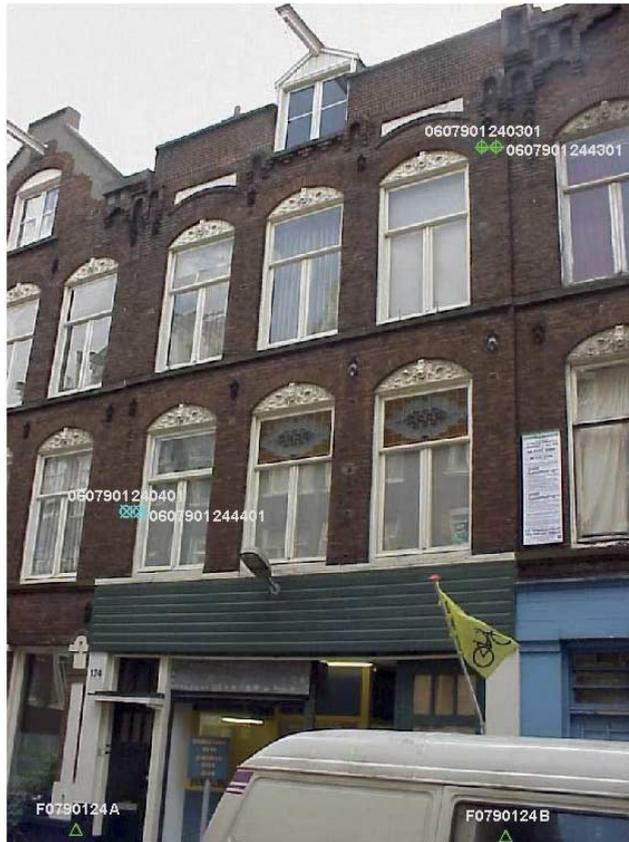
Figure 8.3 Façade with monitoring points Govert Flinckstraat 124 (Ceintuurbaan)

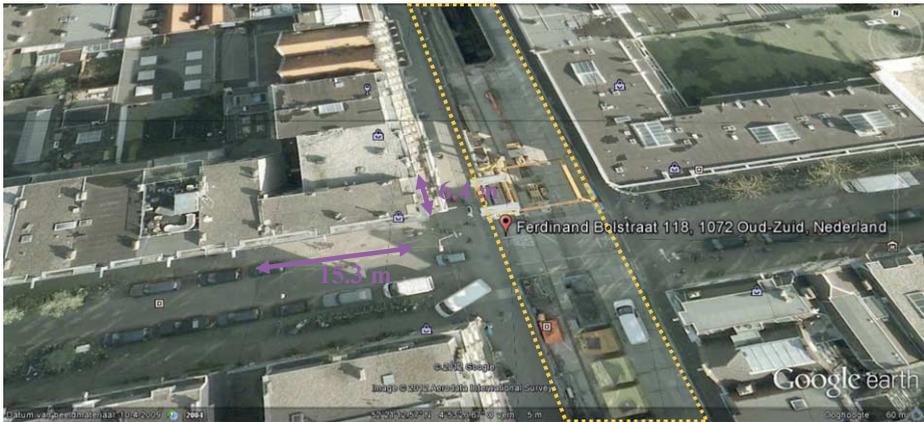
Figure 8.10 Aerial view of Ferdinand Bolstraat 118 (Ceintuurbaan) with dimensions

In cross section 13110WN Ferdinand Bolstraat 118 is analysed. The foundation type (see Chapter 4) is type 1e, this means the foundation is renewed. The location of the buildings and monitoring data as well as the deep excavation is shown in Figure 8.10 and Figure 8.11 and the corresponding displacements in Figure 8.13. A selection of monitoring points on the facades is shown in the pictures in Figure 8.12. Ferdinand Bolstraat 118 is constructed in 1893, has four regular storeys, a top floor and no basement. The top of the original foundation is found at NAP - 1 m and the designed pile load is 65 kN (façade 1st Jan vd Heijdenstraat, perpendicular to the station) to 80 kN (walls shared with neighbouring buildings).

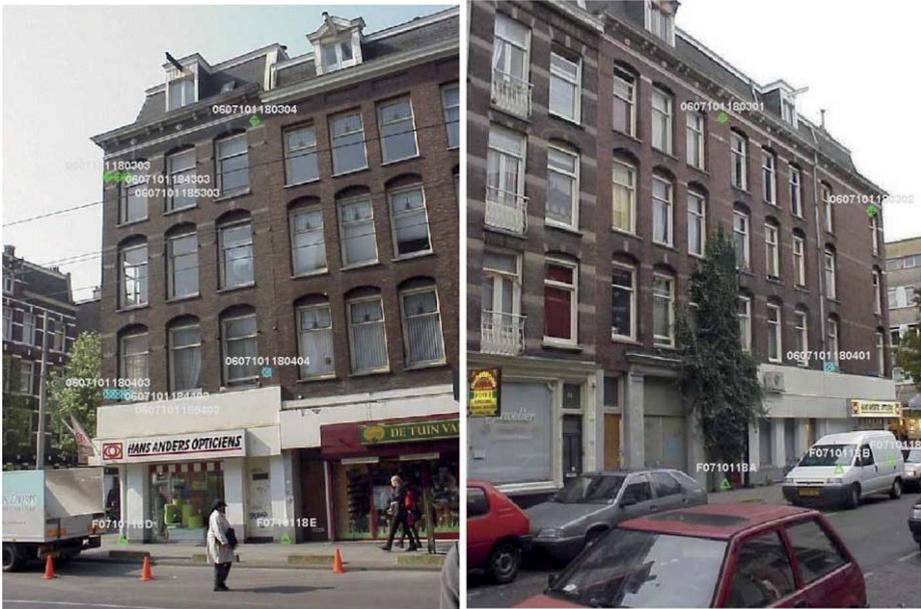
Figure 8.12 Façade with monitoring points Ferdinand Bolstraat 118 seen parallel (left) and perpendicular (right) to deep excavation (Ceintuurbaan)

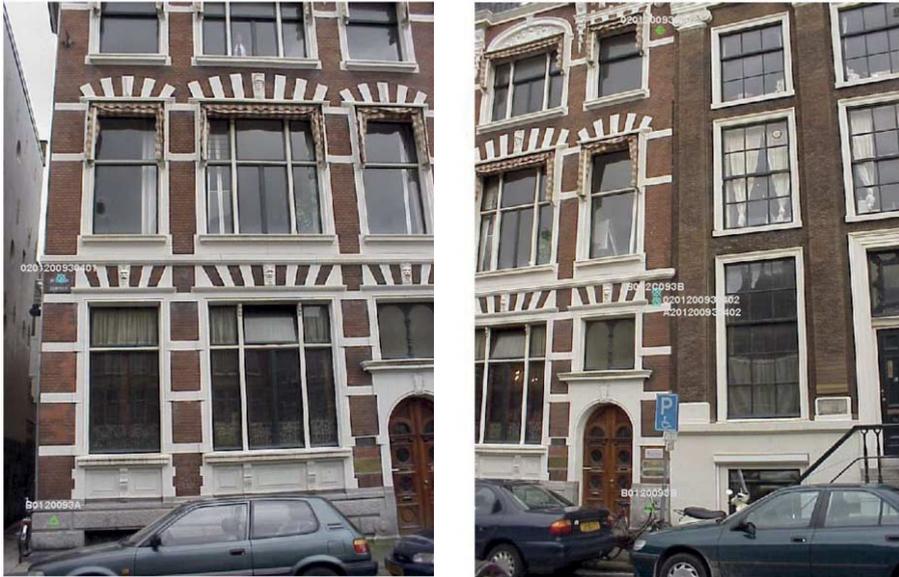
Figure 8.17 Façade with monitoring points Rokin 93 (Rokin)

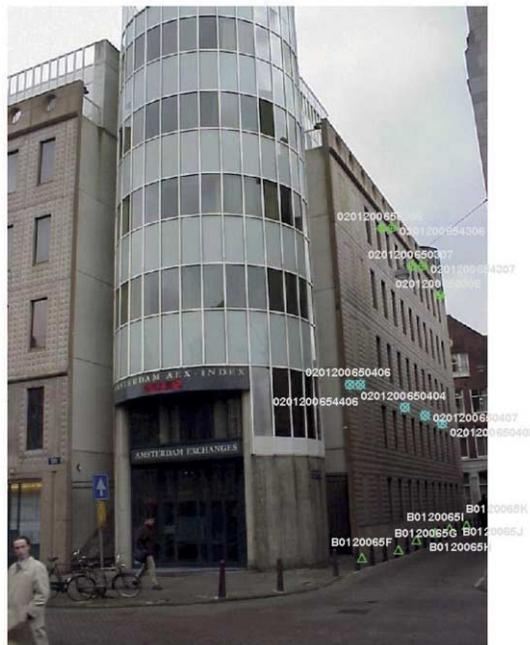
Figure 8.20 Façade with monitoring points Rokin 65 seen from Rokin Station side (Rokin)

In cross section 11131E, Rokin 65 is a modern building with a concrete pile foundation to the second sand layer (type 2a) at about NAP -20 m depth. The monitoring points are shown in Figure 8.20 with the closest distance to the deep excavation of about 15 m. The subsurface measurements of 11131 can unfortunately not be used, but the settlements of Rokin 65 are so small (within 1-2 mm) over the whole period, that it is safe to state that z_i/L_p is approximately 1.0 for this building. See Figure 8.19 for the settlement of Rokin 65

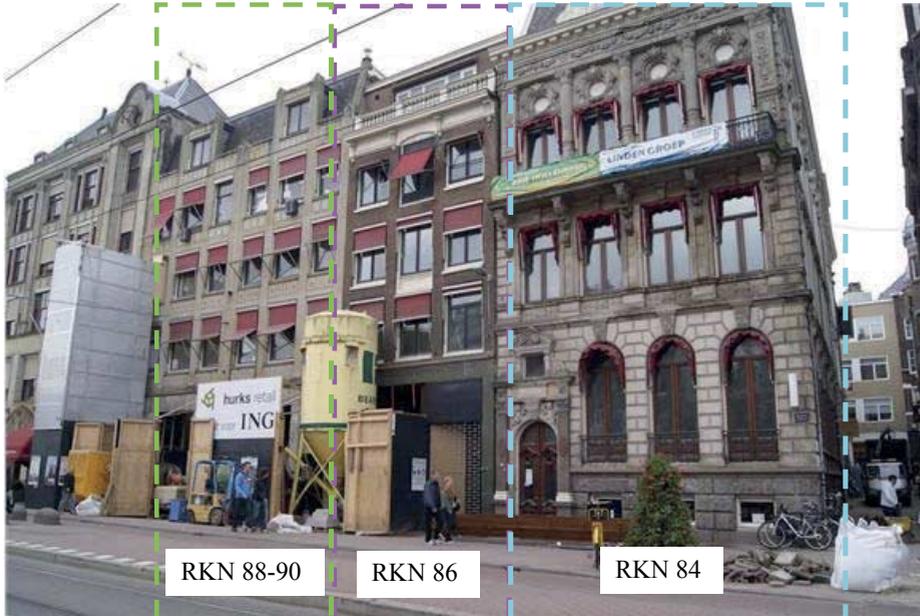
Figure 8.21 Façade with monitoring points Rokin 84 – 86 – 88 – 90 (Rokin)

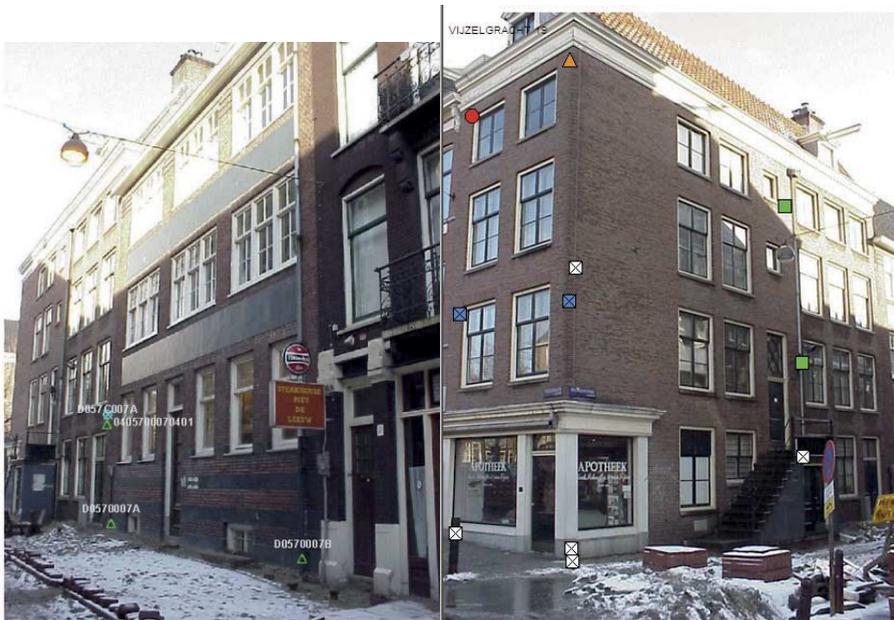
Figure 8.24 Façade with monitoring points Noorderstraat 7 and Vijzelgracht 19 (Vijzelgracht)

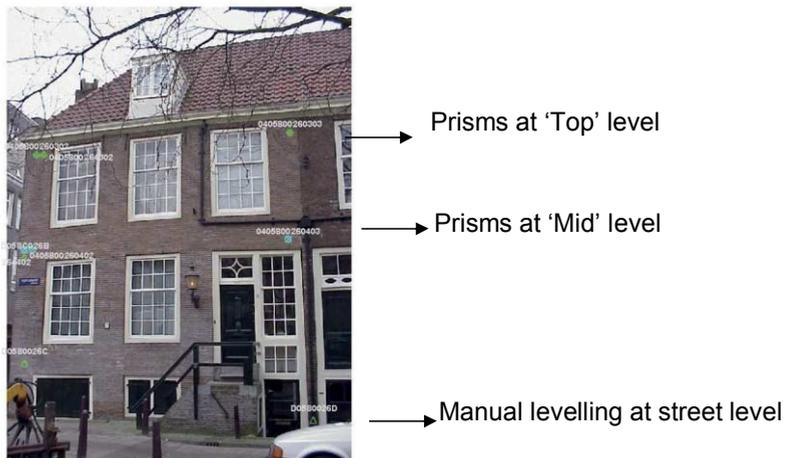
Figure 10.5 Weaverbuilding Vijzelgracht 26 with prism locations (picture Dienst NoordZuidlijn)

The buildings all have a semi-basement, a raised ground floor, and a first floor with a vaulted roof. The rear of the houses include a kitchen addition. The height of the buildings is about 9 m. A foundation consisting of 52 timber piles per house to the first sand layer at a level of around NAP -13 m. The piles are placed under the brick walls in rows of 2 piles. Due to the use of lime mortar instead of cement at the time of construction, the houses deformed in a rather flexible way due to considerable natural soil deformations. Before construction of the North South Line these buildings were equipped with monitoring instruments, comprising optical prisms for total station surveying at two levels and manual levelling bolts at street level, see Figure 10.5.

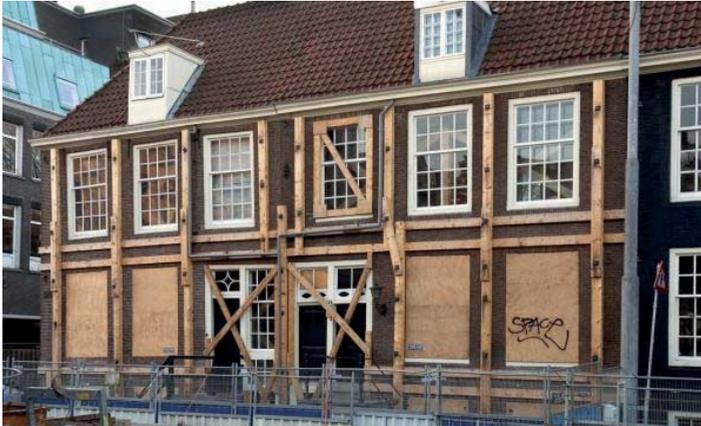
Figure 10.6 Damaged buildings Vijzelgracht 20-26 due to first incident June 2008

To stabilise the historic buildings a timber framework was installed on the outside, see Figure 10.6, as well as inside.

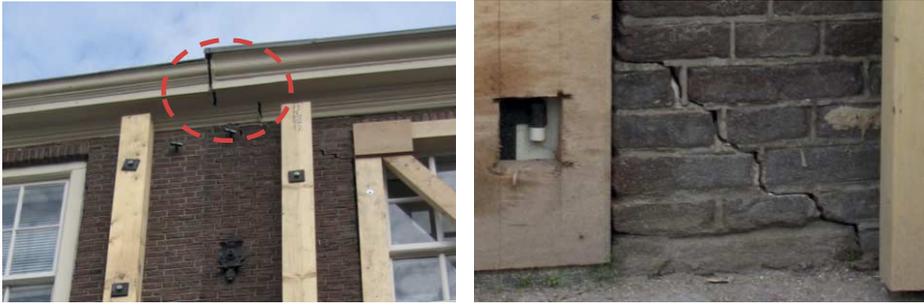
Figure 10.9 Details of cracks; left: crack 1, width max. 20 mm, right: crack 4, width max. 8 mm.

As shown in Figure 10.7, the block of houses Vijzelgracht 20-26 settled a maximum of 150 mm as a consequence of the first incident in June 2008. The building tilted towards the corner of VZG 26, and towards the excavation and the location of the leakage. A slight sagging was found between VZG 26 and VZG 24 and hogging towards VZG 22. The cracks on the inside and outside of the buildings are shown in Figure 10.8 and Figure 10.9. The cracks reported are mainly new cracks or previous cracks that opened significantly.

It can be concluded that the damage to the façade is mainly caused by shear deformation and horizontal extension in the plane of the wall. The damage categories inferred from the deformation measurements are consistent with the actual observed damage. Damage to the buildings as a whole is especially severe in terms of serviceability due to the overall rotation of the building perpendicular to the facades. Severe sloping and tilting of floors and walls are clearly noticeable, which is consistent with Charles and Skinner (2004) who concluded that for low-rise buildings a tilt of 1:250 is noticeable and a tilt of 1:100 requires remedial action, even without any deflection. Separation of the rear façade from both the main house and the kitchen addition is caused by horizontal extension. Its effect can not be quantified because measurements have not been taken at the rear of the buildings; they are also not easily described in terms of ‘traditional’ damage criteria.

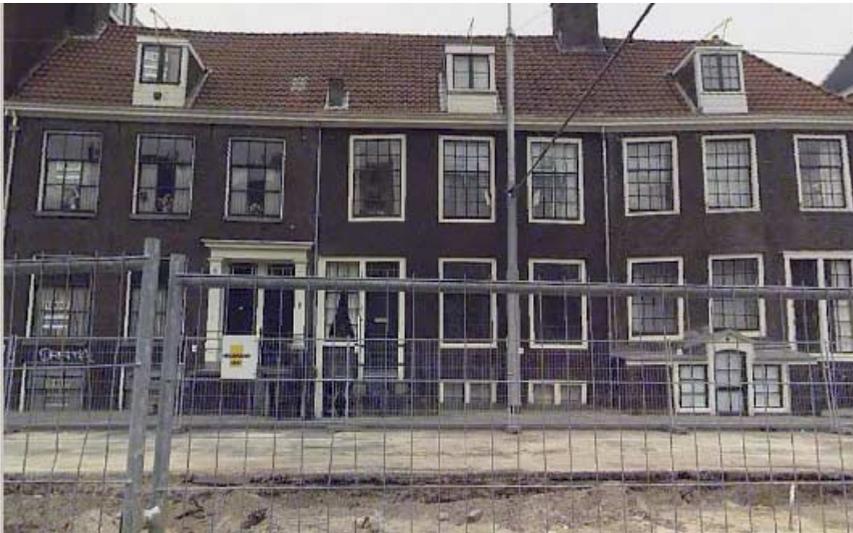
Figure 10.10 Vijzelgracht 8-6-4 before the incident (2002)

Block Vijzelgracht 4-10 settled a maximum of 240 mm directly after the second leakage incident. The foundations of Vijzelgracht 4-8 have been renewed before the construction activities started. The new steel piles and the old timber piles are both founded in the first sand layer. Figure 10.10 shows the buildings before the leakage damage occurred and Figure 10.11 the same buildings after the leakage. It can be seen that there was already a large shear deformation before the leakage.

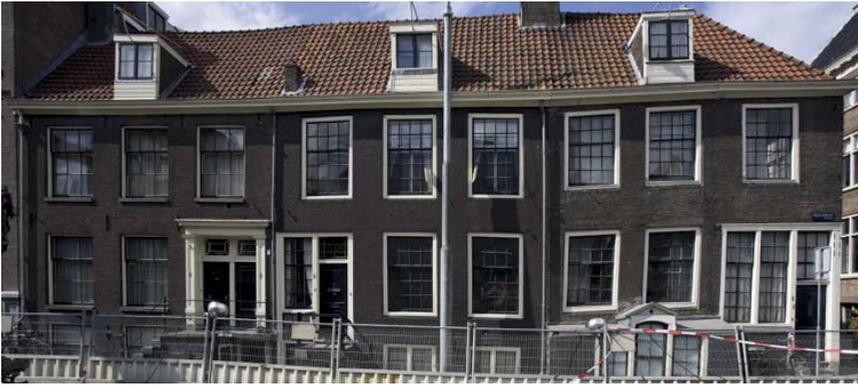
Figure 10.11 Vijzelgracht 8-6-4 after the incident (2008)

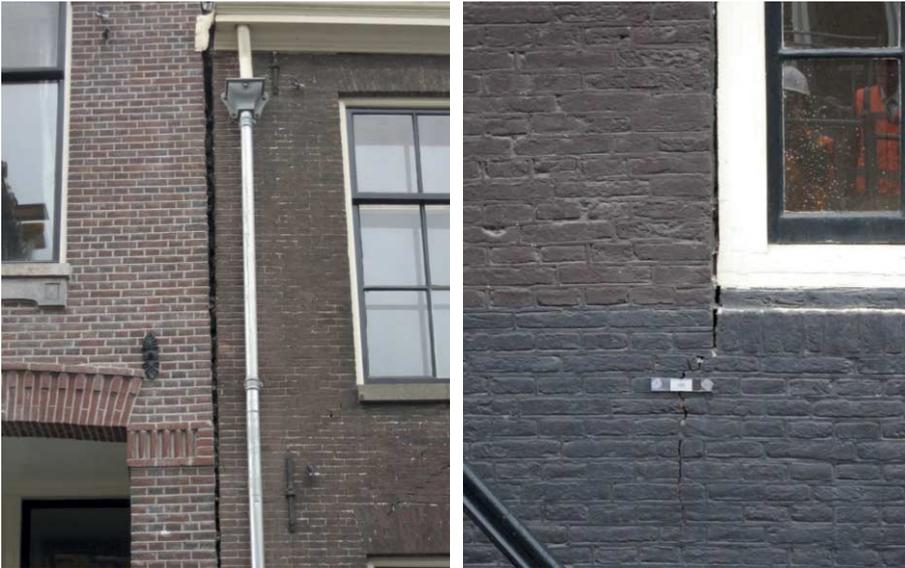
Figure 10.14 Details of cracks shown in Figure 10.12; left: crack number 1 between Vijzelgracht 10 – 8, right: crack number 9 (crack width max. 10 mm)

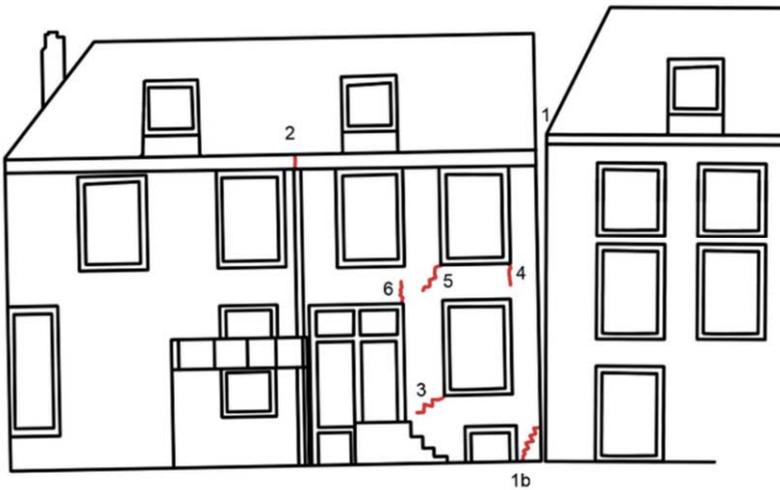
Figure 10.15 Cracks side façade (Vijzelgracht 4 on the left, 1e Weteringdwarsstraat 70 on the right)

Figure 10.12 shows the cracks on the outside of VZG 8 (left), VZG 6 (mid) and VZG 4 (right). Crack 1 is a separation crack of about 60-80mm at the top, due to tilt of VZG 8 away from the neighbouring building on the left side (VZG 10). Cracks 2, 11, 12, 15 and 18 are generally up to 5 mm wide. Cracks 3, 4, 5, 7, 8, 9, 10, 16 and 17 are 5-10 mm wide. Cracks 13 and 14 are 20 mm and 15 mm wide respectively. Figure 10.12, Figure 10.14 and Figure 10.15 focus on new cracks and existing cracks that re-opened.

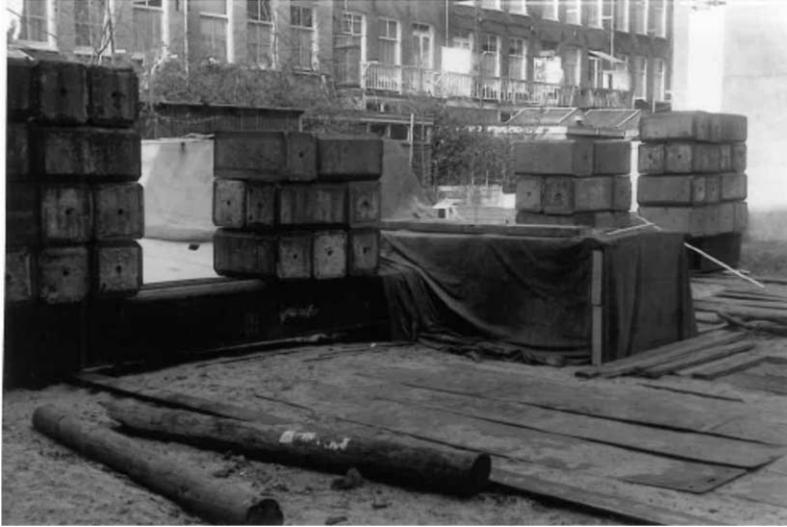
Figure D.5 Pile test set up

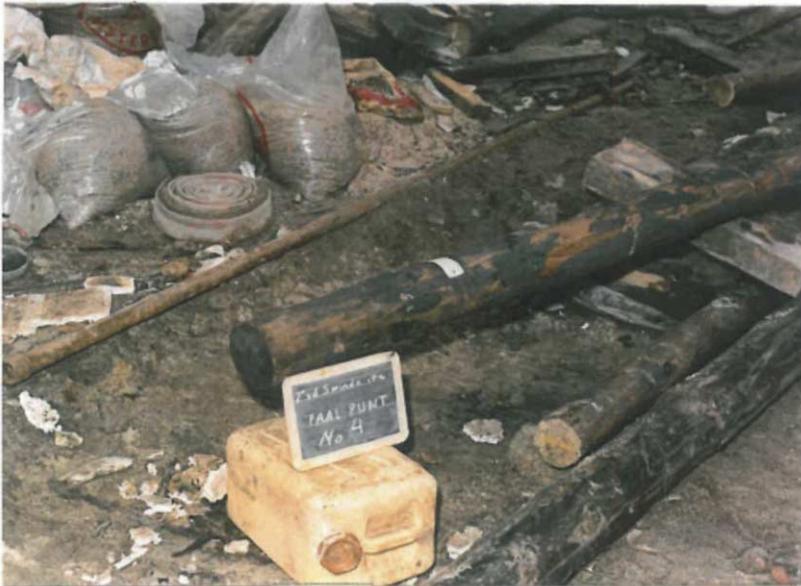
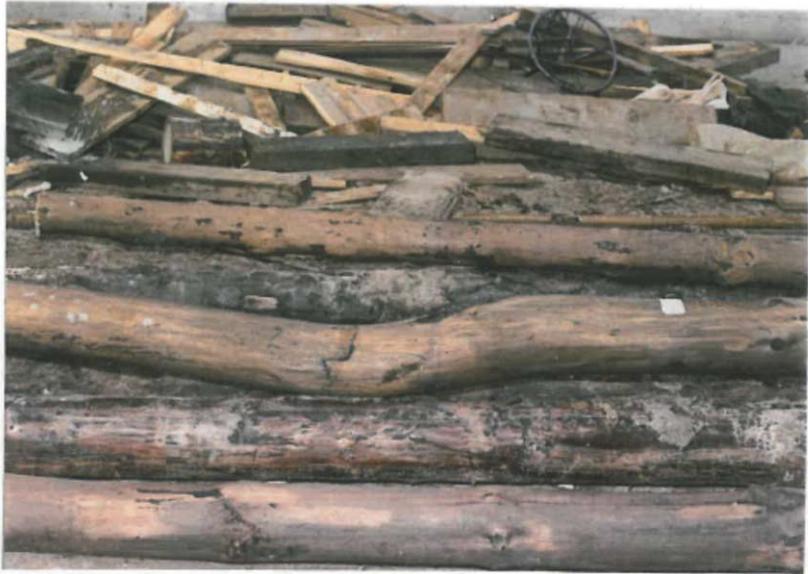
- ← P. Pile 2?
- ← New pile
- ← Pile 4
- ← New pile
- ← P. Pile 3?

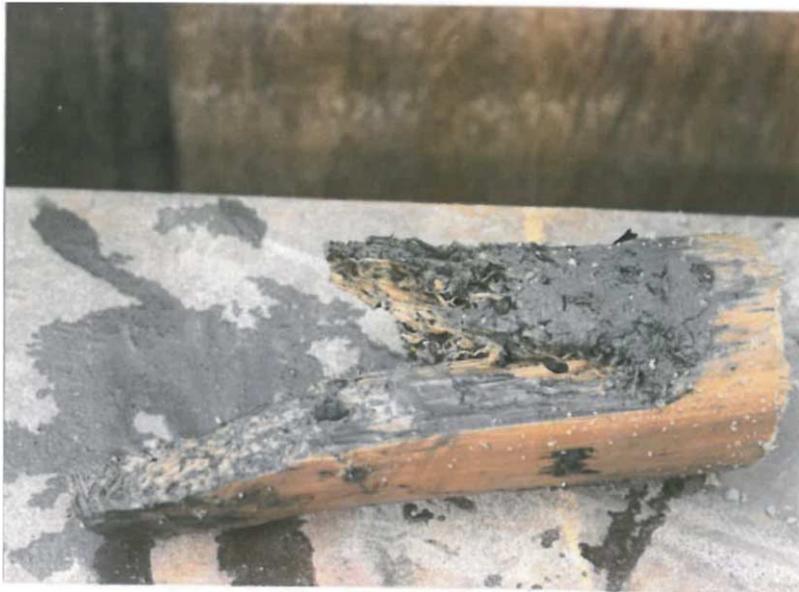
Figure D.7 Broken pile 5
