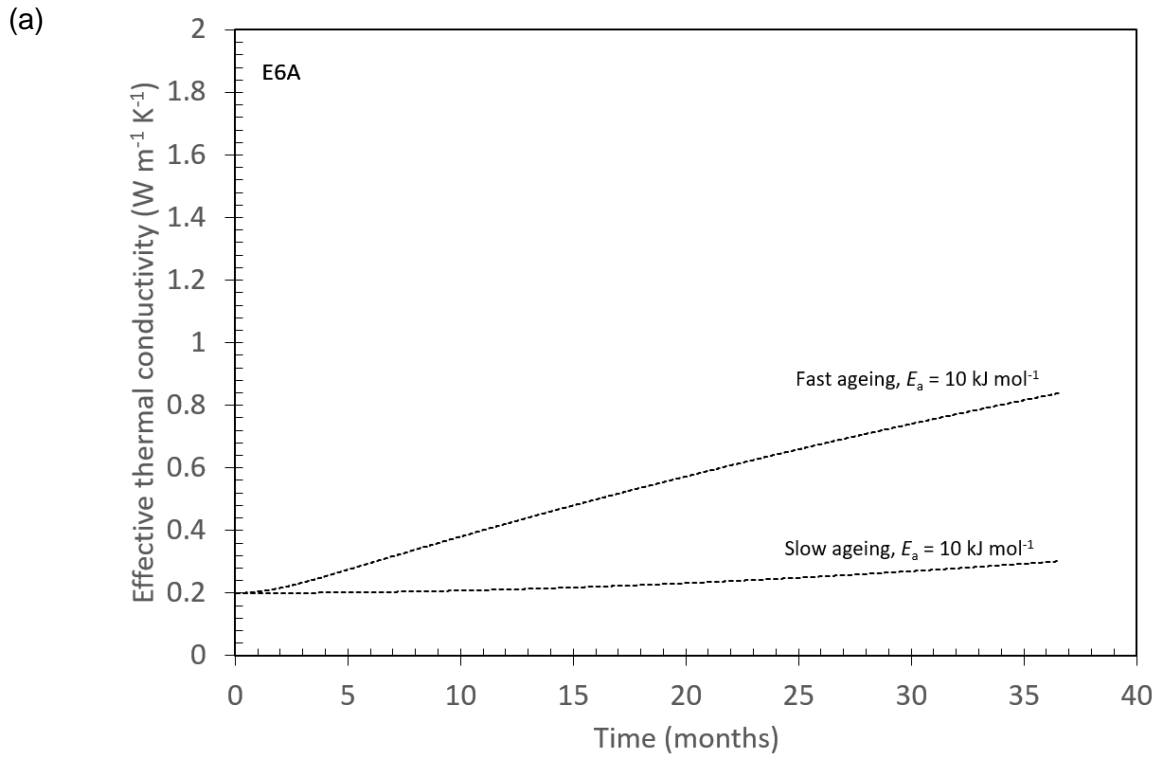
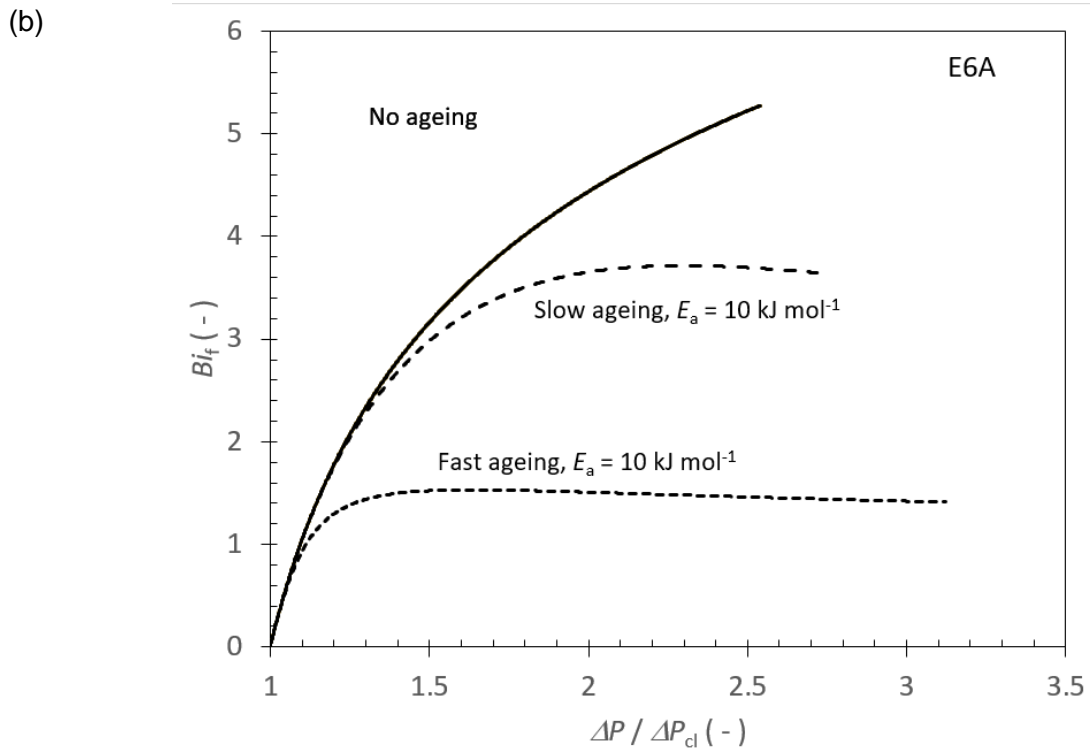
Figure A: Evolution of (a) effective deposit thermal conductivity and (b) thermo-hydraulic performance in Case Study exchanger E6A for fast and slow ageing with weak temperature dependency.

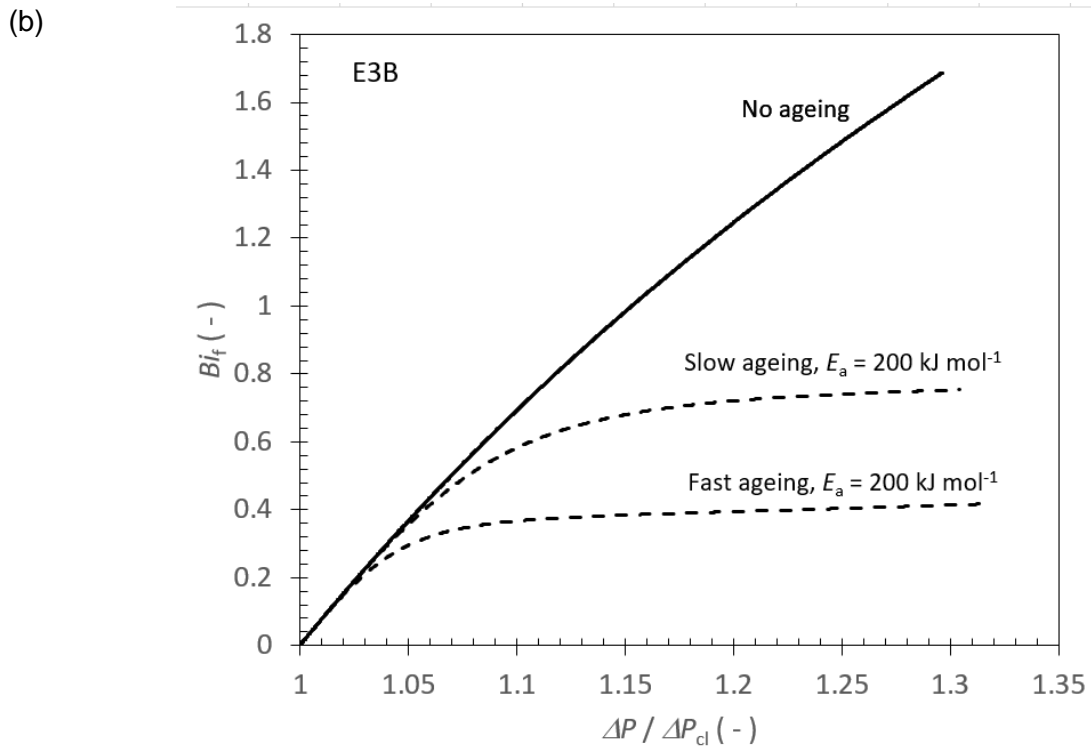
Figure L: Evolution of (a) effective deposit thermal conductivity and (b) thermo-hydraulic performance in Case Study exchanger E3B for fast and slow ageing with strong temperature dependency.
